Journal of the
National
Academy OF
Forensic
Engineers[®]

Vol. 41 No. 2 December 2024

Forensic Engineering Analysis of a Residential Fire Caused by an Open Neutral

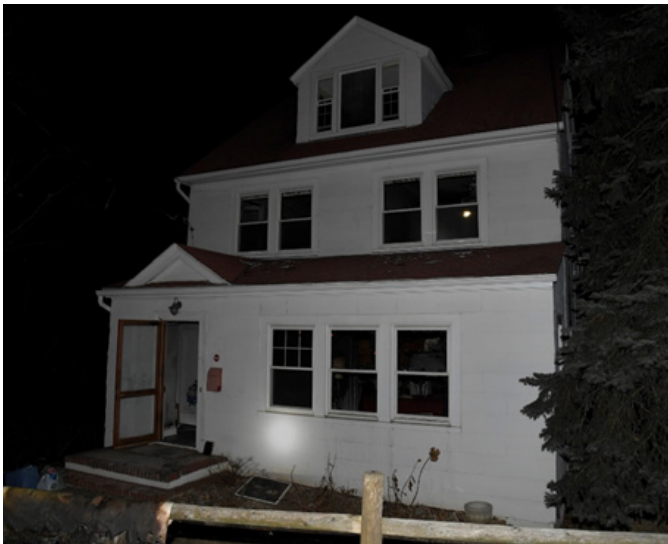
Figure 1

A structural fire broke out in a single-family residential house in Westchester County, New York, resulting in significant damage to the house. The house was a two-story wood-framed structure, approximately 1,800 square feet in size and 103 years old (**Figure 1**).

Front view of the subject two-story single-family residential house.
Photo taken by utility company on the night of the fire.

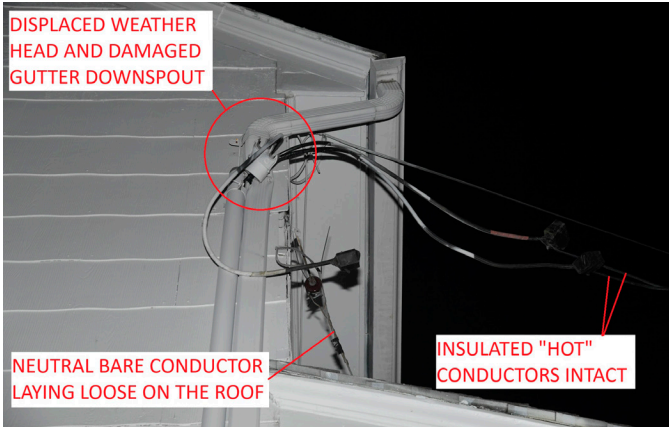
Figure 3

View of the service drop connection at the service entrance to the house — night of the fire (looking south).

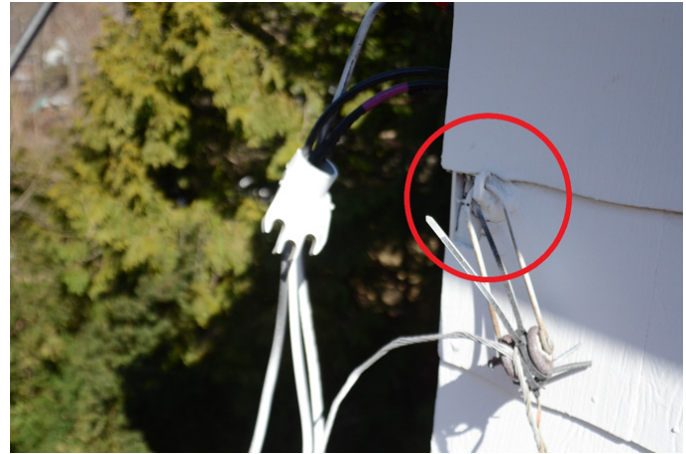
Figure 5

View of the insulator bail firmly attached to the building structure.

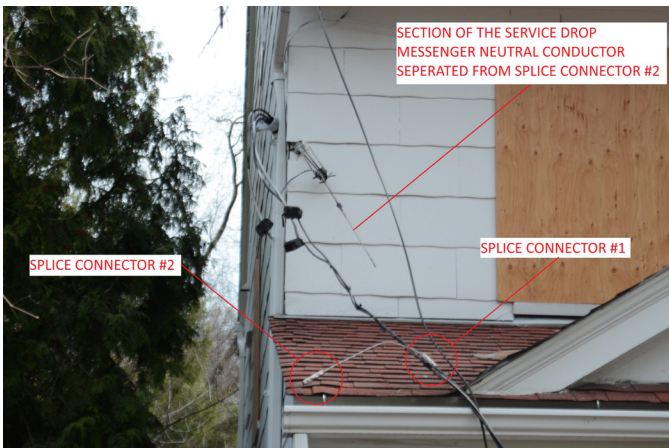
Figure 4

The opposite end of the messenger neutral conductor was found lying on the roof in front of the weather head. The messenger neutral conductor contained two splice connectors (**Figure 4**). A section of the messenger

View of the service drop connection at the service entrance to the house (looking east).

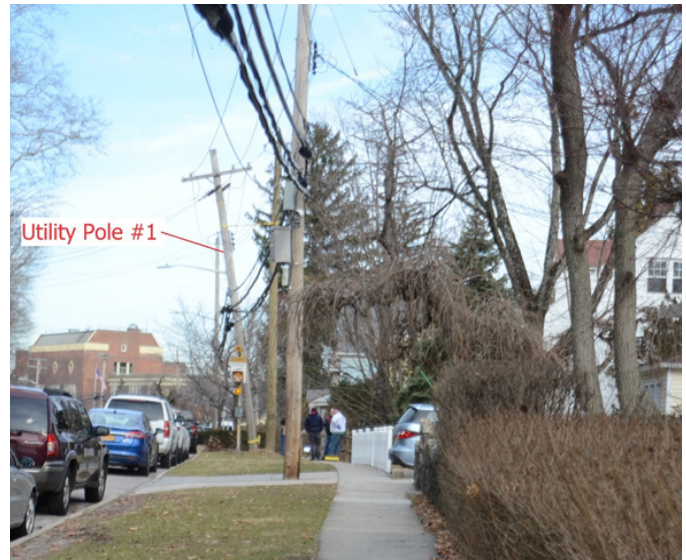
Figure 6

View of the utility pole #1 leaning away from the house.

Utility pole #1 (located directly in front of the house on the east side of the street) had fractured at the base and was leaning toward the street (**Figures 6 and 7**). The utility pole was found leaning on the main power lines running in the north-south direction along the street. No guyed wires were found attached to utility pole #1. Directly across the street (on the west side of the street) was another utility pole (utility pole #2). Power lines crossed the subject street from utility pole #1 to utility pole #2 to feed a nearby school.

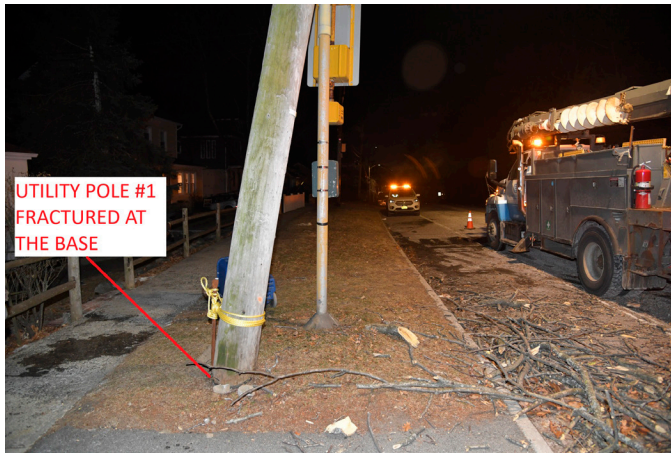
Figure 7

The subject tree that fell was located approximately 30 feet north of utility pole #2. The tree fell onto the primary feeder lines, crossing between utility pole #1 and utility pole #2. Utility pole #1 was pulled in a southwest direction and fractured the utility pole at the base.

Utility pole #1 fractured at the base (night of the fire).

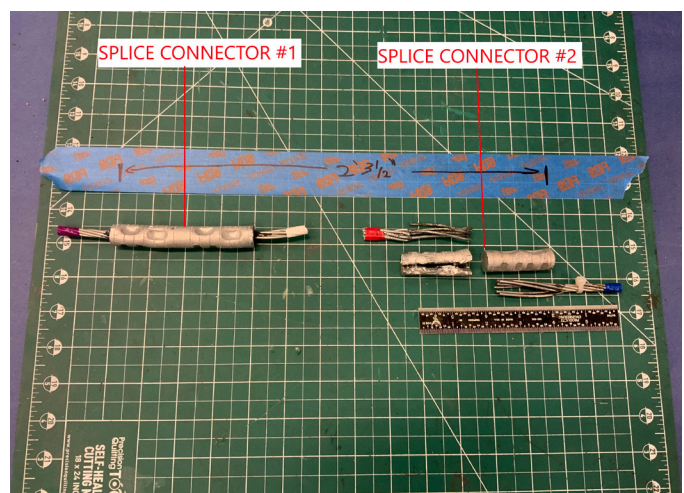
Figure 10
Splice connector #1 and #2 examined during a destructive lab examination.

#1 and #2 are identified by the white and red taped ends. The red taped end of the messenger neutral conductor was intentionally pulled from splice connector #2 during the examination. The conductor connected to the “house” side of splice connector #2 (shown taped in blue) had separated because of the tree fall, resulting in the “open” neutral condition. X-ray examination showed that the crimp was within manufacturer guidelines/specifications (**Figures 11 and 12**).

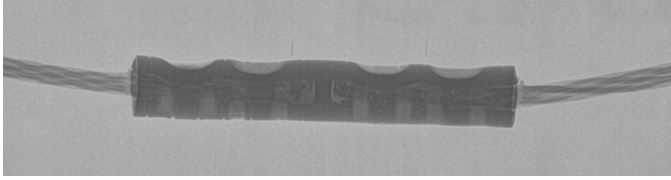
Figure 11

X-ray of splice connector #1 showing proper embedment of the conductors.

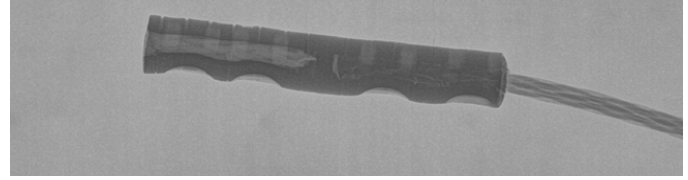
Figure 12

X-ray of splice connector #2 showing proper adequate embedment of “house”-side conductor.

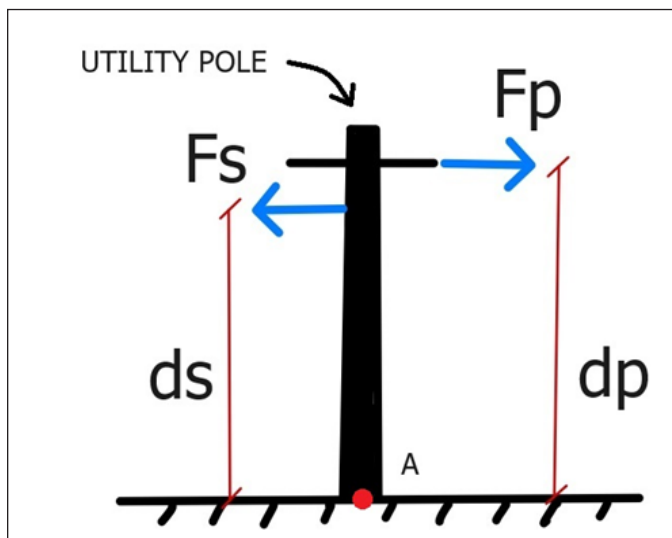
Figure 13 is a free-body diagram of utility pole #1 showing the various forces acting on the utility pole following the tree fall and immediately after the utility pole fractured. The utility pole represents a cantilevered beam with a circular cross-section. At the top of the member, the forces acting on the pole are represented by F_p , the force exerted by the primary power lines crossing the street between utility pole #1 and pole #2, and by F_s , the force resisted by the service drop conductors extending toward the subject house. The distance from the ground to the primary power lines is represented by d_p , and the distance from the ground to the service drop is represented by d_s .

Free-body diagram showing the forces acting on utility pole #1 at the time of the tree fall.

Following the tree fall, the subject pole fractured at the base because of a net bending moment imposed on the subject pole greater than the resisting moment of the subject utility pole. The resisting moment is the amount of force a pole can withstand at the point of maximum stress before it breaks¹⁰.

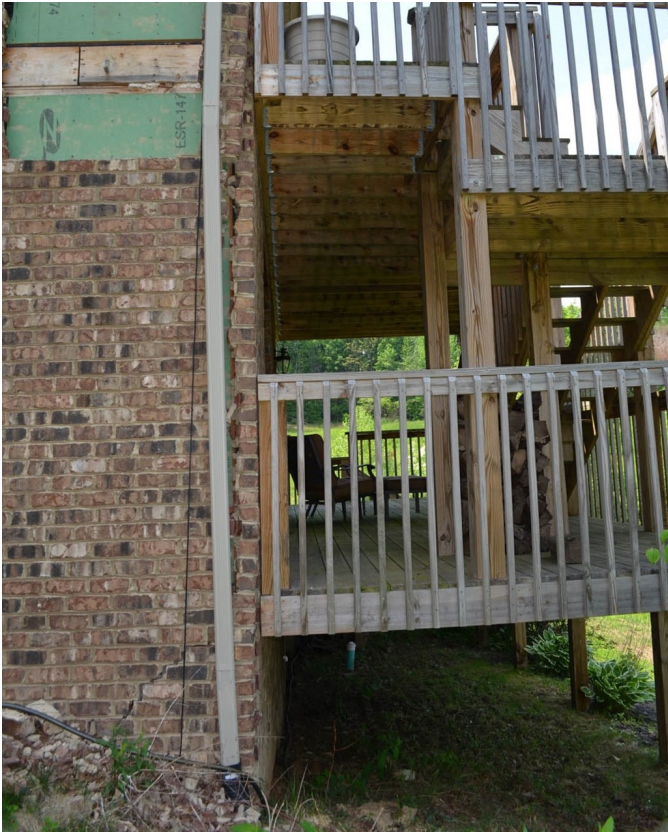
Figure 8

Right rear corner with vertical veneer fractured at the down-spout.

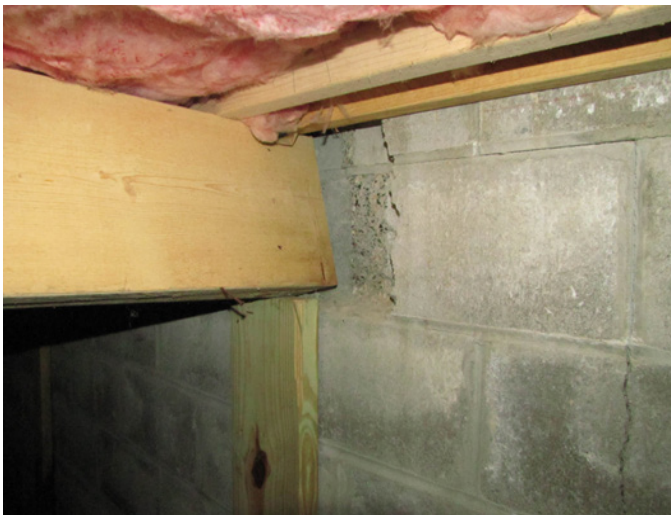
Figure 10
Right-side floor system girder displaced from its bearing seat in the front foundation wall.

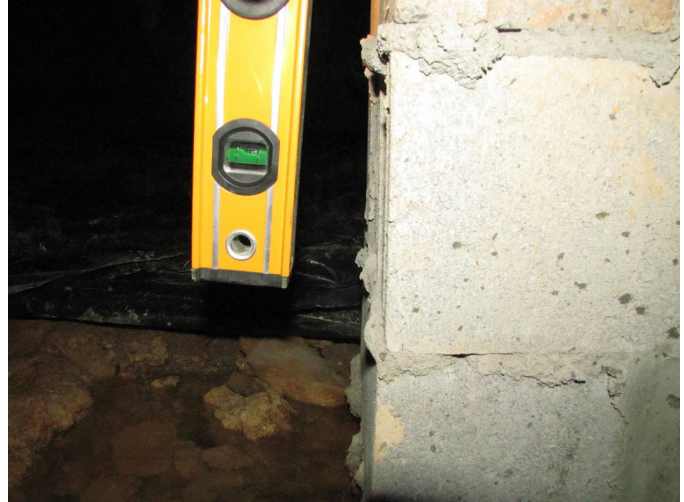
Interior foundation piers in the right crawl space area leaned rearward approximately 2 inches, measured using a 29-inch level (**Figure 11**). Active water movement was observed beneath the polyethylene vapor barrier in the right crawl space region such that the soils of the floor were saturated, soft, and incapable of supporting load. As an example of the soil's condition, while gathering data, A-FE's knees sunk into the mud between 4 and 6 inches throughout most of the right side of the crawl space, while crawl space soil on the left remained reasonably firm and provided resistance to movement. The front foundation wall was broken at interior and exterior wall corners as well as vertical cracks in the field of the wall. Active water movement through the crawl space had eroded soil from

Figure 11
Right-side floor system pier measurement from plumb with active water surrounding the column.

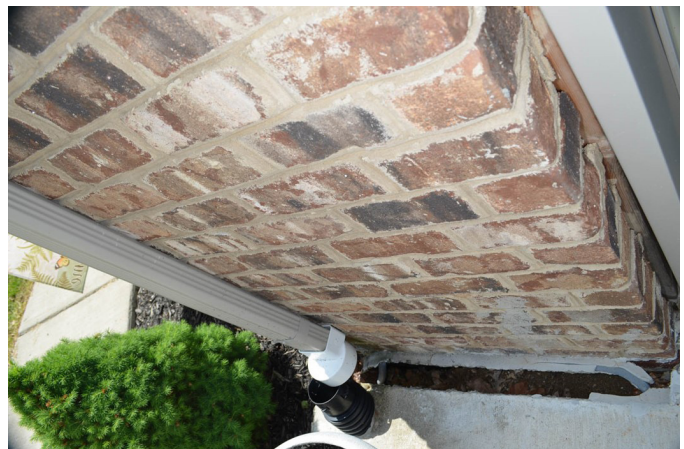
The effects of the structure's movement were exacerbated at the garage. Gaps between the driveway and structure caused by the foundation's lateral movement exceeded 3 inches to the left (west), away from the driveway and 1 inch rearward (**Figure 12**), were observed at the front corner along the right side of the garage. Caulking placed in the joints between the driveway and garage walls or floor was found torn and stretched. Inside the garage, a 1- to 1½-inch gap existed between the left and rear edges of the garage floor slab and adjacent foundation

Figure 12
Front right corner of structure at the garage with displacement of structure to the west manifested by gap with driveway and roof drainage down-spout leader connection.

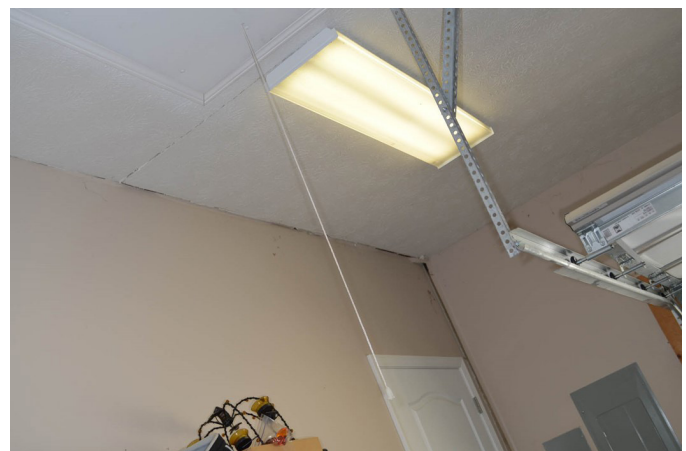
Figure 15

Right rear corner of the garage at the ceiling with displacement of structure manifest by gap with the ceiling and wall at the electrical distribution panel.
