Journal of the  
**National**  
**Academy** OF  
**Forensic**  
**Engineers**<sup>®</sup>

Vol. 42 No. 1 June 2025

<b>‡ Forensic Deformation Analysis of a Farm Clevis Using Photographs and Exemplar Tests</b> .....	1
<i>By Michael Stichter, PhD, PE, DFE (NAFE 1162M) and Wade Lanning, PhD</i>	
<b>ø FE Analysis of a Modular Fireplace Fire with an Improperly Constructed Hearth Extension</b> .....	11
<i>By Jerry R. Tindal, PE (NAFE 642S)</i>	
<b>‡ Forensic Analysis of an Elevated Pool Vault</b> .....	33
<i>By Brian C. Eubanks, PE, DFE (NAFE 962S), Garrett T. Ryan, PE, DFE (NAFE 1125M), and Derek T. Patoskie, PE (NAFE 1312A)</i>	
<b>υ Failure of a Climbing Treestand Due to Corrosion and Selective Leaching of Cable’s Galvanic Layer: Failure Analysis and Experimental Study</b> .....	45
<i>By Olin Parker (NAFE 1334A), Jahan Rasty, PhD, PE (NAFE 768S), and Matthew Mills, PE (NAFE 1199A)</i>	
<b>ø Using Ground Penetrating Radar Techniques in Forensic Structural Engineers</b> .....	67
<i>By Chakradhar Gondi, PE (NAFE #1329A), J. Vincent Barnes III, PE, and Michael J. Wightman</i>

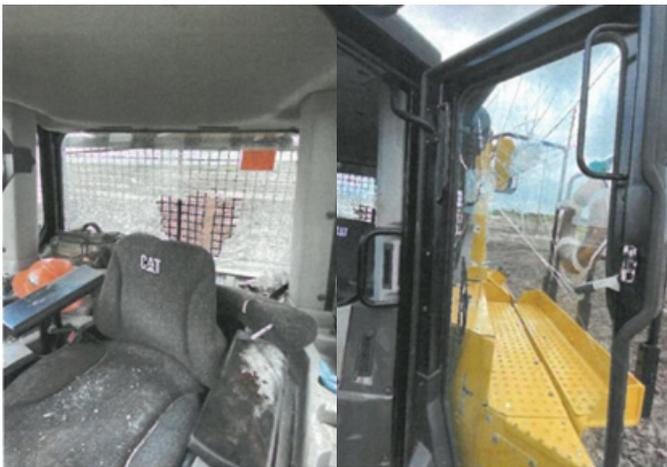
**Figure 6**

Photographs of the bulldozer cab included in the contractor incident report showing damage to a steel guard and the rear window (left) and fractured left front cab window (right).

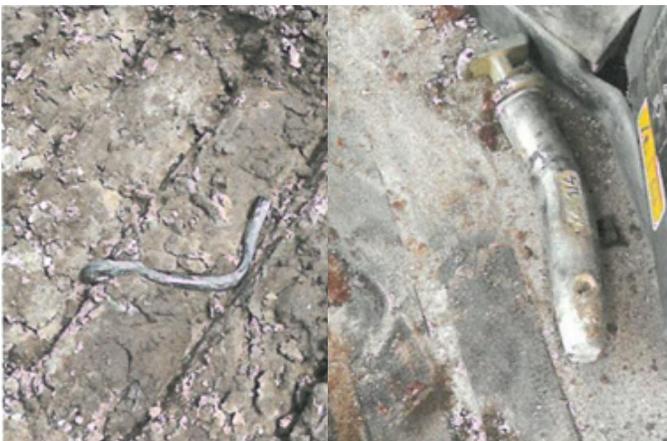
**Figure 7**

The locations where the clevis bow and clevis pin were found are shown in **Figure 7**. Although the exact distance that the clevis bow traveled is unknown, photographs of where it was recovered showed it embedded in soil that exhibited an impression from the bulldozer track.

Most likely, when the clevis failed and departed from the mired equipment, the clevis bow traveled past the bulldozer, landed on the ground in front of the bulldozer, and was then run over when the bulldozer continued to roll forward — after the operator was incapacitated by the head injury from the clevis pin. The clevis appeared to have sunk into the mud under the track, and did not exhibit any deformation or damage from being run over.

Failed clevis found some distance beyond the bulldozer (left) and clevis pin found inside the bulldozer (right) from photographs included in the contractor incident report.

The subject clevis also had a bent pin, and the ear that retained the pin was significantly more deformed than the other ear (**Figure 7** and **Figure 13**). Similarities between post-failure conditions of the subject clevis and one of the exemplars (**Figure 18**) indicated that they followed a similar series of deformation steps. Thus, the subject clevis failed by the same sequence of deformation and load transfer as the exemplars — and with similar forces in excess of the clevis' rating. The MSHA was correct to cite the mine operator for using the clevis above its rating.

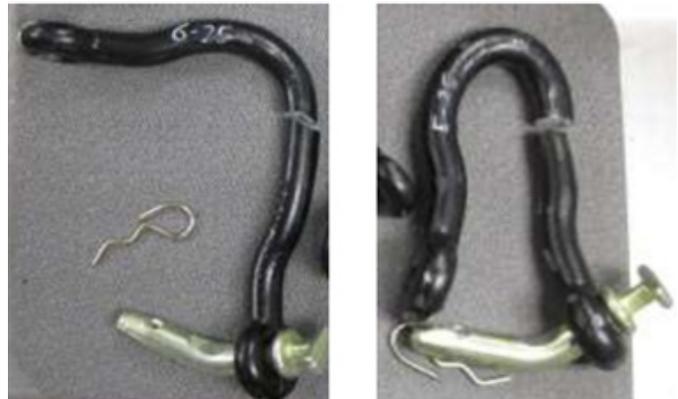
**Figure 8**

The MSHA-tested shackles that were in-line or only slightly side-loaded (longitudinal loading) all had bent pins (**Figure 8** and **Figure 9**), and failed at more than twice the shackle's load rating. Bending of the pins indicates a three-point loading condition that existed before the pin disengaged from the clevis ears. Most likely, the maximum force during the test was at the yield point of the pin, which was loaded in three-point bending with relatively short moment arms.

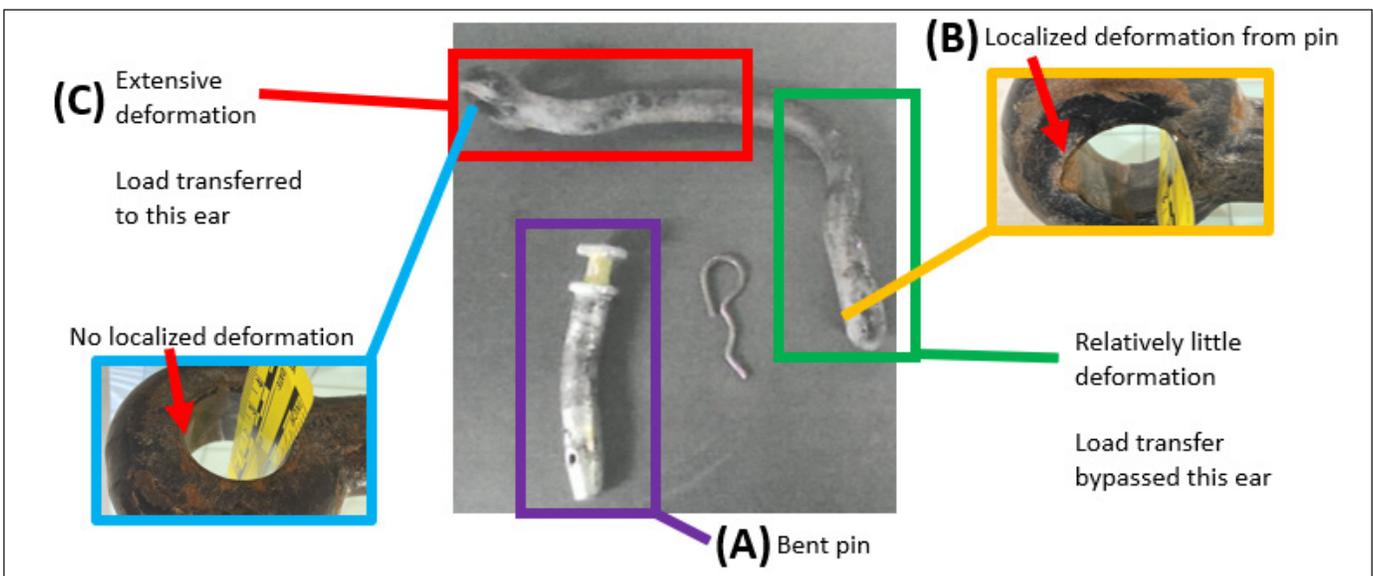
**Figure 13**

After the pin bent, the angle of the bend would create a lateral force component that would tend to make the ears of the shackle spread apart. The bend in the pin indicated a three-point bending loading condition, which would exist while the pin was in contact with both ears, but would not exist after the pin disengaged from one or both ears. Bending of the pin after it disengaged from one ear would be a cantilever bending condition, with maximum stress in the pin at the base of the cantilever where the pin passed through one ear.

Deformation at that location was not apparent in the available photographs. Therefore, the bend in the pin occurred before the ears began to spread. Bending of the pin was the first step in the failure (Figure 13A). Before the pin bent, force between the pin and the clevis ears would have been parallel to the overall tensile forces. After the pin bent, the angle of the bend would have resulted in a horizontal component of forces between the clevis ears and pin,

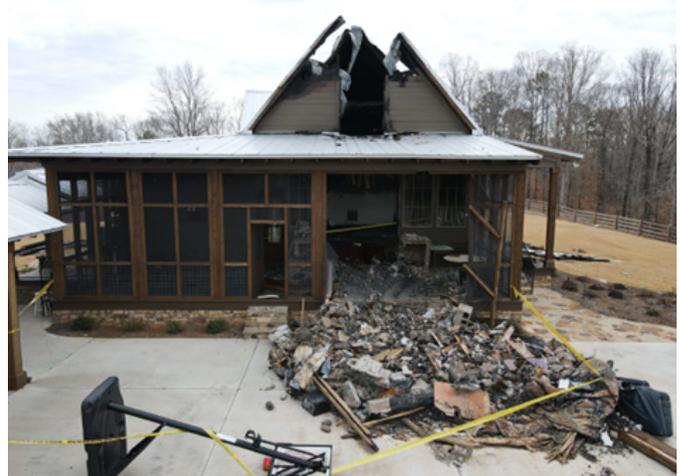
**Figure 2**

A view of the south side of the home after the fire with the remains of the stone veneered chimney and fireplace chase. The fire department utilized a track hoe during overhaul operations, making reconstruction more difficult.

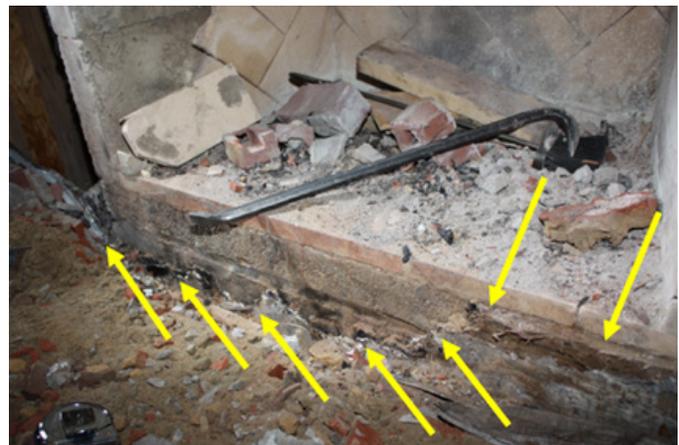
**Figure 25**

Prior Case #5. A view with the hearth extension masonry removed, exposing the joint between the hearth and the hearth extension. The yellow arrows indicate the OSB remains and burned-away portions of the OSB that was sandwiched between the hearth and the hearth extension. The fire spread until reaching the left side of the fireplace where the interior side of the OSB ran vertically up the chase.

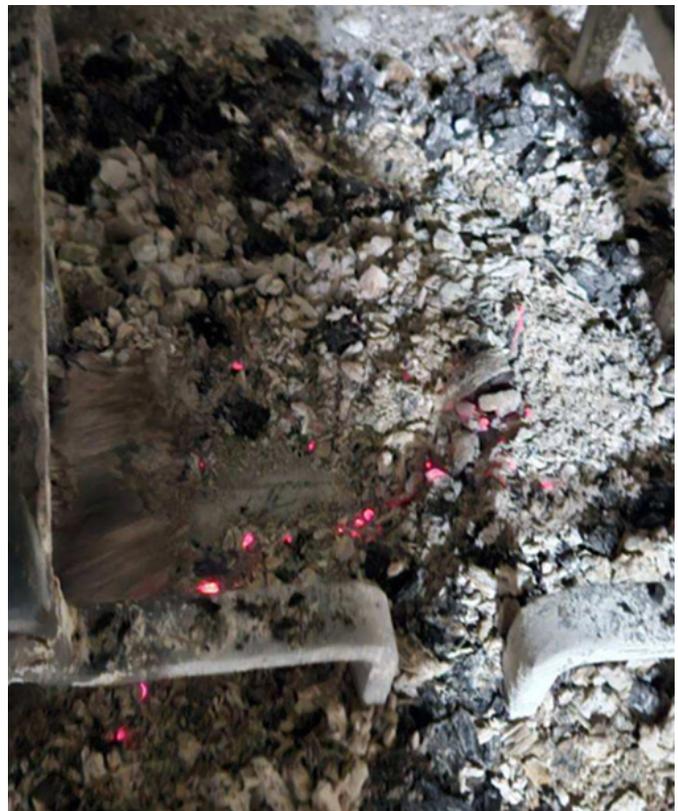
**Figure 35**  
A view of hot glowing embers hidden in the ash and uncovered 7 hours after active burning ceased in the fireplace.

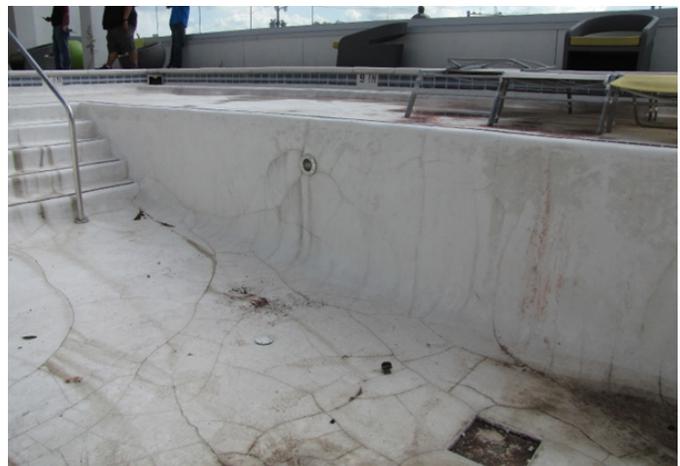
**Figure 3**  
Cracks observed in the plaster lining of the pool shell.

As previously stated, most of the cracks observed in the plaster lining of the pool appeared to exhibit a pattern consistent with craze cracks or map cracks, which is consistent with distress patterns causally related to ASR. As a result, the authors determined that the distress observed in the plaster lining and gunite/shotcrete of the pool shell was causally related to ASR. In addition, the distress related to ASR was exacerbated by construction deficiencies associated with the thickness of the pool shell and the depth of gunite/shotcrete cover over the reinforcement steel, which likely increased the volume of reactive materials available for ASR to occur and located the tensile reinforcement

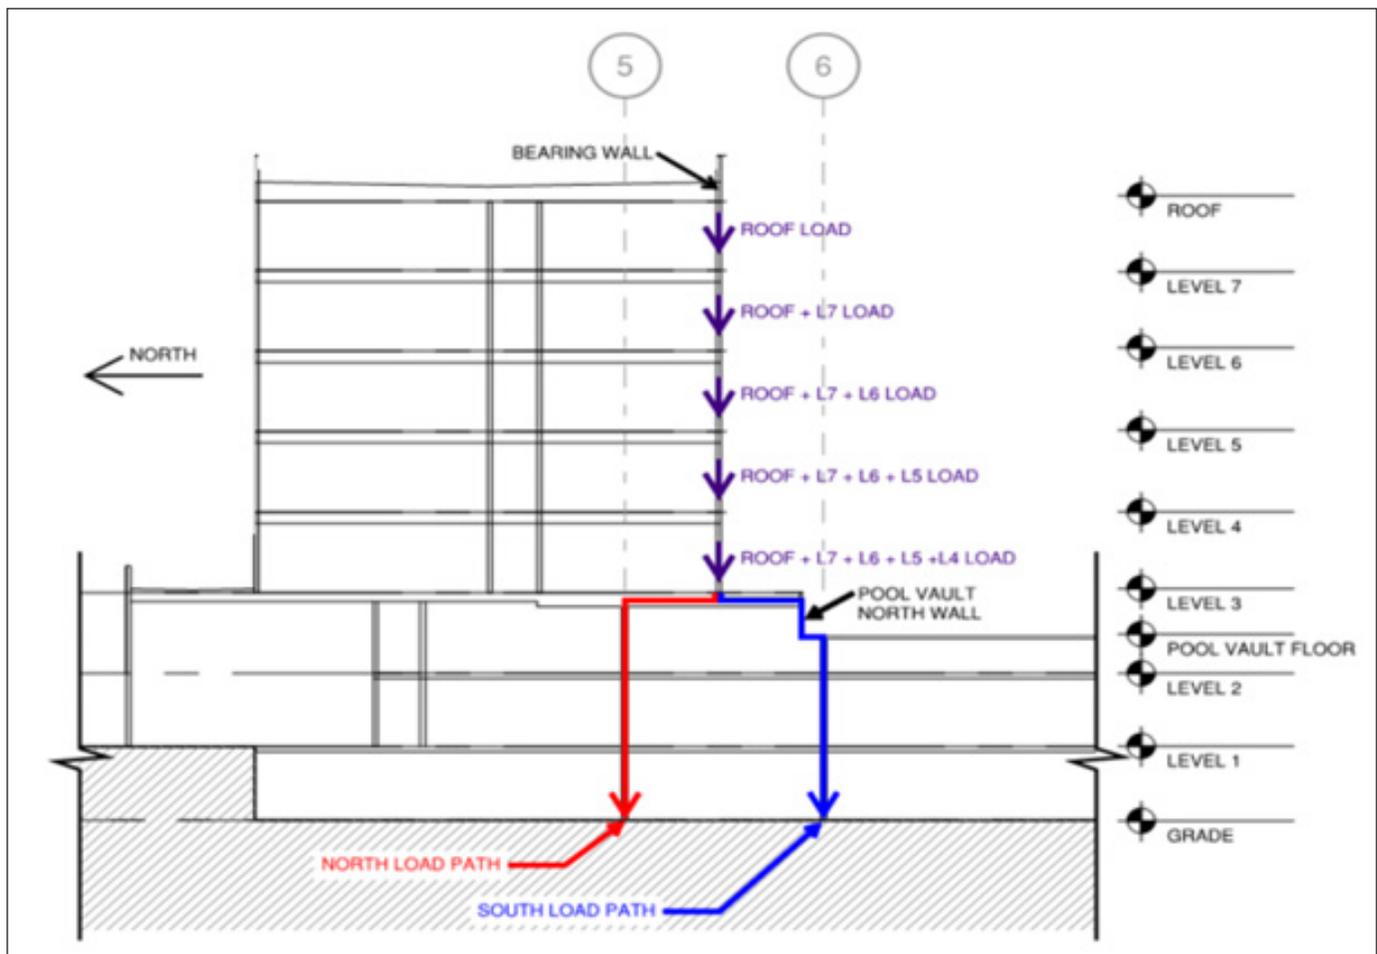
It should be noted that a load-bearing wall that supported the wood-framed superstructure from the fourth-floor to the roof was supported on the third-floor podium slab approximately 11 feet away from the concrete pool vault. Based upon the aforementioned structural analyses, it was determined by both the authors and the owner’s consultant that the SEOR failed to accurately consider the portion of the design load applied from the aforementioned load-bearing wall that would be transferred through the third-floor podium slab into the concrete pool vault, which contributed to the structural inadequacy of the engineered design, as illustrated in **Figure 10**.

**Figure 10**  
Load-bearing wall supported on the third-floor podium slab.

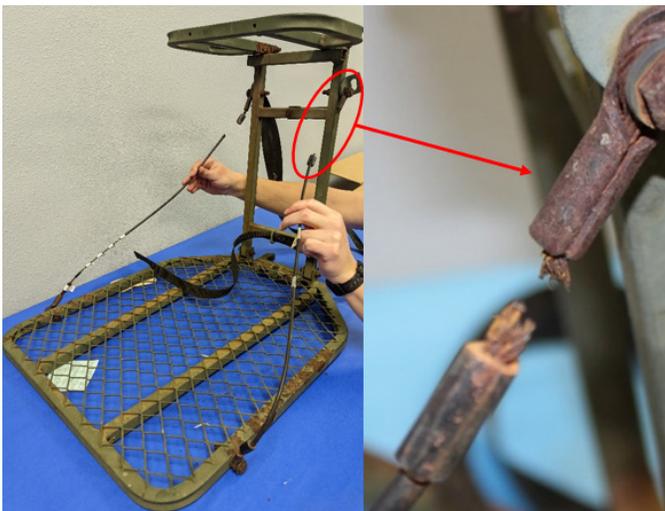
**Figure 3**  
Failure location on the left-side cable.

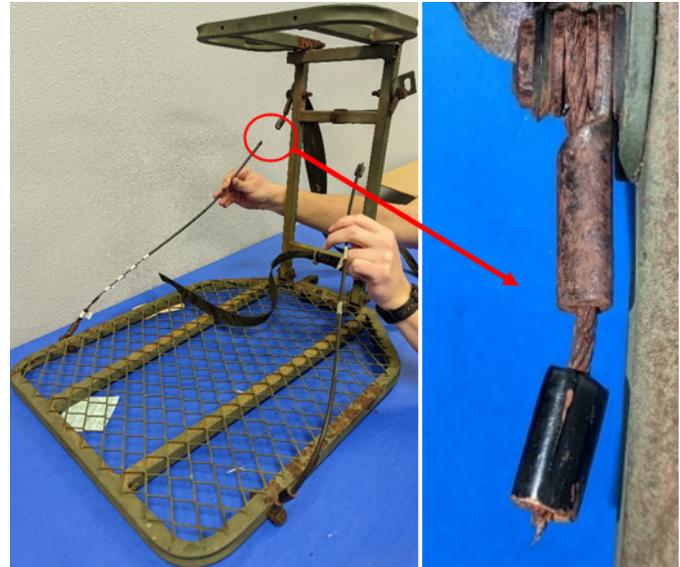
**Figure 4**  
Subject treestand showing failure location of the right- and left-side cables.

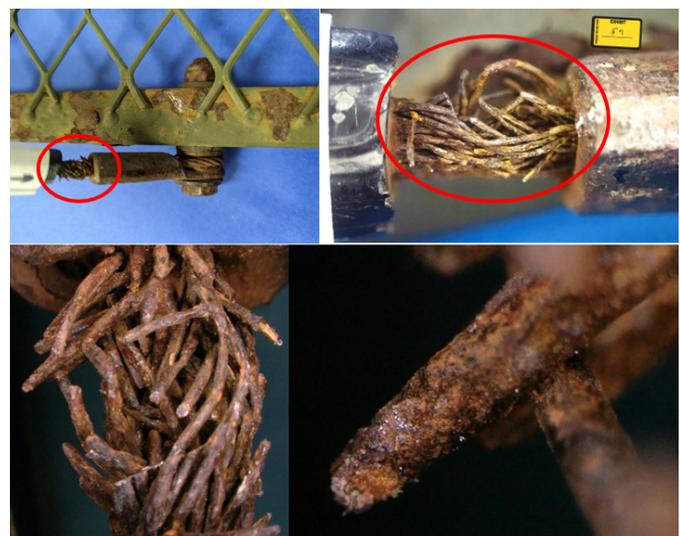
attached backward, which likely introduced additional bending stresses on the cable at the area next to the eyelet. This segment of the cable between the eyelet and the copper crimp showed moderate signs of fraying attributable to ductile overload, as evidenced by the elongated fractured tips of the individual wire strands in the frayed area (Figure 5). As evidenced by the ductile nature of the individual strand failure, the fraying observed in the segment of the cable between the crimp and eyelet near the foot platform was limited to the loading experienced during the failure event due to overload and not a condition that pre-existed the failure.

**Figure 5**  
Right-side cable foot platform attachment and the frayed segment between the eyelet and crimp with focus on elongated strands, characteristic of ductile failure.

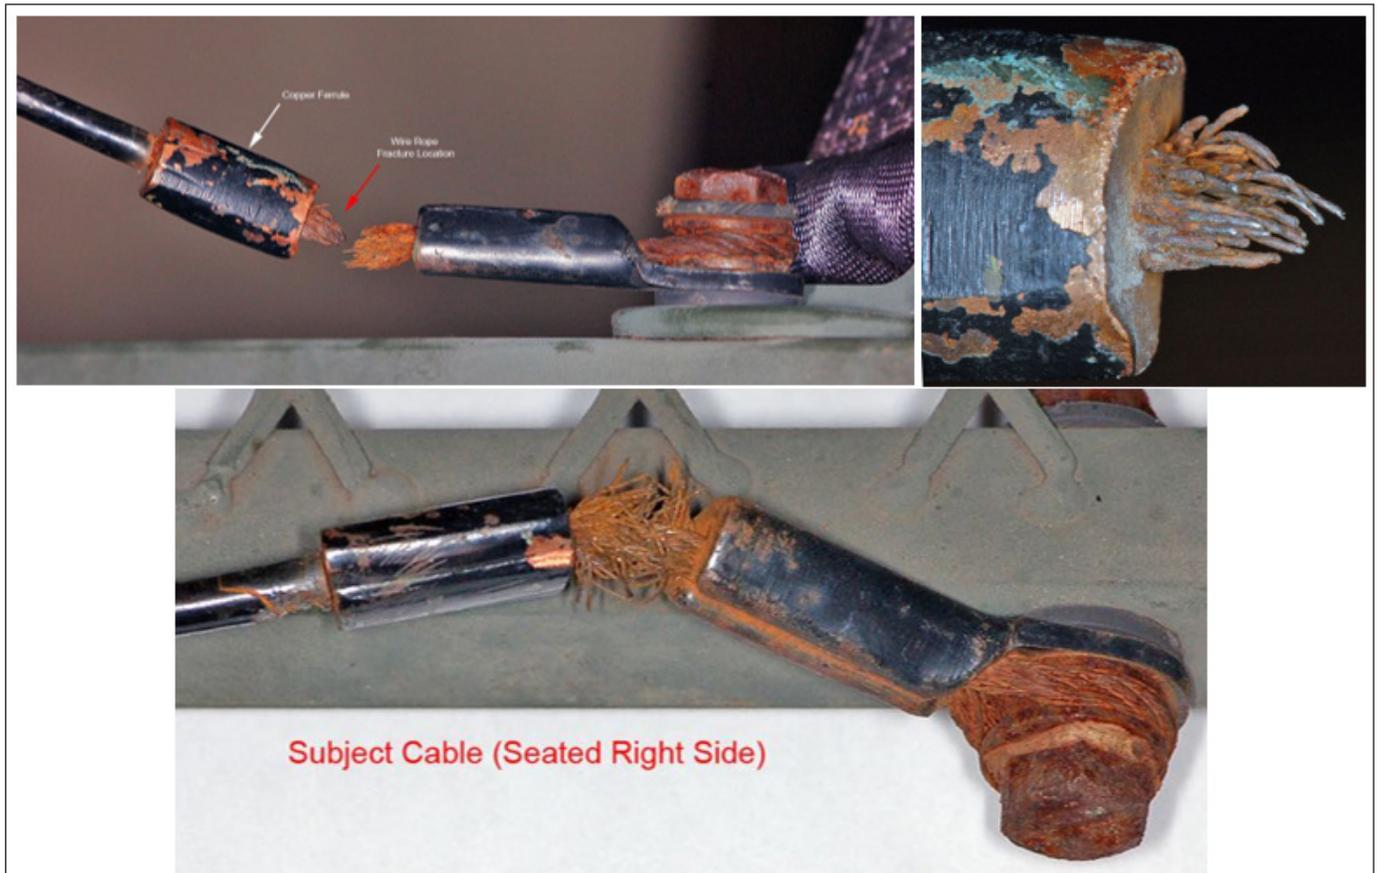
**Figure 30**

Cable failure in the second similar incident.

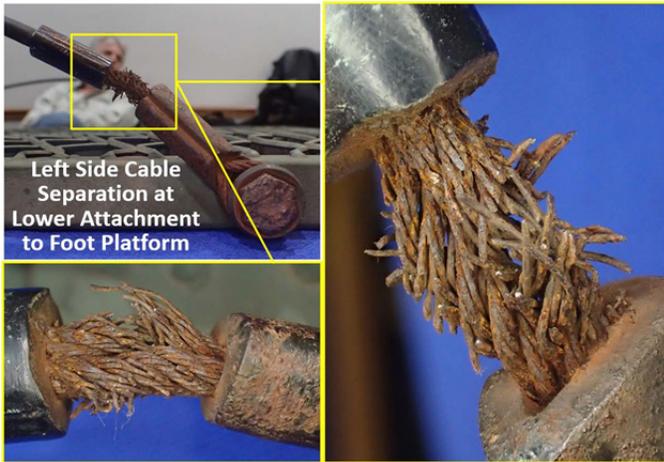
**Figure 32**  
Fraying of wire strands in the segment between the eyelet and crimp that occurred following the initial failure.

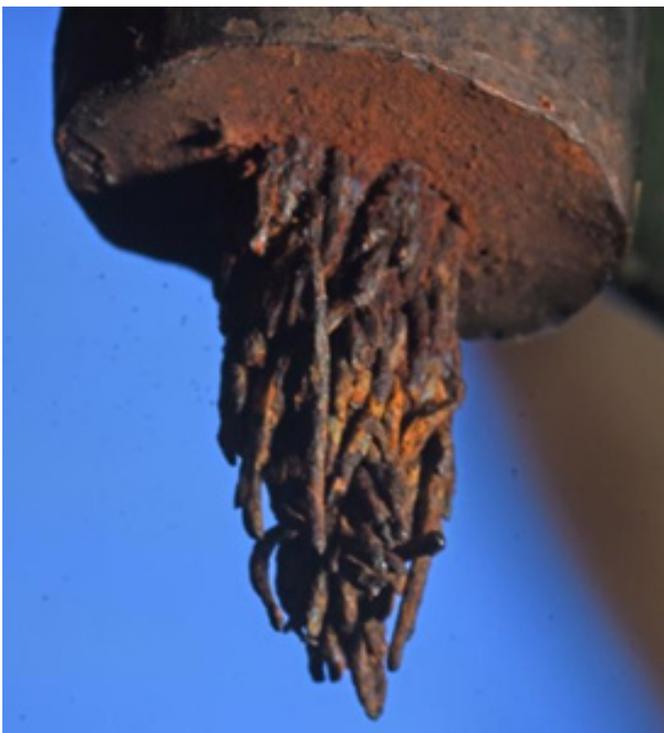
**Figure 33**  
Close-up view of cable failure in the third similar incident.

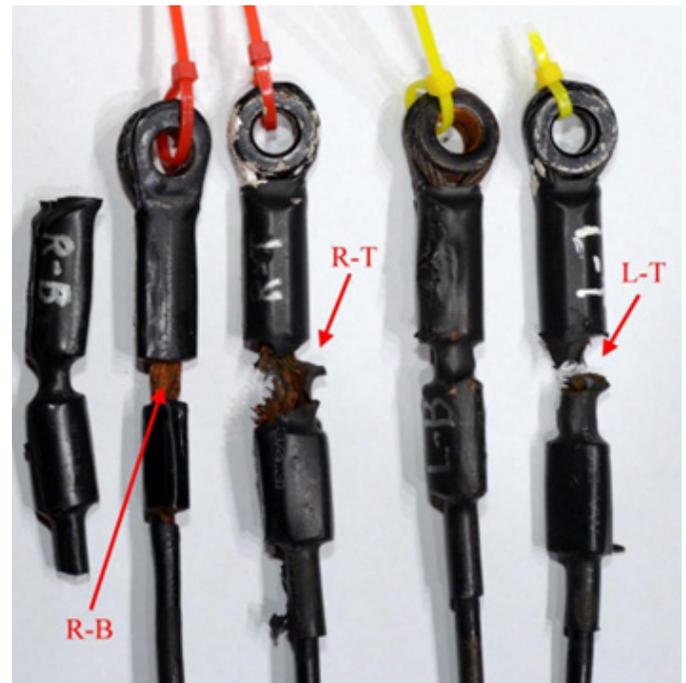
**Figure 35**  
Failed cables from the treestand in the fifth similar incident displaying extensive corrosion.

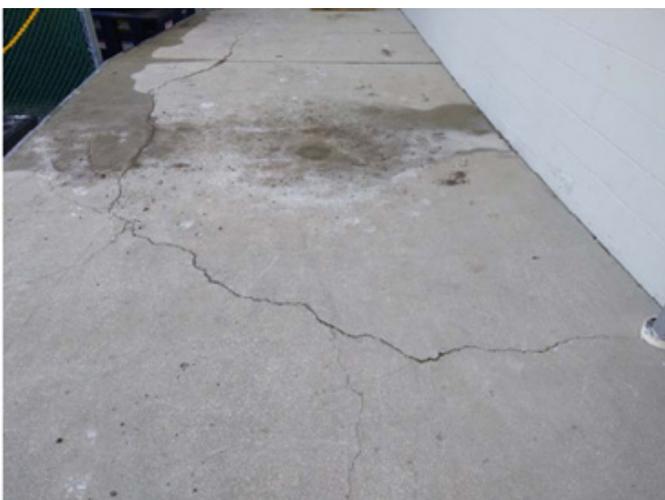
**Figure 4**  
Up to 1/2-inch-wide crack across the slab.

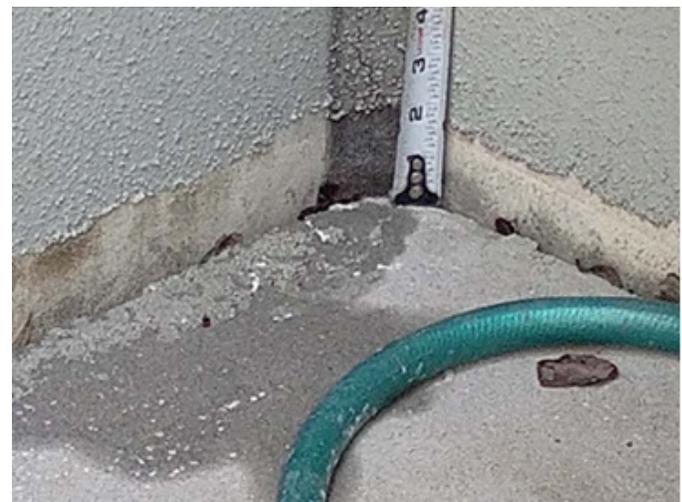
**Figure 5**  
Up to 2 inches of slab drop in the eastern edge.
