Journal of the
National
Academy of
Forensic
Engineers[®]

Vol. 42 No. 2 December 2025

Discerning Wind-Related Damage to Residential Roofs

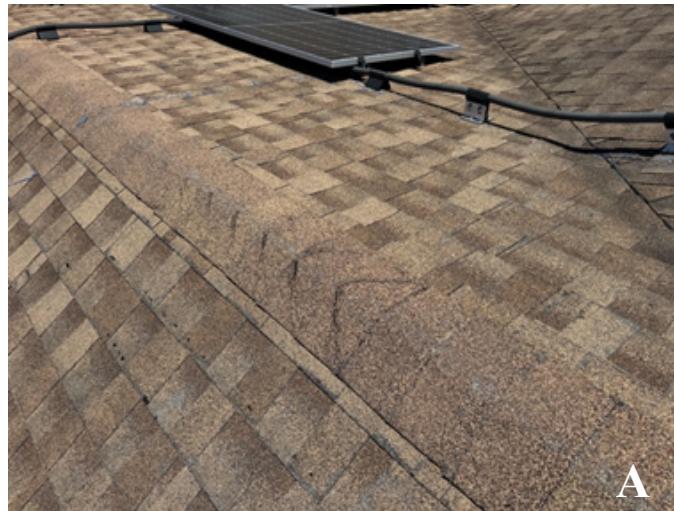
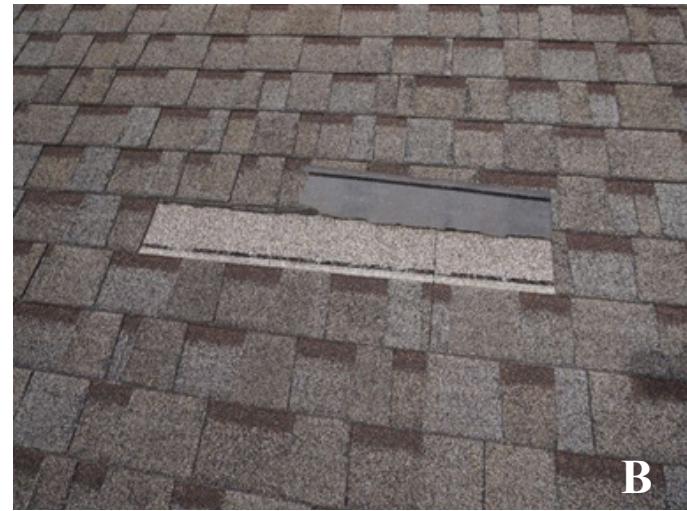
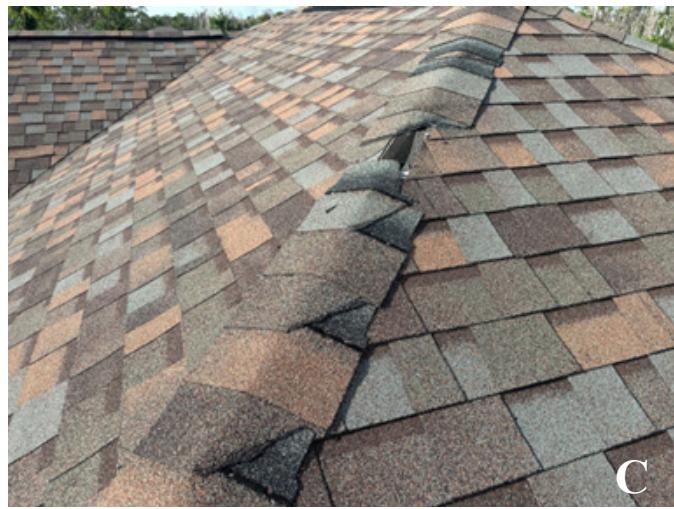
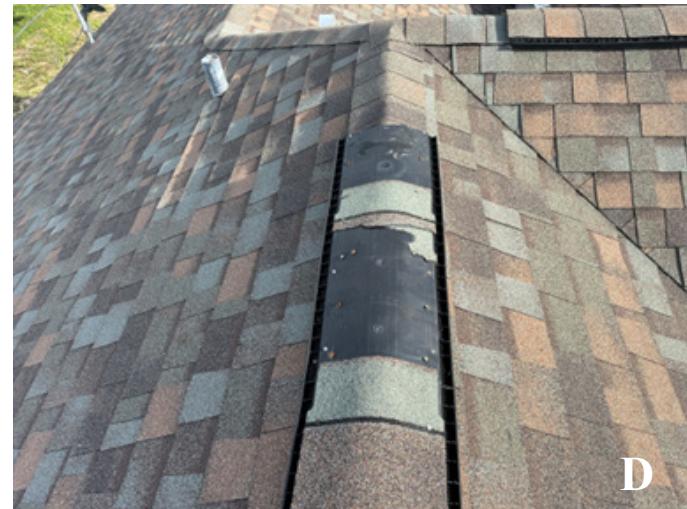
A previous study was able to identify four primary modes of asphalt shingle failures, which were obtained from field observations performed after Hurricane Frances in 2004⁴⁵. According to the study, the four identified wind-induced damage modes are: 1) creasing (Figure 3a); 2) flipping/flapping (Figure 3b); 3) tearing/removal (Figure 3c, Figure 3d and Figure 3e); and 4) abrading from flying

Wind-related damage: a) creasing, b) flipping/flapping, c) tearing of hip shingles, d) tearing of ridge shingles, e) removal, and f) windborne debris impact (linear pattern).

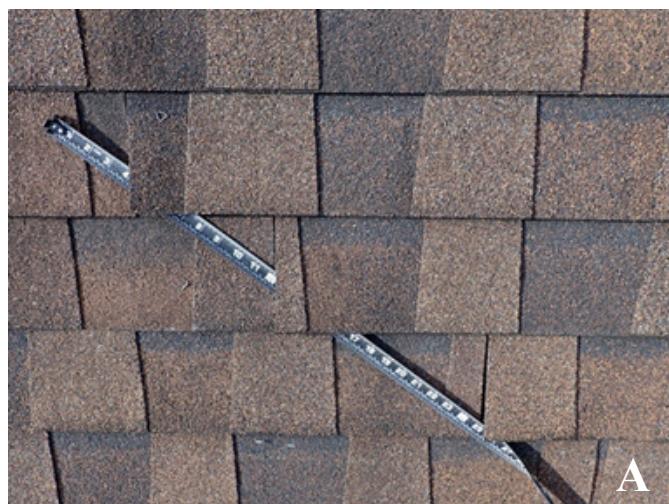
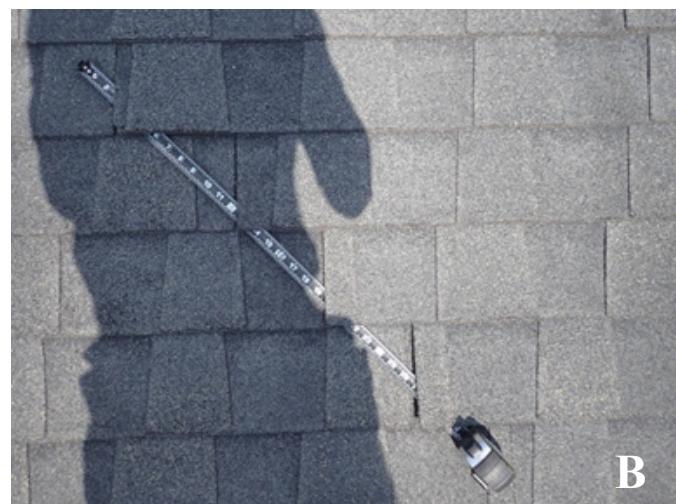
Figure 4
Shingle diagonal debonding pattern.

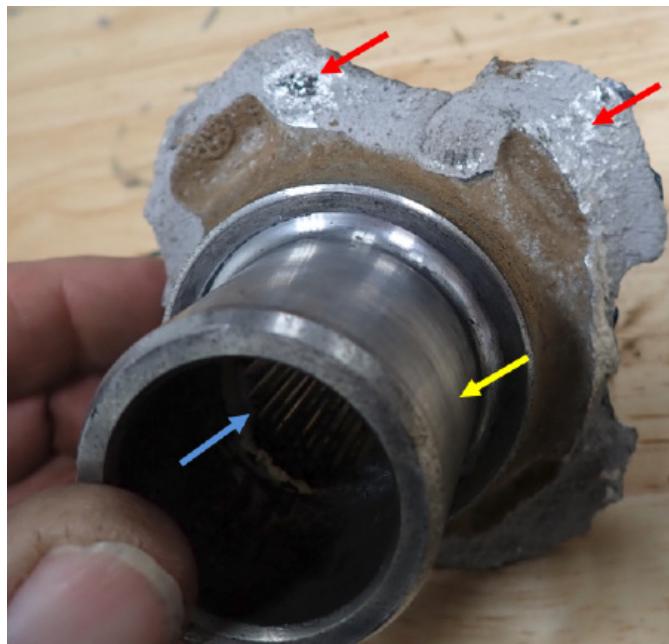
Figure 9

Central detached fragment of aluminum wheel hub, shown from inboard side.

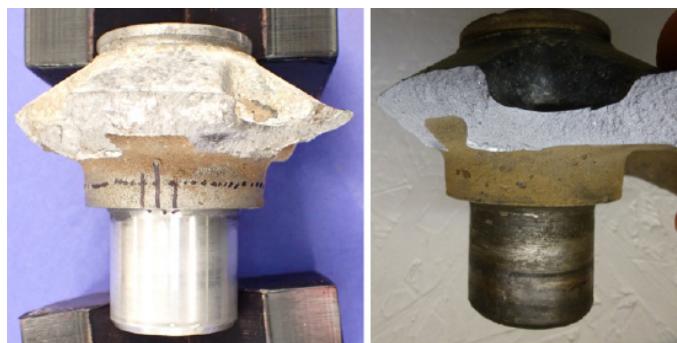
The general shape of the fracture surface from the in-board-to-outboard loading produced an angular wheel hub fracture surface, reasonably matching the incident wheel hub (**Figure 14**). While the incident hub was rotating at least 5 revolutions per second at the initiation of yaw and of loss of control, the fracture is a form of “Hertzian cone” in which the principal tensile stresses within the brittle material subjected to focal compressive loading ensures an angular, conical crack progression⁷. As an analogy to the instant fracture, a lead pellet that is discharged from an air rifle into common annealed window glass will produce an entry hole the same diameter as the pellet, a conical fracture downstream of impact through the glass thickness, and, finally, a larger damage diameter hole at the exit plane.

Figure 14
Incident wheel hub (left); Tested wheel hub given inside-to-outside loading (right).

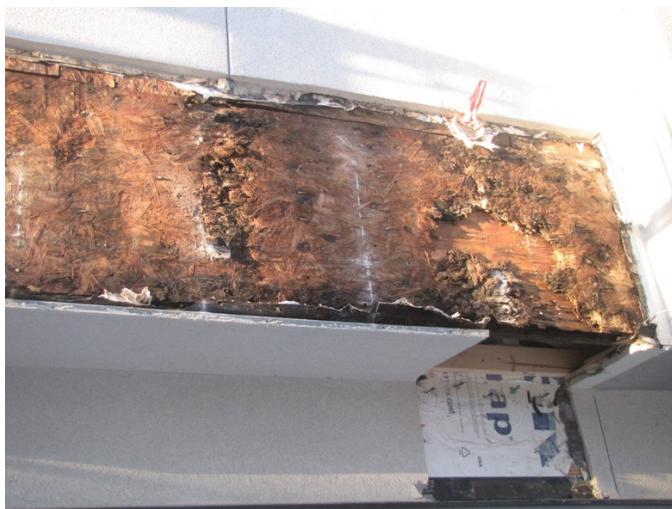
Figure 2

Example of deteriorated wood framing at vertical-to-horizontal transition without a drainage mechanism.

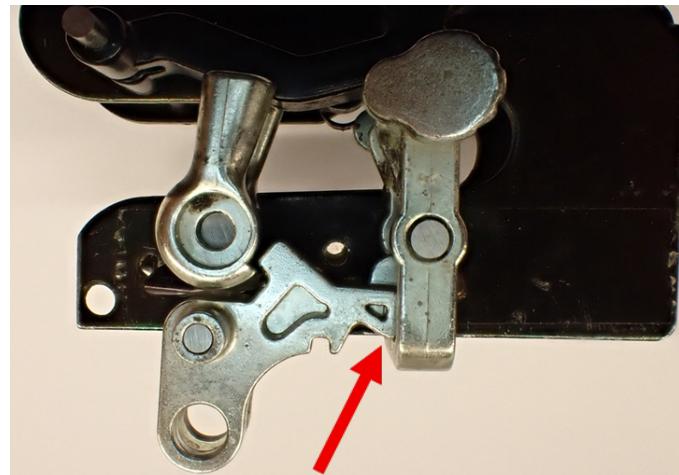
**Figure 9**

Based upon analysis and investigation of the incident crossbow, it was determined that this trigger design was sub-optimal. It was found that the ADF lever, while somewhat valuable, was not “active” in that the safety could be moved to FIRE after an arrow was loaded. Then if the arrow were removed, the safety would not automatically return to SAFE. In addition, the geometry of this mechanism was such that the bowstring could be deliberately or

Incident crossbow trigger mechanism showing position in which the tumbler is barely constrained by the mating ledge of the safety (see red arrow).

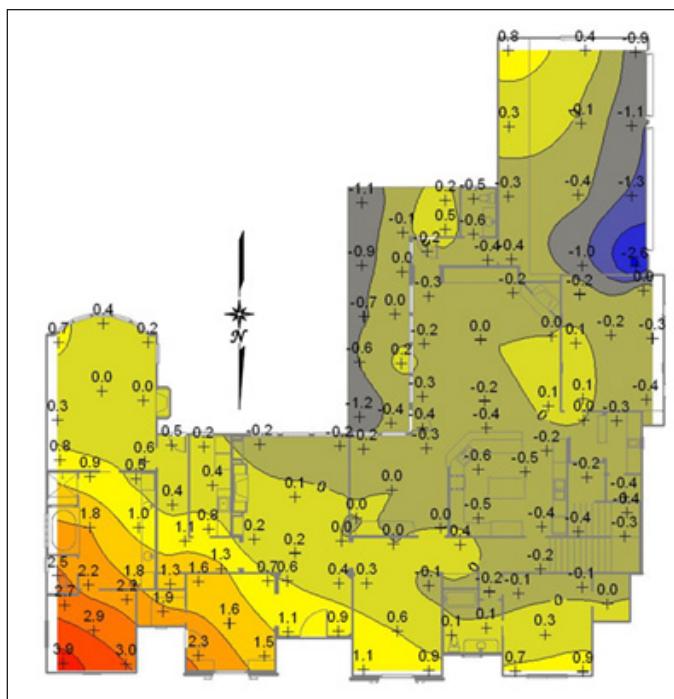
Figure 5

Although the site soils were reportedly remediated, the geotechnical report indicated that the subject residence could still be susceptible to potential movements up to 4.5 inches after soil remediation. The as-built site drainage conditions did not adhere to the recommendations of the geotechnical investigation report nor the provisions of the building code, and alternative approved drainage methods were not implemented at the northeast corner of the subject lot. As a result, surficial water was directed toward the northeast corner of the residence, which induced differential heave of the foundation at that location.

Relative elevation survey of subject residence (October 17, 2011).

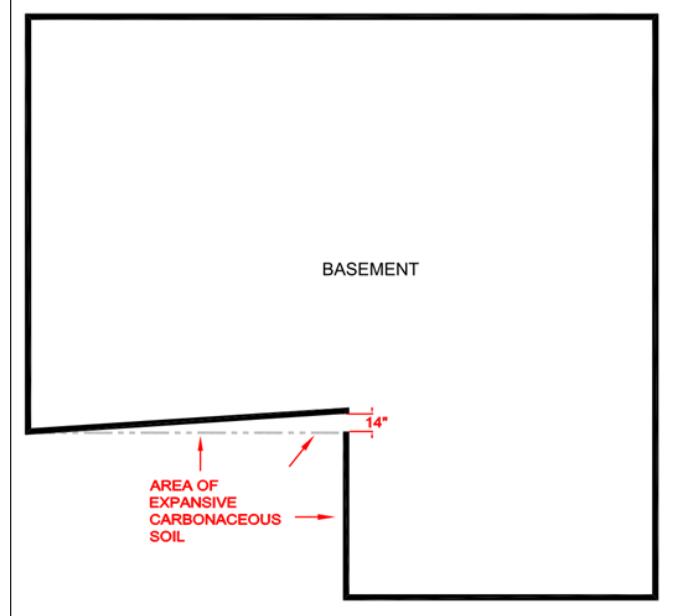
Figure 11
Schematic of the resultant movement of the basement wall.

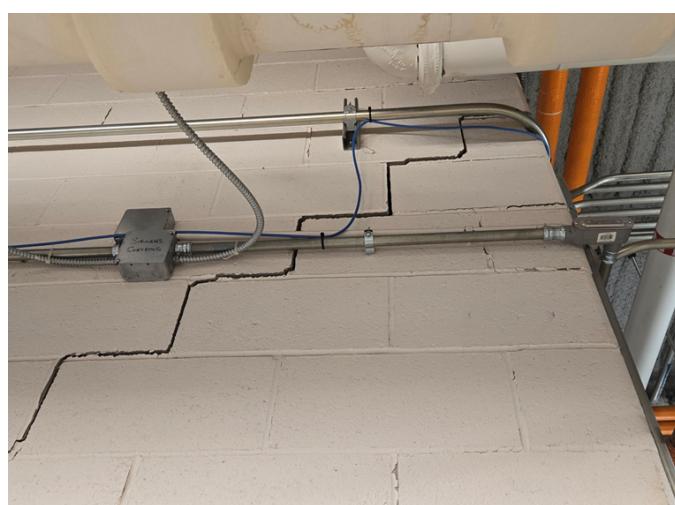
Figure 13
Photograph of cracking in masonry wall.
