Journal of the  
**National**  
**Academy** OF  
**Forensic**  
**Engineers**<sup>®</sup>

Vol. 42 No. 2 December 2025

# Discerning Wind-Related Damage to Residential Roofs

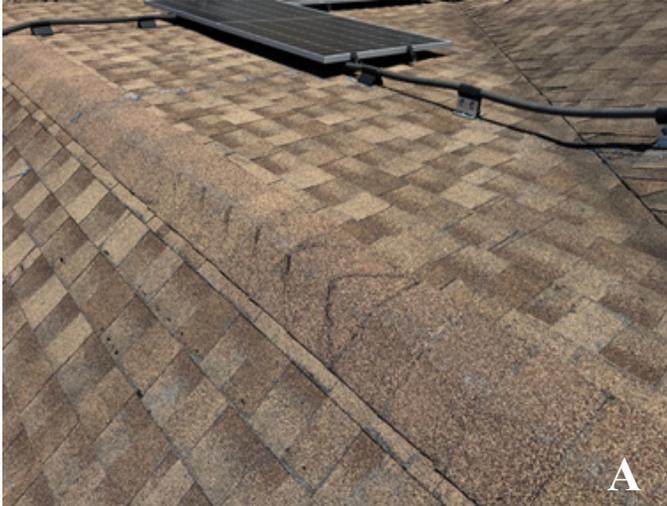
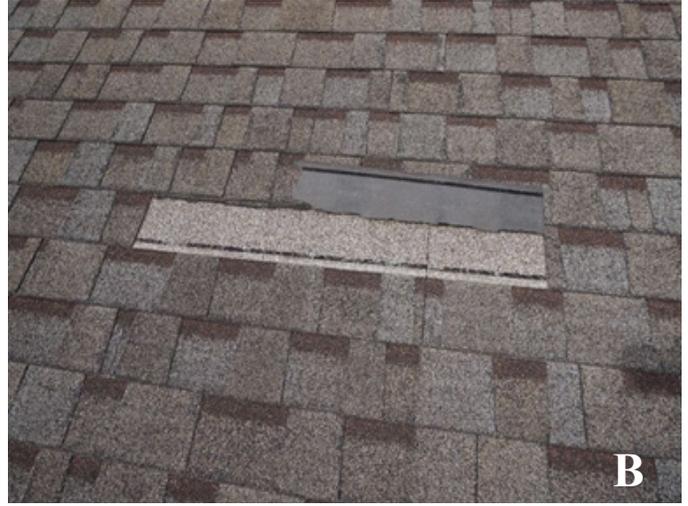
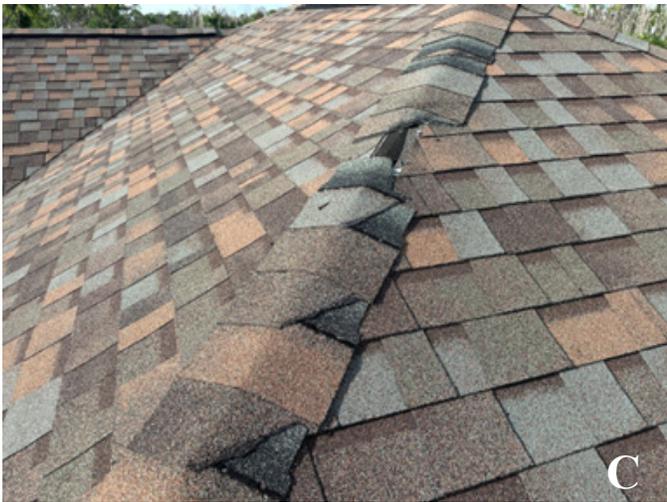
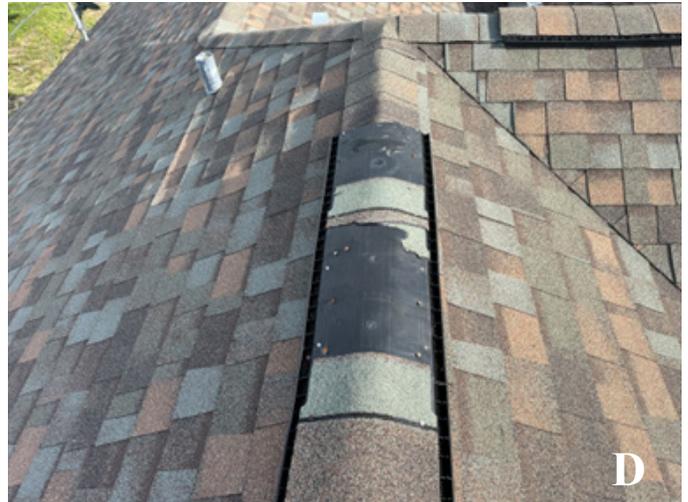
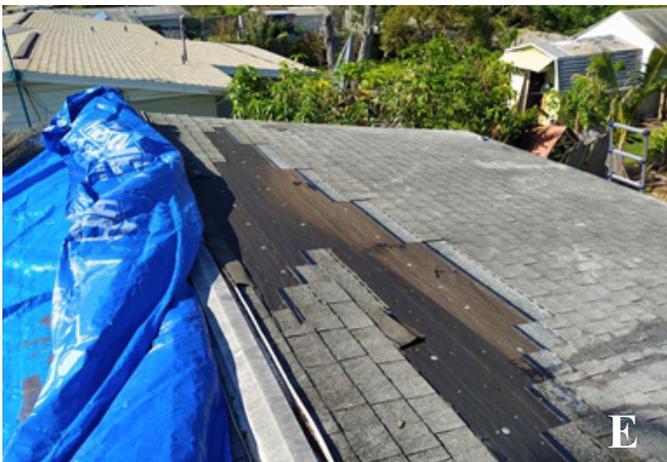
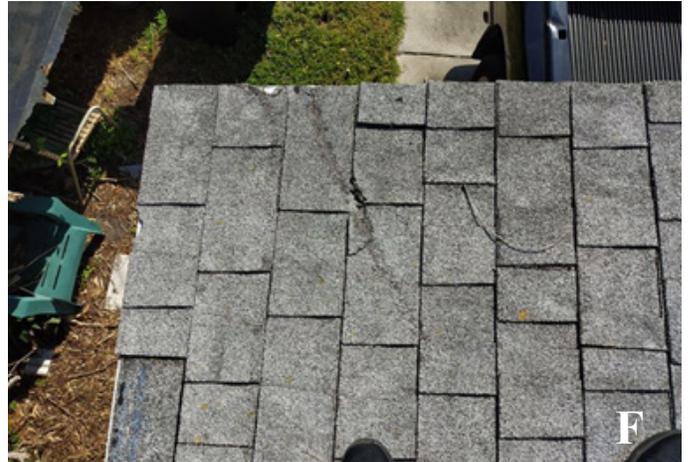
**Figure 3**

A previous study was able to identify four primary modes of asphalt shingle failures, which were obtained from field observations performed after Hurricane Frances in 2004<sup>45</sup>. According to the study, the four identified wind-induced damage modes are: 1) creasing (**Figure 3a**); 2) flipping/flapping (**Figure 3b**); 3) tearing/removal (**Figure 3c**, **Figure 3d** and **Figure 3e**); and 4) abrading from flying

or falling debris (**Figure 3f**)<sup>45</sup>. In addition, the study identified factors that can lead to asphalt shingle failure during windstorms, such as degree of weathering, design, quality of manufacture, and quality of installation.

Wind-related damage: a) creasing, b) flipping/flapping, c) tearing of hip shingles, d) tearing of ridge shingles, e) removal, and f) windborne debris impact (linear pattern).

Shingle flipping/flapping is a failure mechanism observed in asphalt shingles, characterized by the uplift and permanent deformation of individual shingles due to aerodynamic loading. This phenomenon initiates when the shingle is detached from its asphalt sealant strip, typically as a result of wind-induced pressures exceeding the adhesive bond strength. Once unsealed, the leading edge of the shingle is susceptible to uplift and rotation.

If the imposed deformation exceeds the elastic limit of the shingle assembly (comprising the asphalt coating and the fiberglass or organic mat), the material undergoes localized creasing. This creasing represents a plastic deformation process in which the mat's flexural stiffness is irreversibly compromised, and the asphalt matrix may exhibit both macro and micro fracturing or cohesive failure. The result is a permanent loss of structural and elastic recovery capacity. Once this threshold is exceeded, the shingle is unable to return to its original installed position, thereby losing its functional performance in terms of wind resistance, water shedding, and overall system integrity. Similar to the shingle creasing phenomenon, shingle flipping/flapping will develop in the roof slopes facing the predominant wind direction and should first appear in roof edges/eaves, rakes and hip/ridge lines, before manifesting in the roof field<sup>12,14,45,46</sup>.

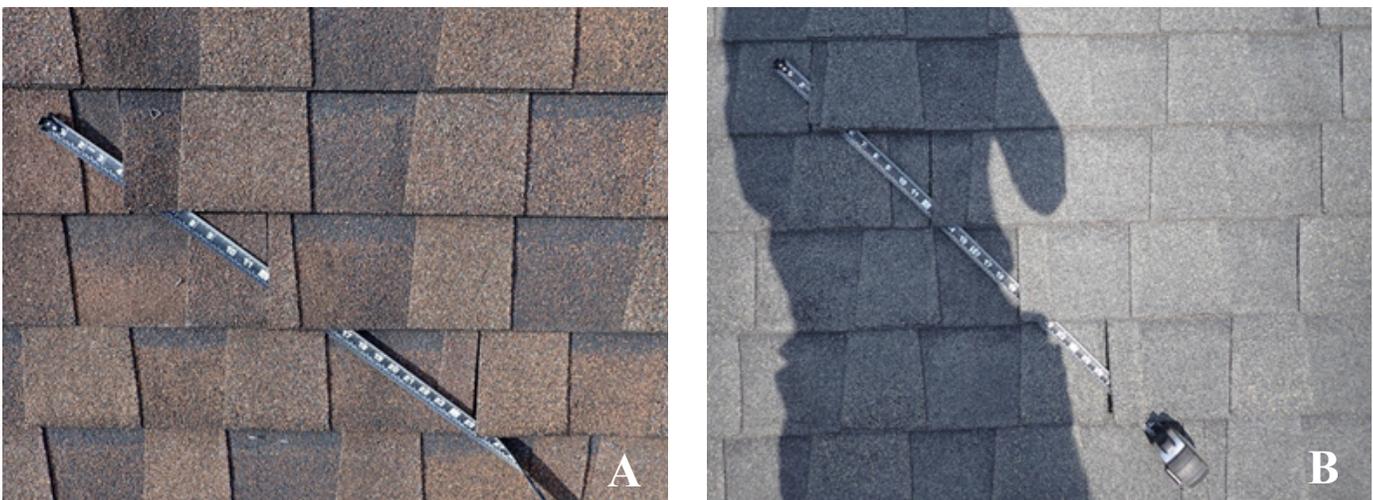
**Figure 4**  
Shingle diagonal debonding pattern.

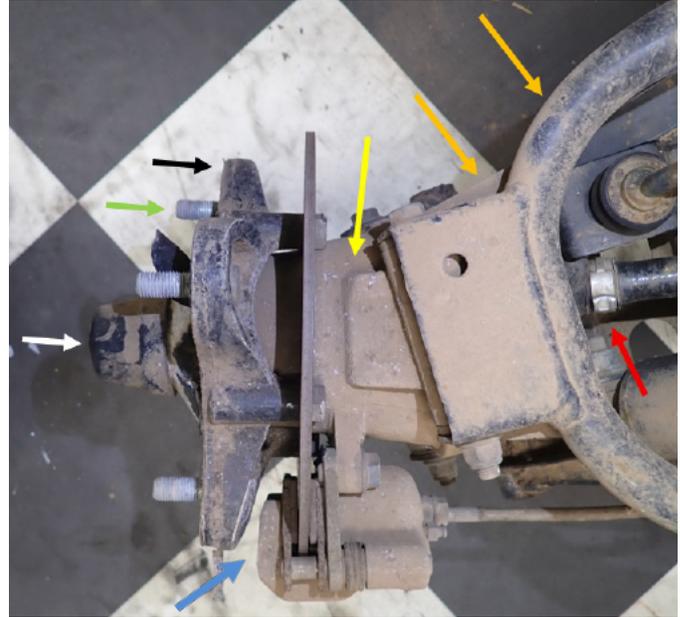
**Figure 3** shows an overhead view of the left rear drive assembly, with the wheel and tire removed. From outboard to inboard is the grease cap (white arrow), which covers the cotter pin, castellated nut, washer, and threaded outboard end of the driving axle assembly. Next is the aluminum hub (black arrow), which has been painted black and contains four threaded studs to mount the wheel and the brake disc at the inboard side, which is secured by four low-profile hex head screws. The wheel hub is mounted against the bearing carrier (yellow arrow), a cast aluminum part that mounts the wheel bearing internally and the brake pad and shoe assembly externally (blue arrow). The

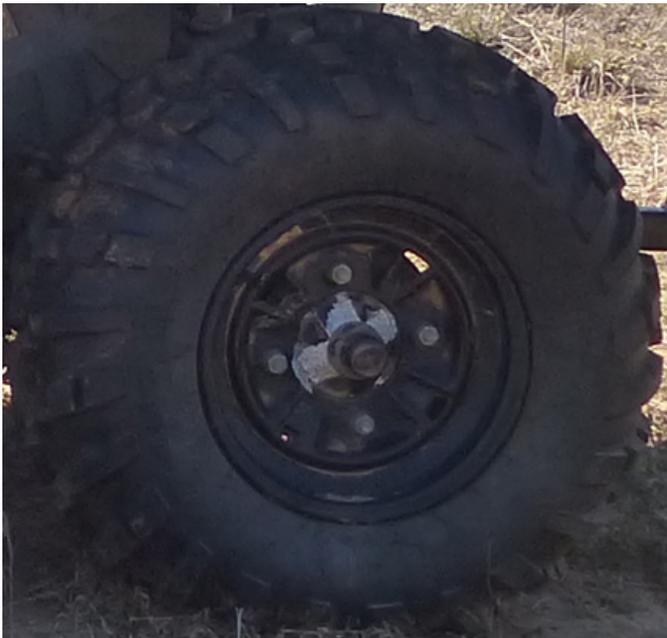
**Figure 5**

In addition to the CV boot, other relevant external damage at the left rear wheel position of the incident vehicle included a circumferentially fractured cast aluminum wheel hub, as shown in **Figures 5** and **6**. In **Figure 6**, note the chipped edges of the central fragment as indicated by red arrows. This chipping was consistent with damage after the circumferential crack separated the central and outer hub segments, during relative movement between the fractured segments.

Left rear wheel and tire showing paint spalling at the cast aluminum center hub.

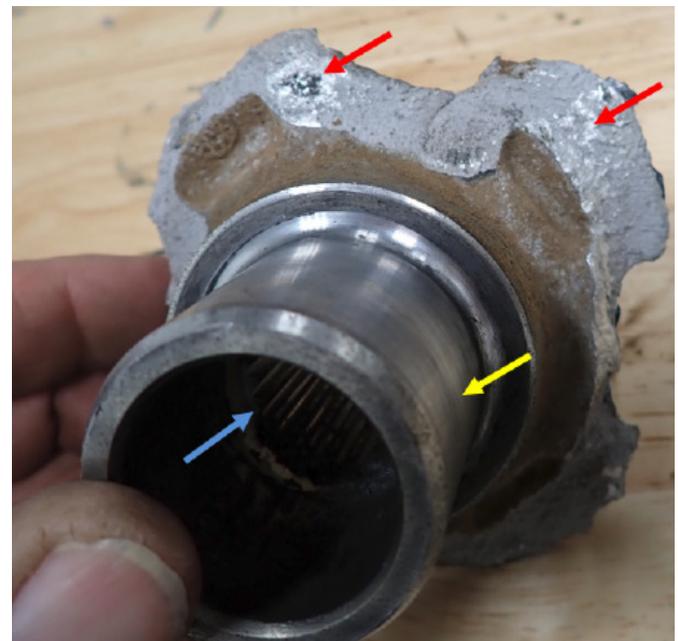
**Figure 9**

Central detached fragment of aluminum wheel hub, shown from inboard side.

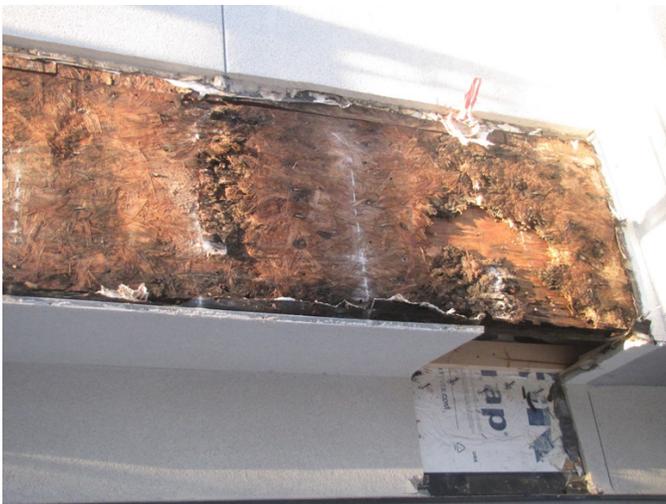
**Figure 2**

Example of deteriorated wood framing at vertical-to-horizontal transition without a drainage mechanism.

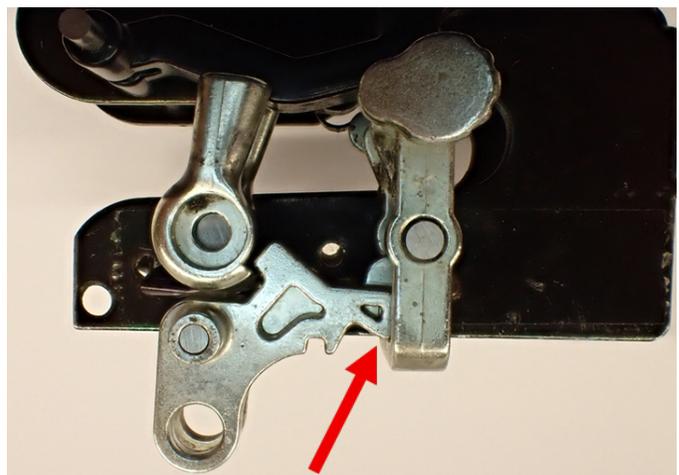
**Figure 9**

Based upon analysis and investigation of the incident crossbow, it was determined that this trigger design was sub-optimal. It was found that the ADF lever, while somewhat valuable, was not “active” in that the safety could be moved to FIRE after an arrow was loaded. Then if the arrow were removed, the safety would not automatically return to SAFE. In addition, the geometry of this mechanism was such that the bowstring could be deliberately or

Incident crossbow trigger mechanism showing position in which the tumbler is barely constrained by the mating ledge of the safety (see red arrow).

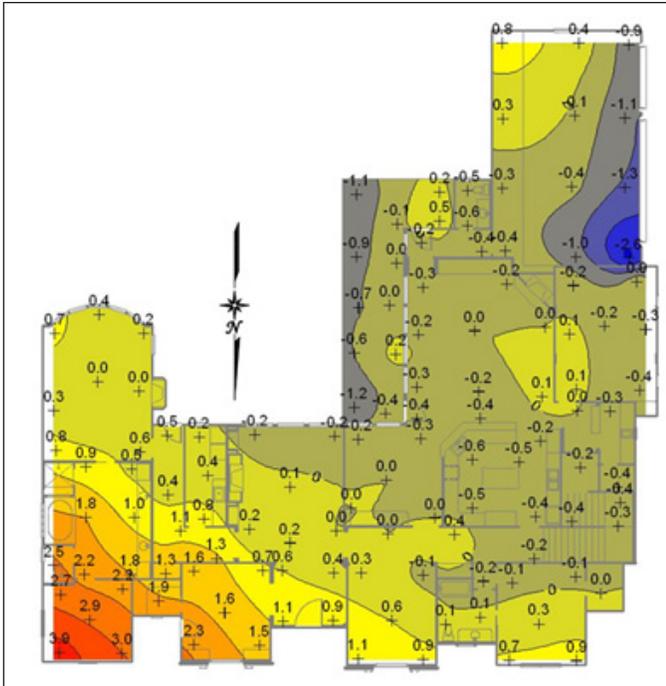
**Figure 5**

Although the site soils were reportedly remediated, the geotechnical report indicated that the subject residence could still be susceptible to potential movements up to 4.5 inches after soil remediation. The as-built site drainage conditions did not adhere to the recommendations of the geotechnical investigation report nor the provisions of the building code, and alternative approved drainage methods were not implemented at the northeast corner of the subject lot. As a result, surficial water was directed toward the northeast corner of the residence, which induced differential heave of the foundation at that location.

Relative elevation survey of subject residence (October 17, 2011).

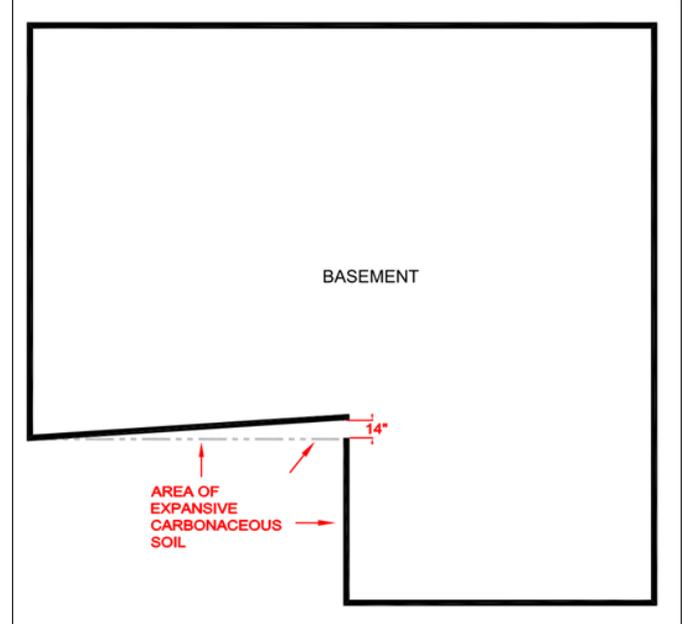
**Figure 11**  
Schematic of the resultant movement to the basement wall.
