Journal of the
National

Engineers[®]

Vol. 32 No. 2 December 2015

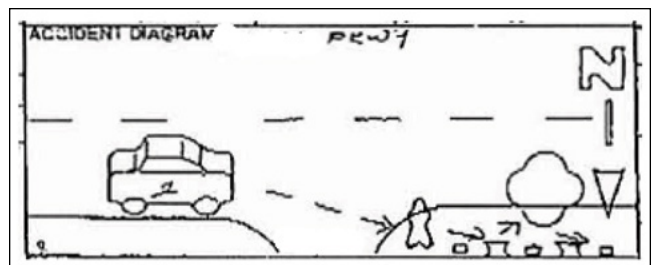
Figure 1

Police report diagram shows the vehicle traveling west. Then it veers to the north to strike the pedestrian standing on the sidewalk, strikes the fence, strikes the tree, and comes to rest west of the tree.

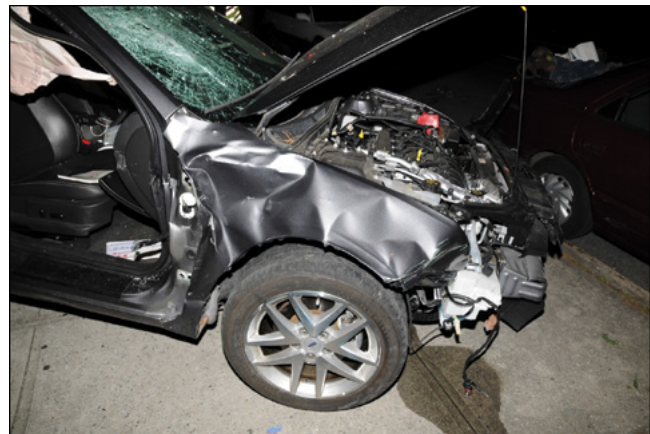
Figure 3

The pedestrian's head came in contact with the windshield, as observed by the spider pattern (see **Figure 3**), which appears to be bowing outward, on the passenger side of the defendant's vehicle. This bowing was probably caused by contact with the tree on the driver's side as the vehicle rotated into the tree.

Defendant's vehicle in rest position on sidewalk. Notice the spider pattern on the windshield, which is a classic indication (as noted in the medical examiner's report) that the pedestrian's head struck the windshield at that point.

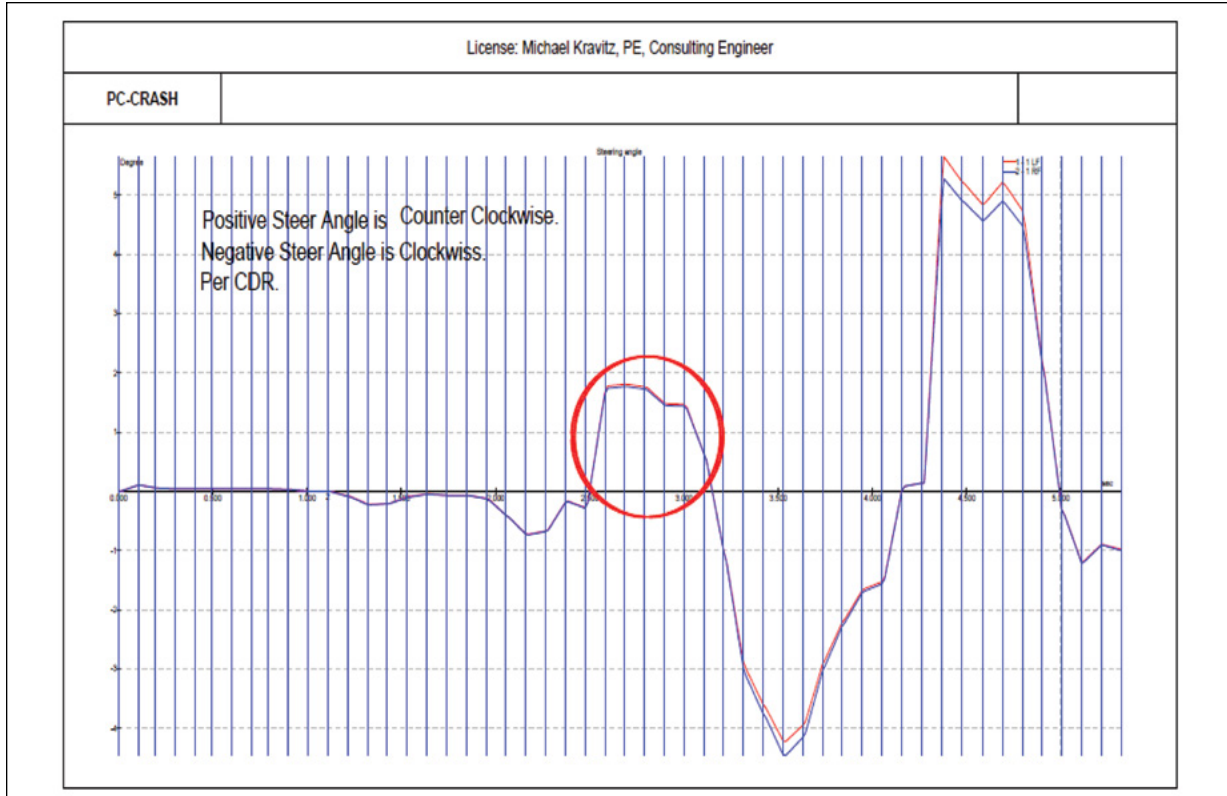
Figure 15

Stability control telltale flashing light at 2 Hz signaled at 2 seconds prior to AE, which coincided with a hard steer to the left, as shown in Figure 15.

Steering diagram shows a hard steer to the left (counter-clockwise) at approximately 2.3 seconds prior to AE. The hard steer to the left is what the author opines is an evasive action by the driver to avoid the pedestrian or a reflex action after striking the pedestrian. Vehicle travels left to right.

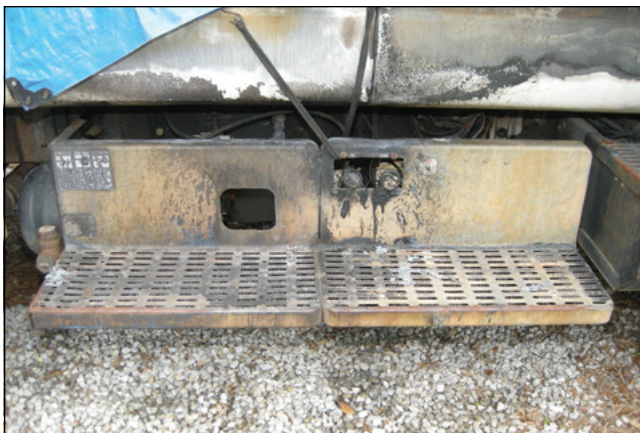
Figure 3

Damage to passenger side steps and control gauges.
Note unused extra hole in steps.

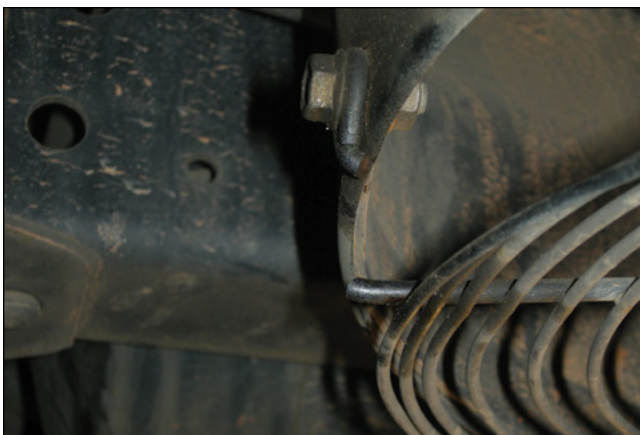
Figure 5

Inspection and testing of compressor system components also revealed that the mounting loops for the steel wire grill (located under the oil cooler fan) had fractured in three of four locations, causing the grill to sag downward (**Figure 5**). The center of the fan grill directly supported the fan motor such that this sagging was causing the fan blade tips to make contact with the fan shroud under the oil cooler. The blade tips and shroud evidenced abrasion damage from this contact. Detailed metallurgical examination of the failed mounting loops indicated fatigue fracture over time with possible initiating damage from road debris impacts.

Fan grill support fracture (one of three).

Functional testing of the oil cooler fan assembly was performed, including the shroud and grill with three out of four supports fractured. The testing demonstrated that the fan rotation was significantly impeded by the contact between the blade tips and shroud, with intermittent stoppage occurring. This contact and rotation interference was found to be affected by the changing vibration as the fan speed varied due to this

Inspection and testing of the subject compressor system oil cooler assembly indicated that several functional conditions likely impeded the cooler's performance. The cooler fan grill support fractures were resulting in probable intermittent slowing or stopping of the fan rotation. Analysis of these fractures indicated that thrown debris from the truck rear axle tires was a probable contributor — in combination with expected vehicle road vibration. Also noted in the installation manual for this system (provided by the manufacturer) was that the subject under-truck rear installation location for the cooler was one of several options for positioning it — with the other optional locations in areas less vulnerable to road hazards. In addition, during the cooler installation, incorrect wiring connections resulted in reverse rotation, which caused reduced air flow even when the fan was rotating unimpeded. Therefore, it was determined that installation deficiencies had resulted in compromise of the oil cooling system on the subject vehicle, which was the probable cause for the compressor system overheating, leading to the incident. In addition, the system design, which permitted installation in an area under the truck where damage due to road debris was an expected condition, was deficient and also contributed to the oil cooler conditions.

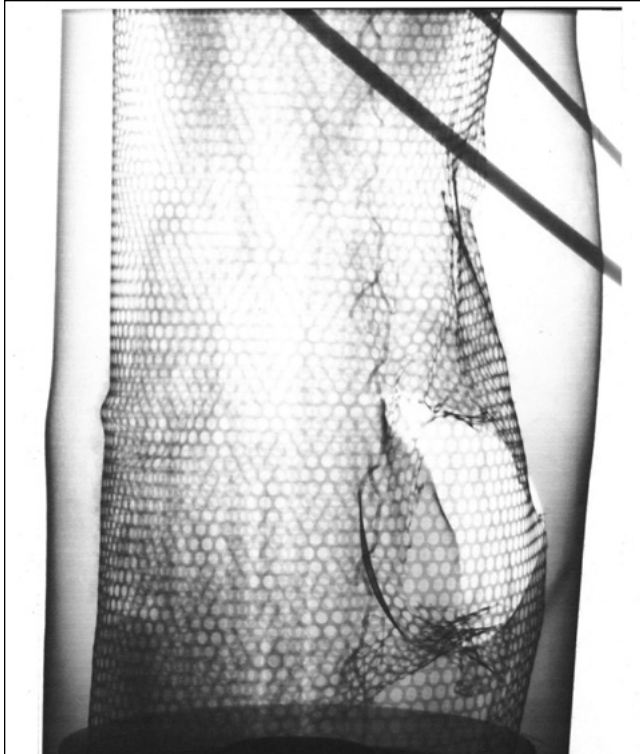
Figure 6

Metallurgical analysis of the ruptured oil coalescer/separator cylindrical shell was performed, including computerized tomography x-ray scanning and scanning electron microscope viewing of the failure region with energy dispersive analysis for materials characterization (**Figure 6**). The findings of this analysis revealed that the material had been overheated from within, resulting in rupture by normal operating pressure forces. In addition to the rupture location, the shell had also bulged outward in several other locations due to overheating while at or below system design pressure. It was determined that the system was below the design pressure based on no evidence of relief valve or high pressure shutdown control actuation prior to the coalescer rupture.

Oil coalescer/separator x-ray image in rupture zone.

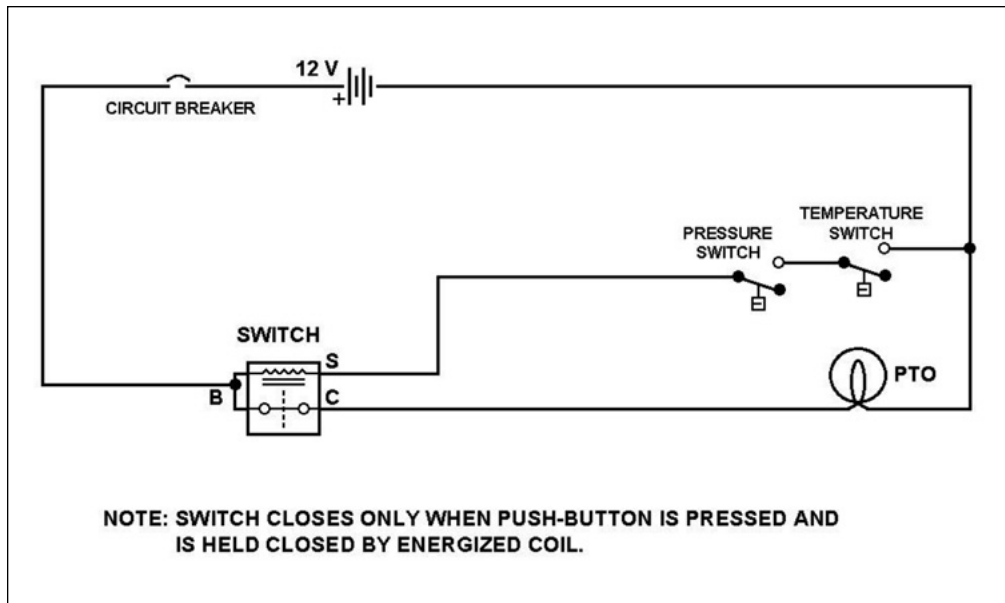
Figure 7
Original safety shutdown circuit.

The subject compressor system design and installation included automatic shutdown controls in the event of either an air/oil over-temperature or over-pressure condition. However, the control system also included a manual reset push button, which would allow the operator to not only restart the system if an over-temperature or over-pressure condition existed, but would also override those automatic shutdown

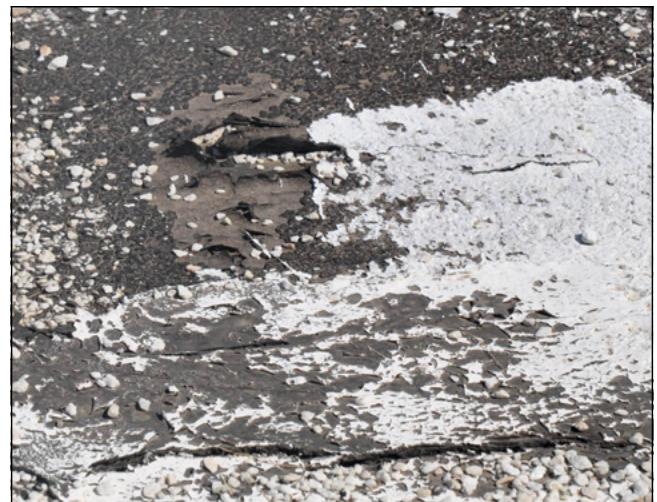
Figure 5

Areas similar to that shown in **Figure 5** were observed throughout the roofing systems over the two-story buildings. No areas of impact damage were observed on any of the roofs. Spatter marks observed throughout the property were consistent with only minor hail, approximately 0.25 inches in diameter. Additionally, conversations with onsite maintenance personnel during the inspection revealed that the roof had been leaking for years. This was consistent with observations of the interior spaces.

Split/failing section of roofing.

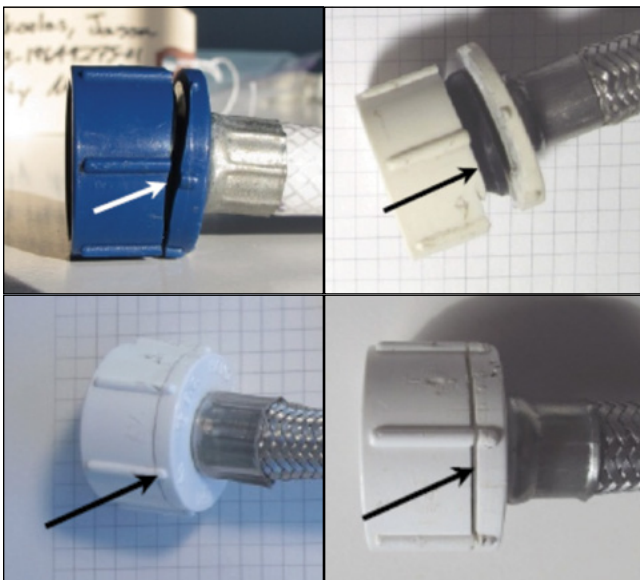
Figure 1 shows several typical “failed” nuts that were provided to the author for evaluation. Failure typically occurs in the first thread of the injection-molded plastic coupling (nut).

Figure 1
Failed coupling nuts.

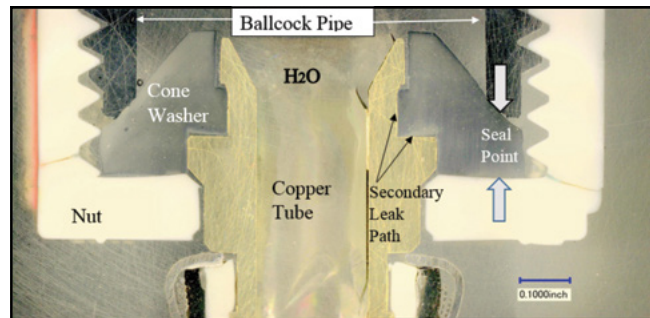
Figure 3 is a photograph of a nut assembly that has been potted in a metallurgical laboratory, cut into halves, and polished. This nut fractured at the first thread.

Figure 3
Cross-sectioned failed connector nut assembly.

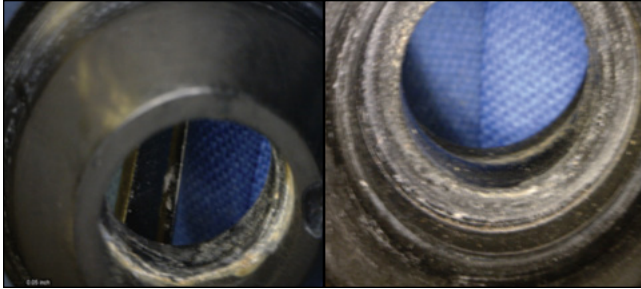
Figure 9

a leak through this path. **Figure 9** shows a cone washer taken from a failed nut. Note the calcium deposits on the inside and bottom surface of the cone washer. This indicates that leakage had occurred for quite some time through this secondary leak path. The user apparently continued to tighten the nut, hoping to stop the leak and finally caused the nut to fail.

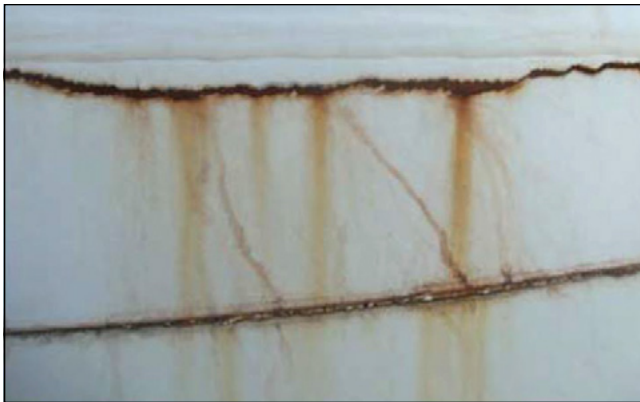
Figure 4
Crack in tower.

The most likely candidate for loading that could cause a crack to form at the observed location is vortex-induced vibration. In Chapter 2 of his seminal book on the subject, Blevins¹ provides an excellent discussion of the mechanism that causes vibration in cylindrical towers and stacks. For smooth cylinders, such as the wind generator tower, lift forces will be developed due to Bernoulli's principle* at the sides of the tower that result in lateral forces (forces perpendicular to the flow direction). The formation and subsequent shedding of vortices that disturb the flow around the cylinder (**Figure 6**) and alternate from side to side provide a harmonically varying (sine or cosine) load on the tower.
