Journal of the
National
Academy OF
Forensic
Engineers[®]

National Academy of Forensic Engineers®

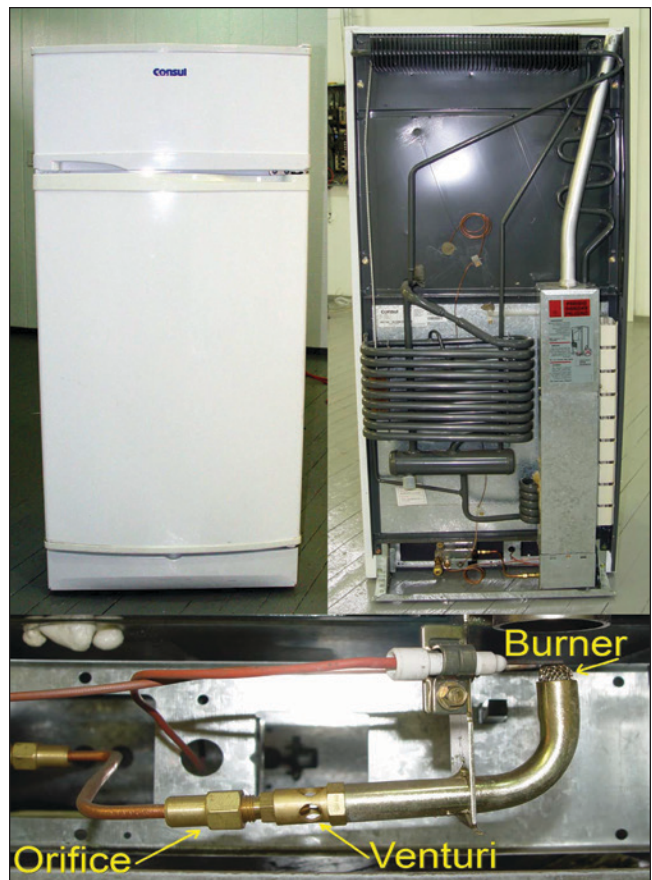
Figure 1
LP-gas refrigerator, front and back.
Lower photo shows gas train components.

In response to the initial lawsuit, the subject refrigerator was tested onsite by an expert for the refrigerator manufacturer. He first tested the refrigerator, as found, and recorded a high CO reading in the flue (~3,500 ppm). An examination revealed the venturi* was blocked with dog hair, and the vent was coated in soot. In addition, he determined the appliance had not been adjusted for high altitudes. He cleaned the venturi and vent, restarted the refrigerator, and recorded a CO reading of more than 2,000 ppm immediately after startup.

The discussion/negotiation between the plaintiff and refrigerator manufacturer is unknown. However, the third-party certification of the appliance design to a national standard (ANSI/AGA Z21.19, *Refrigerators Using Gas Fuel*²) was likely disclosed. The plaintiff’s explanation was that the high CO reading, after cleaning, was due to the refrigerator not being derated for the altitude. The “as-found” CO reading was due to a lack of derating and the obstruction of the venturi.

The refrigerator manual included instructions for derating the refrigerator. These amounted to increasing the regulated pressure to the appliance†. Additionally, a high-altitude burner orifice (smaller diameter) was available, although not mentioned in the manual. These findings were apparently not disputed by the plaintiff’s expert. The first lawsuit was dismissed.

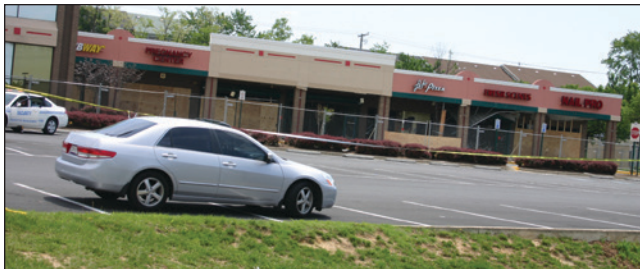
Figure 2

A view from the front of the shopping mall of the tenant spaces that sustained the most extensive explosion damage.

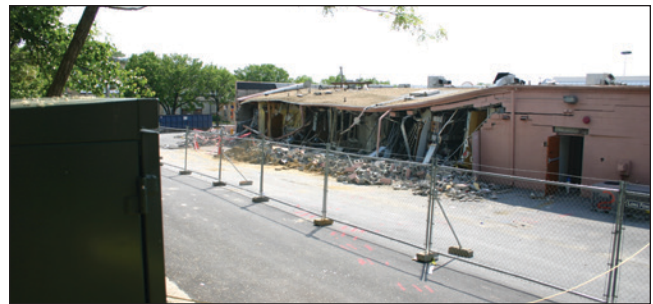
Figure 3

A view from the rear of the shopping mall of the tenant spaces that sustained the most extensive explosion damage.

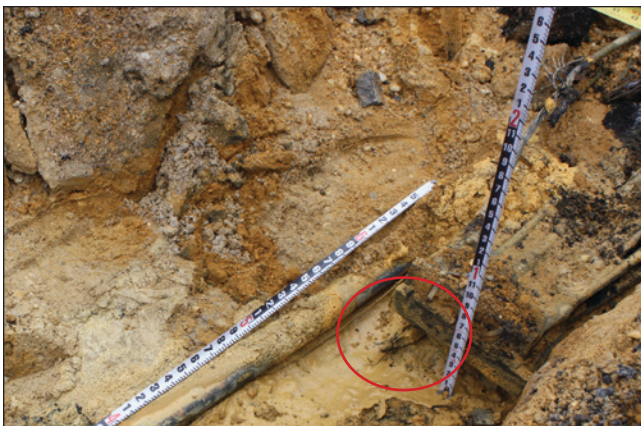
Figure 18

The fuel source for the explosion was determined to be natural gas originating from multiple failures in the 2-inch plastic underground gas distribution main. Gas utility company personnel, utilizing combustible gas indicators, entered the front of the pizza shop and conducted measurements from the front of the restaurant to the rear. At the rear of the restaurant, they detected natural gas migrating into the structure along the rear CMU wall and through the electrical and plumbing penetrations. Evidence of natural gas was also directly observed by the owner of the pizza shop, fire department personnel, and gas utility employees; it was observed bubbling up through a puddle of water accumulated in a cracked area of the asphalt surface behind the restaurant prior to the occurrence of the explosion. The puddle was located directly above the gas distribution main.

Most of the remains of the destroyed electrical cables were removed before the joint exam by employees of the gas company. Clearances to the remaining cable sections were approximately 3 inches.

The faulting cables had charred and burned holes through the plastic gas main, allowing gas to escape. Note the stub of a destroyed section of power cable (circled) adjacent to the burned section of gas line.

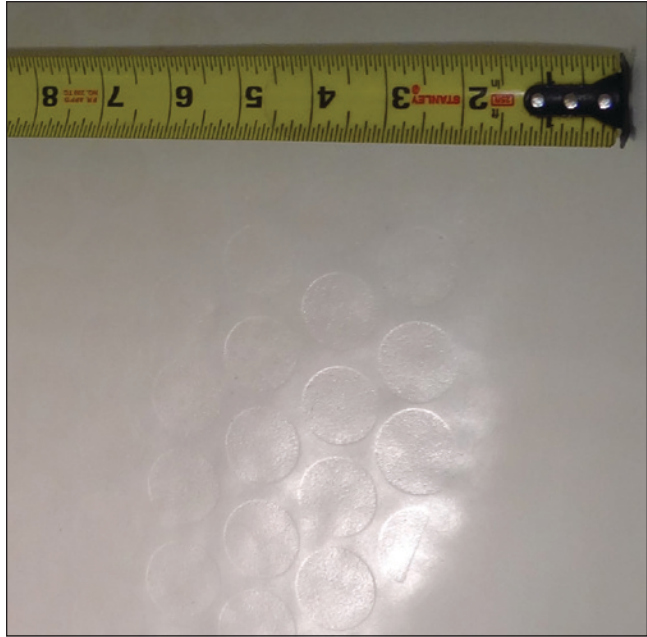
surface of the bathtub (see **Figure 4**). If the subject bathtub were to be subject to the requirements of modern standard ASME A112.19.1M, the traction features would be required to come within certain distances of the sides of the bathtub — the subject bathtub conformed to these modern dimensional requirements.

Figure 4
Slip-resistant features along bottom of subject bathtub.

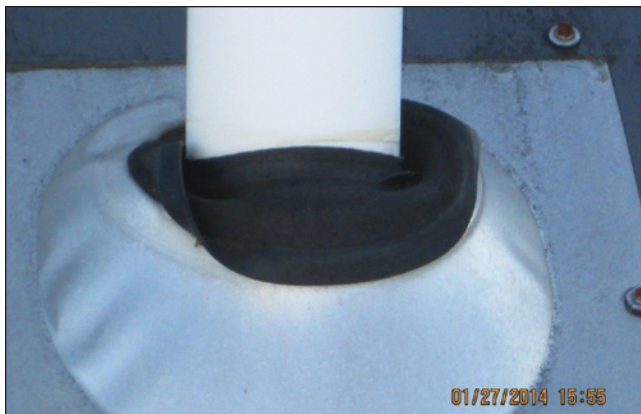
As seen in **Figure 3**, water leakage was initially thought to be caused by a leaking roof boot seal around vent piping, due to the manner in which the boot was damaged. The boot was damaged in a manner consistent with heavy snow load deflecting the roof sheathing and distorting the rubber seal and aluminum flange. It was later determined that this was not possible, however, due to the steel roof construction and strength of the roof truss system. Another explanation was sought.

Figure 3
Damaged roof vent boot.

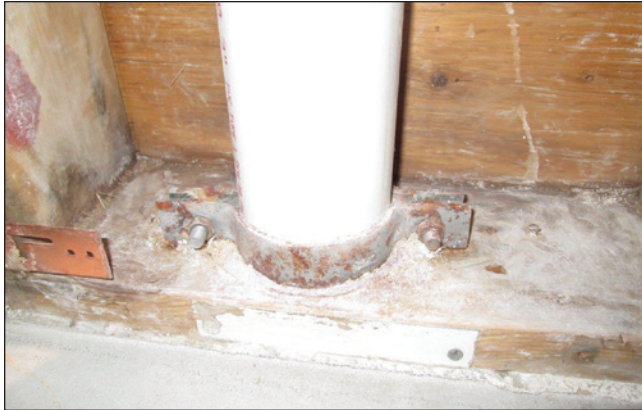
Figure 6
Vent stack pipe resting on riser clamp.

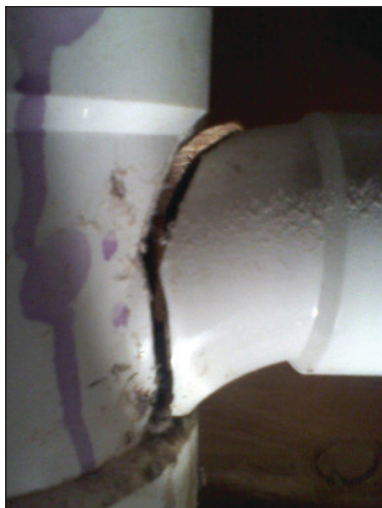
Although photograph documentation was not provided from the earlier pipe breaks from past years, the most recent event’s damaged fitting was photographed by the condominium management staff and provided to investigators (**Figure 8**).

Figure 8
Provided photo of cracked “tee” fitting at riser.

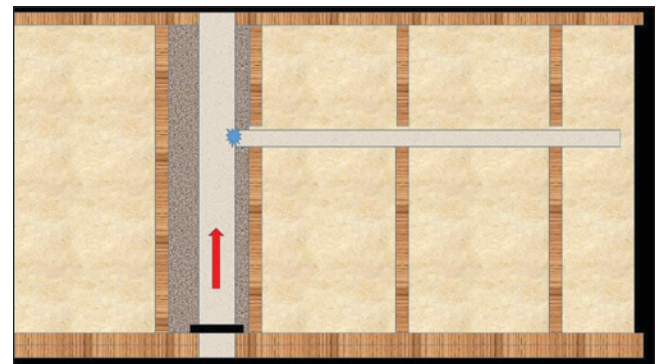
The installation method of this piping being constrained (see **Figure 10**) without accommodation for expansion, contraction, or building movement — combined with reports of where past plumbing repairs were located (and how they failed) — led to the author’s opinion that a plumbing system design defect was the cause of the piping failures and building damage.

Figure 10
Diagram of piping connection to vent riser.

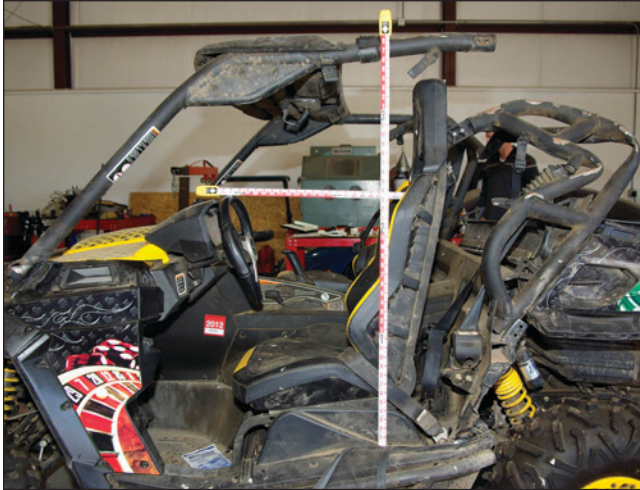
Figure 8

As described above, the UTV's center of gravity did not gain significant height above the ground during the initial forward pitchover. When the roof struck the ground, the roll cages collapsed and deformed but did not fully compress down to the body of the UTV. It is reasonable to conclude that increased roll cage strength would have reduced the exposure to occupant injuries. In the opinion of the authors, even a moderate increase in roll cage strength would have prevented the collapse of the roll cage.

Case A: Side view of roll cage damage. Front half of roll cage has been temporarily placed on the vehicle. (The A-pillars were cut at the front frame attachment points after the accident by rescue personnel.)

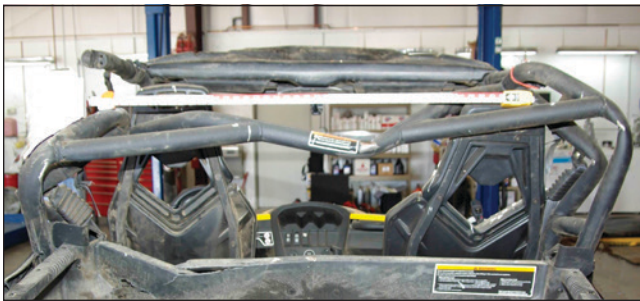
Figure 9

Case A: Rear view of roll cage damage.

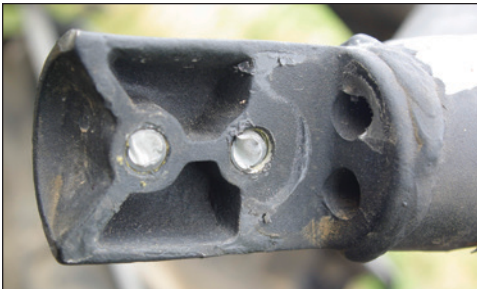
Figure 10

Case A: Failed bolted connection in side header tube.

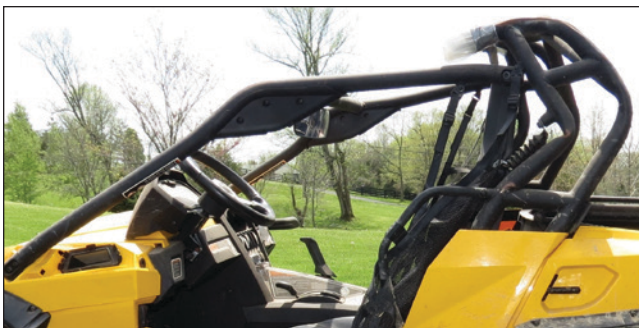
UTV Damage: One corner of the front bumper was deformed rearward. The roll cage collapsed at the B-pillars above the driver's head, and the bolted connections in the side header tubes failed in shear. The front half of the roll cage collapsed downward at the bolted connections, and the bolts attaching the front of the roll cage to the frame had also failed in shear. The

The level of B-pillar roll cage deformation in Case B suggests that when the roof struck the ground, the forces of contact were marginally greater than the

Figure 14
Case B. Side view of failed roll cage.

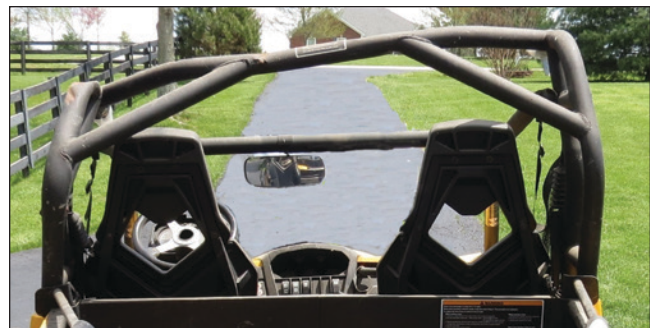
Figure 15
Case B. Rear view of failed roll cage.

Fundamental mechanical engineering design practice and numerous roll cage design standards require triangular trusses. This is accomplished with diagonal bracing. Diagonal braces can be included in a four-point mount design, or they can be added by utilizing six mounting points to the frame. Diagonal bracing is standard in roll cages designed for off-road racing vehicles where the probability of rollover is higher than in passenger cars. Longitudinal and lateral diagonal bracing should have been included in the UTV roll cage design. Fundamental engineering design principles should have been incorporated into the entire UTV design from the conceptual stage.

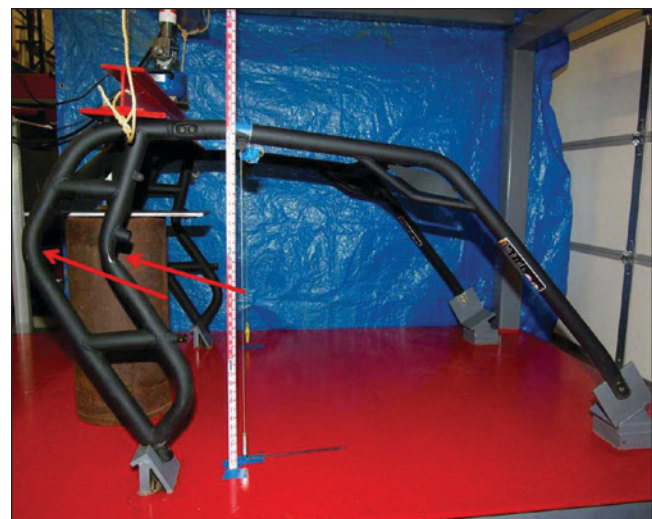
Figure 18

The test setup is shown in **Figure 18**, and the load displacement data is shown in **Figure 19**. The B-pillars buckled at a vertical load of 16,510 pounds.

Laboratory testing of an exemplar roll cage. Z-shaped B-pillars buckled at bends (arrows).

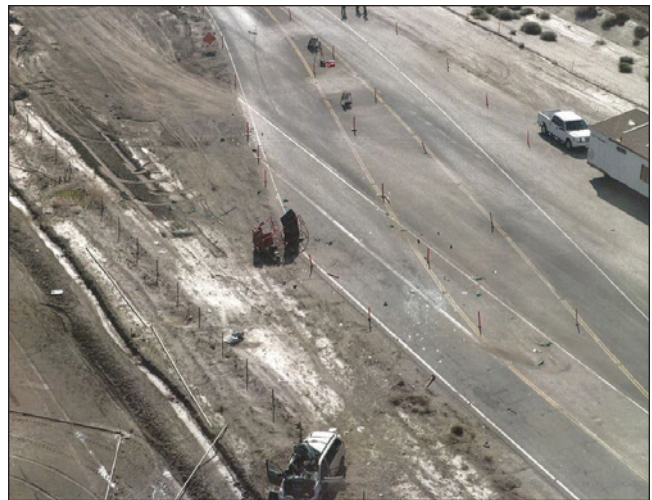
Figure 10
Obliterated lane lines.
