Journal of the  
**National**  
**Academy** OF  
**Forensic**  
**Engineers**<sup>®</sup>

* <b>Effects of Evidence Spoliation on Forensic Engineering</b>	
<b>Analysis of Alleged Brake Servicing Defects . . . . .</b>	<b>13</b>
<i>By John Leffler, PE (NAFE 709S)</i>	
† <b>Forensic Engineering Analysis: Biomechanics is an Engineering Discipline . . . . .</b>	<b>23</b>
<i>By William E. Lee III, PhD, PE (NAFE 655S)</i>	
‡ <b>Forensic Engineering Tools and Analysis of</b>	
<b>Heavy Vehicle Event Data Recorders (HVEDRs) . . . . .</b>	<b>33</b>
<i>By Jerry S. Ogden, PhD, PE (NAFE 561F) and</i> <i>Mathew Martonovich, PE (NAFE 968M)</i>	
‡ <b>The Impact of the Lack of Marine and Rail Standards on the Transportation of</b>	
<b>Large Power Transformers . . . . .</b>	<b>51</b>
<i>By David Gillingham, P. Eng. (NAFE 935A)</i>	
‡ <b>Forensic Engineering Analysis of Fuel Usage and Thermostat Settings . . . . .</b>	<b>63</b>
<i>By John Certuse, PE (NAFE 708F)</i>	
‡ <b>Forensic Engineering Analyses of a Home Fire . . . . .</b>	<b>75</b>

# Effects of Evidence Spoliation on Forensic Engineering Analysis of Alleged Brake Servicing Defects

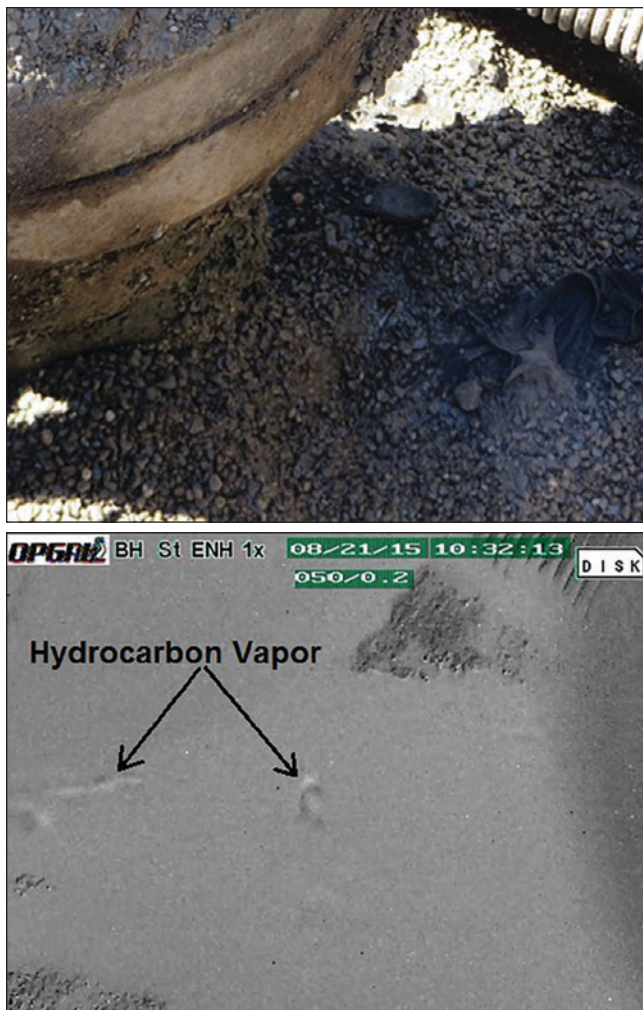
It is also useful to remove the standing water from the well cellars to screen the well using an infrared camera. Infrared video may be used to demonstrate conditions at the well to regulators. When used properly, infrared video can show whether gas is streaming at a high rate or wafting at a low rate (**Figure 5**).

**Figure 5**  
Photographs of a cellar in visible light (top) and in infrared (bottom).

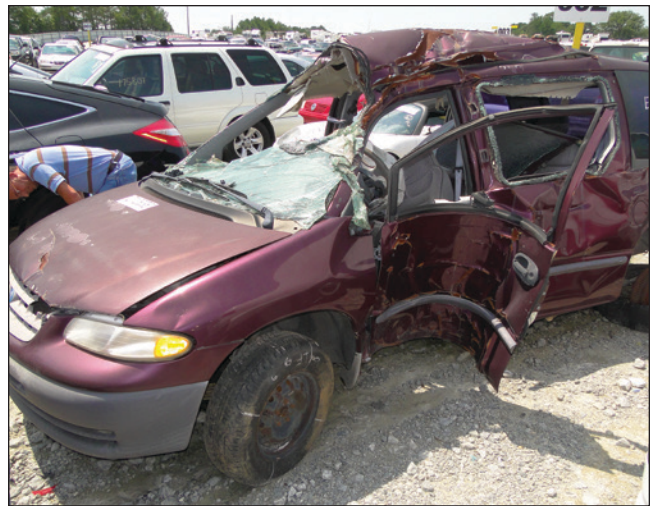
**Figure 1**  
Impact damage to minivan.

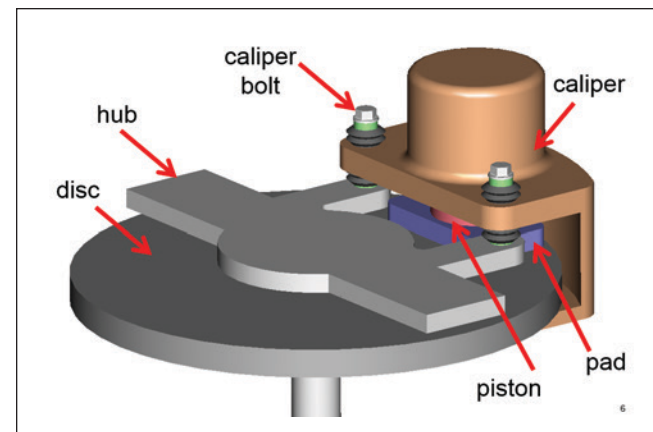
**Figure 2**

The plaintiff's expert alleged that the incident was due to this bent lower caliper bolt causing brake pulling upon application. The subject minivan utilized single-piston sliding front brake calipers that have two bolts (**Figure 2**). In such designs, the caliper piston is inboard and (when actuated) presses the inboard brake pad against the disc. This piston force simultaneously causes the caliper to slide axially along lubricated cylindrical "slider" bushings (**Figure 3**), in turn causing the outboard features of the caliper to pull the outboard brake pad against the disc. The upper and lower caliper bolts locate and retain these lubricated cylindrical bushings. Over time, improperly maintained sliding caliper assemblies may bind or drag if the caliper itself cannot slide freely on the lubricated cylindrical bushings. Additionally, since the piston's force application is offset from the cylindrical bushing axes, a bending load is imparted to the cylindrical bushing/caliper interface. The bushings often (including on this minivan) have a rubber "bellows" type boot around them to reduce the ingress of contaminants into the bushing grease. It can

be seen from **Figures 2** and **3** that if one of the caliper bolts were significantly bent, it could causing binding or dragging of the caliper in use.

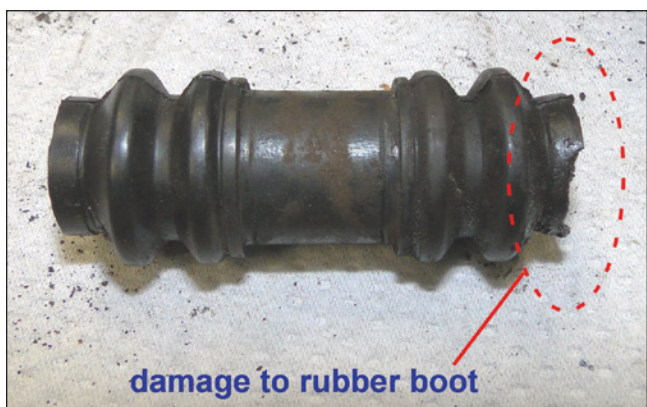
**Figure 6**  
Damage to lower slider’s rubber boot.

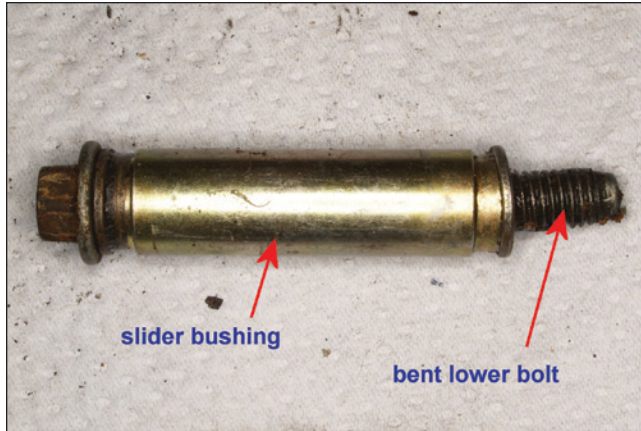
The plaintiff hired an expert to inspect the vehicle, and he conducted inspections in August and September of 2011. According to his deposition testimony, in his first inspection, he did not find any notable issues with the brakes. He was also able to depress the brake pedal and found that the vehicle had "full pedal," which typically means that the brake pedal was not noticeably soft nor would the pedal slowly sink under sustained foot pressure. The plaintiff's expert's testimony went on to say that he was instructed (by his retaining attorney) to do another inspection and disassemble components in order to try and find problems. His second inspection was conducted alone, without participation by (or notice to) other potentially involved parties. During this second inspection, he removed the front brake calipers, disconnected the hydraulic brake hoses to the calipers, and took custody of these parts. During the removal of the right front caliper, the plaintiff's expert reported discovering that the passenger's side (right) lower front brake caliper bolt was bent.

**Figure 7**  
Lower slider bushing and bent bolt.

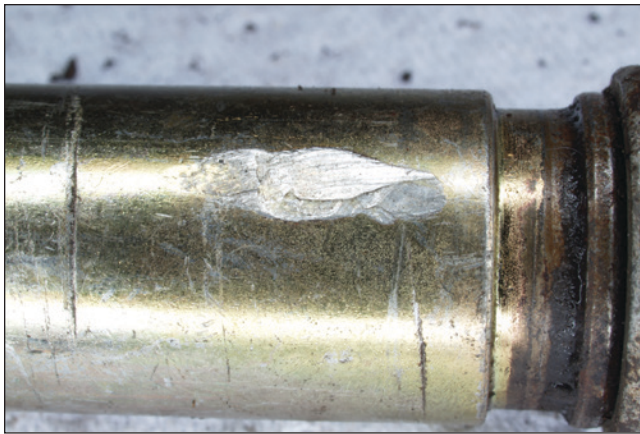
**Figure 8**  
Impact/wiping marks on inboard end of slider bushing.

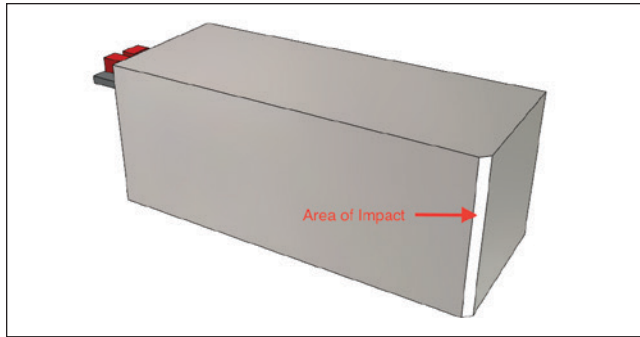
**Figure 7**

the transformer impacted the side of the vessel during offloading, as shown in **Figure 7**. This impact event was observed and logged by the marine surveyor, whose report was used by the forensic engineer as evidence for his investigation.

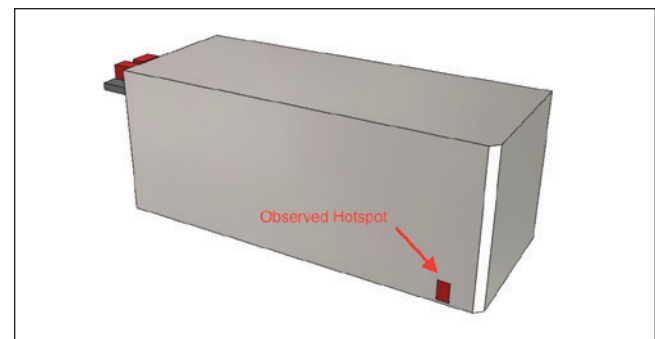
**Figure 8**

Following the commissioning and energization of the transformer, the owner observed internal gassing. Using an infrared imaging camera, they discovered a hot spot near one of the mounting feet for the core and coil assembly, as shown by the red spot in **Figure 8**. The owner conducted an internal inspection of the transformer tank and provided photographs to the forensic engineer. After analyzing the photographs, as well as construction drawings of the transformer core assembly, the forensic engineer subsequently determined that the core assembly had shifted within the tank, placing one of the three mounting feet too close to the tank wall. This physical shift changed the electrical dynamics of the transformer, which led to arcing activity between the core assembly and the tank wall.

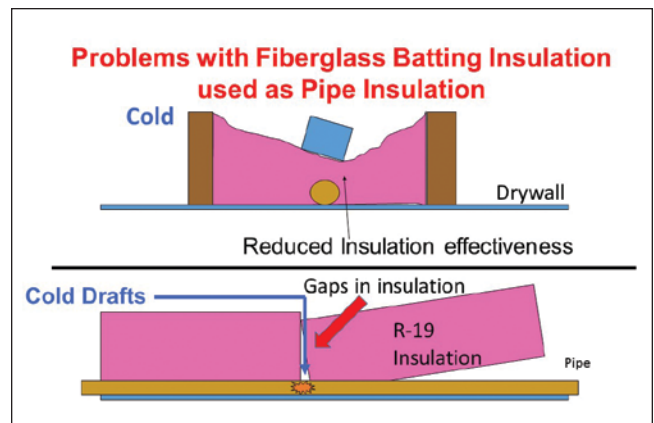
8). Additionally, current use of fiberglass batting or loose fill insulation is prone to separation causing gaps, compression, and settling — all of which reduce their intended performance.

**Figure 8**  
Typical problems with batting-type insulation.

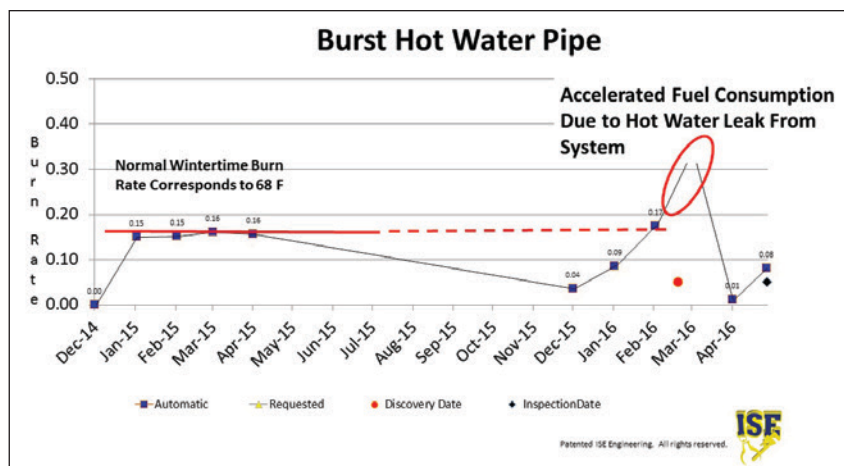
**Figure 14**  
Fuel usage burn rates showing hot water pipe burst.

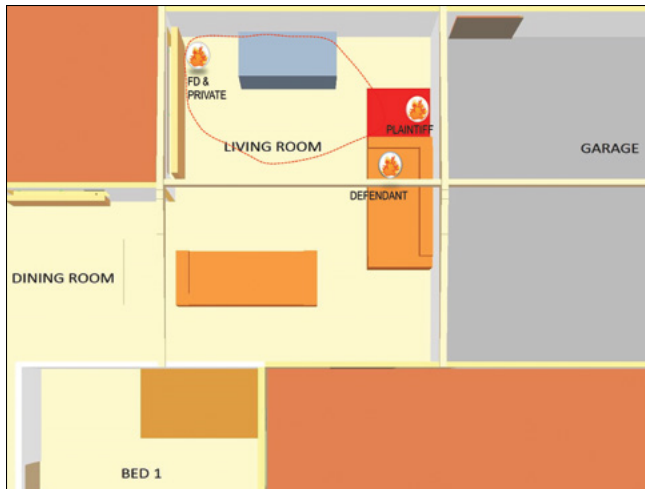
The O&C expert (#3) of the tenant (plaintiff) opined that the origin was in the south wall close to the east

**Figure 10**  
Disputed origins within living room.

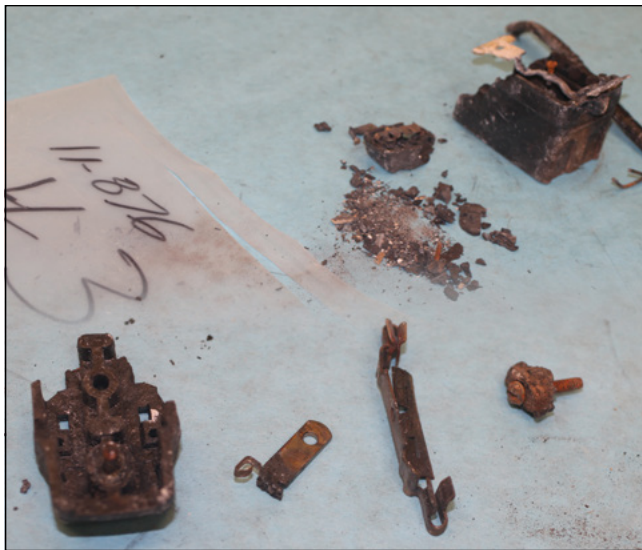
The two extension cords were daisy-chained, the failure-mode was localized, and internal melting of the prongs/blades was consistent with electrical resistance heating and faults/arcs (**Figure 17** and **18**). Evidence item #3 shows the remains of the outlet behind the couch in the south wall of the living room (**Figure 19**).

**Figure 19**  
Evidence #3 outlet from the south wall of living room.

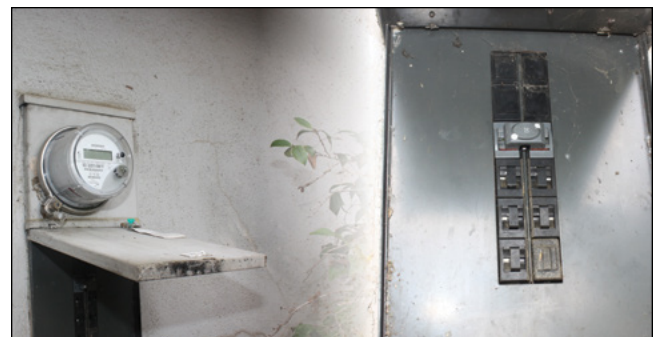
**Figure 23**

Analyses of the photos of the meter and the breaker panel found that there was no main breaker for the electrical system (**Figure 23**). Furthermore, it was noted that most of the breakers were of the “pushmatic” type, implying that they were 1960s vintage electrical breakers with associated installation. The trace indicated a ganged-pair of circuit breakers were utilized
