Journal of the  
**National**  
**Academy** OF  
**Forensic**  
**Engineers**<sup>®</sup>

Vol. 34 No. 1 June 2017

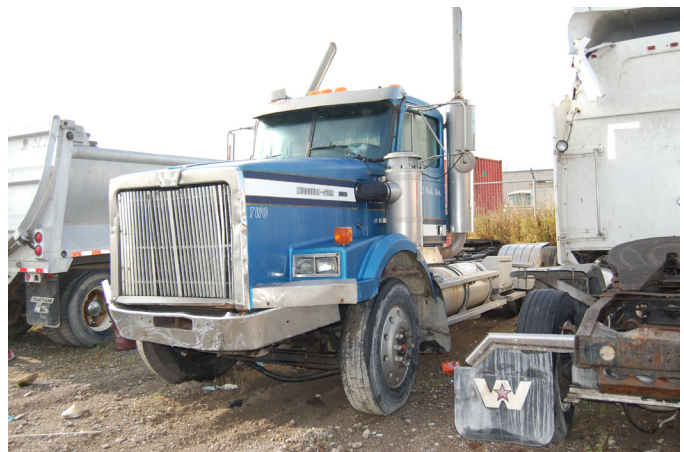
**Figure 11**

Front view of the tractor with post-impact bumper deformation.

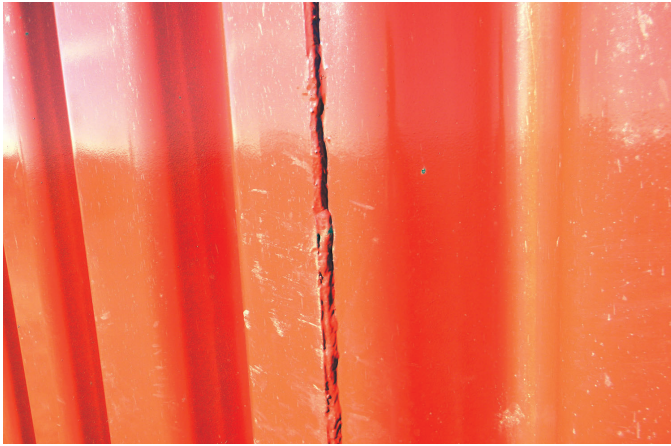
**Figure 5**  
Typical weld defect — open seam.

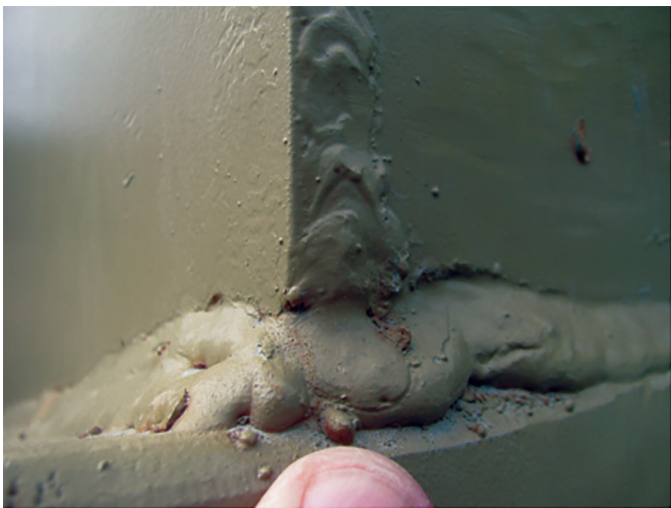
**Figure 6**  
Typical weld defect — undercut.

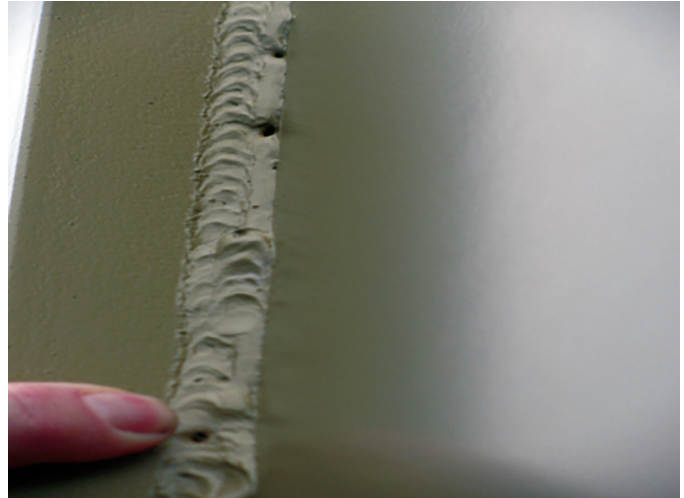
**Figure 7**  
Typical defective weld — pores.

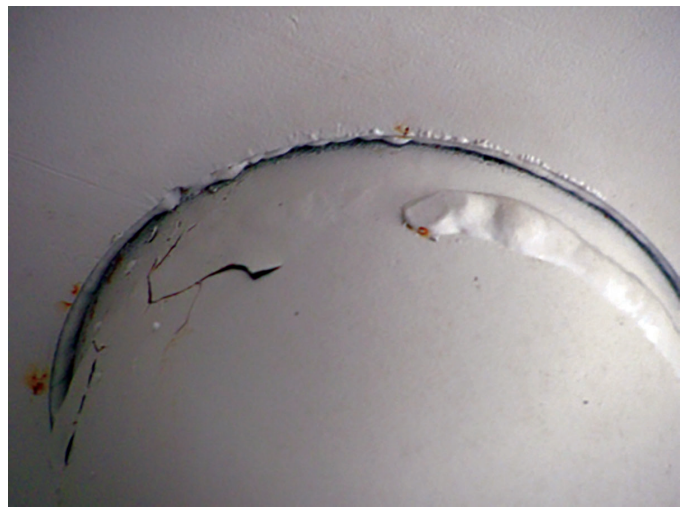
Inspections were performed by the owner’s third-party inspection company on selected tanks in Alaska. These inspections were valid and reliable for welds on the subject fracking tanks. The Alaska Department of Environment Conservation (ADEC) reviewed the inspection plans and did not object to the owner’s third-party inspector’s findings. Numerous welds in the fracking tanks leaked and were not fit for service.

**Figure 8**  
Typical defective weld, incomplete and non-fusion.

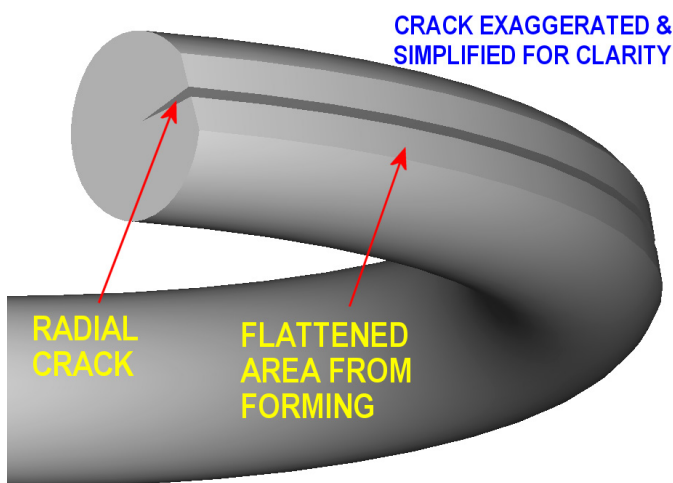
- In the litigation, it was asserted by other experts that Delmar was the responsible entity for the fatigue failures, due to the radial cracking of certain portions of the spring wire. Some of this radial cracking was observed to be originating from the “center” of the flattened area of the wire, and some was observed to originate from the galled/abraded area of the wire surface inherent in the forming process. See **Figure 7** for a simplified representation of the cracking. Note that not all fatigue failures showed evidence of this radial

**Figure 7**  
Radial cracking.

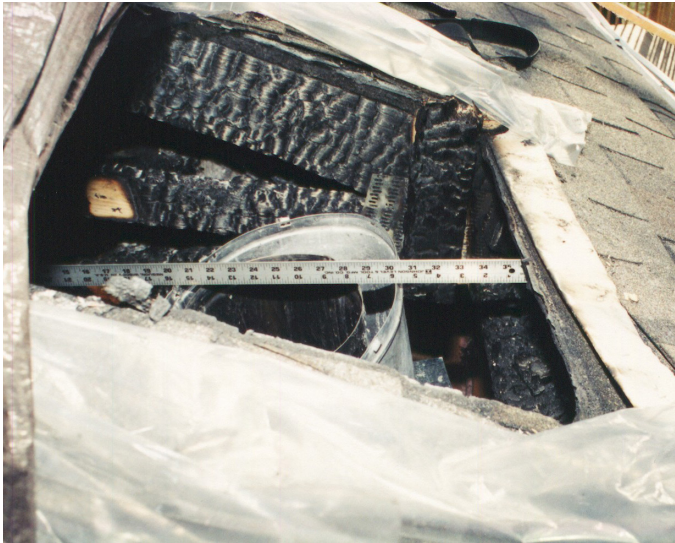
**Figure 4**  
Top of chimney assembly in house attic.

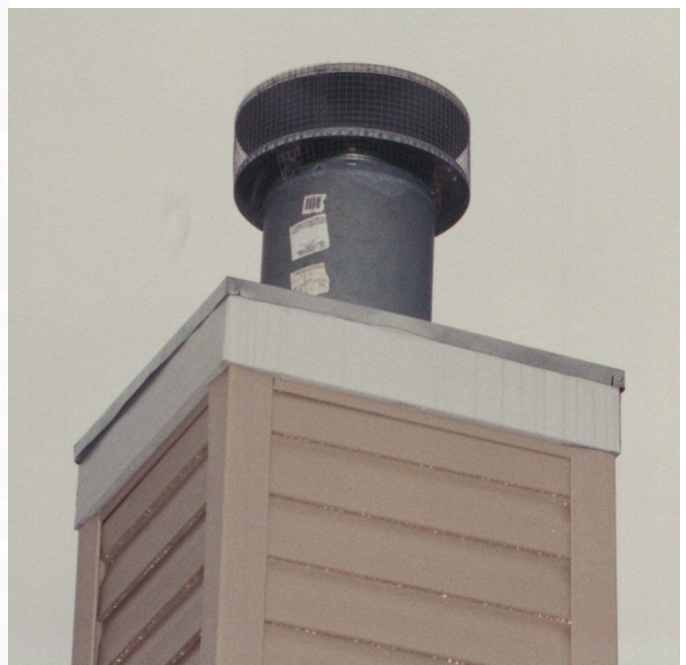
An inspection of an exemplar house that had been constructed by the same builder revealed that the upper portion of the fireplace chimney and rain cap clearly extended above the top of the wooden chase (**Figures 6 and 7**).

**Figure 7**  
Exemplar chase showing chimney and termination cap extending above.

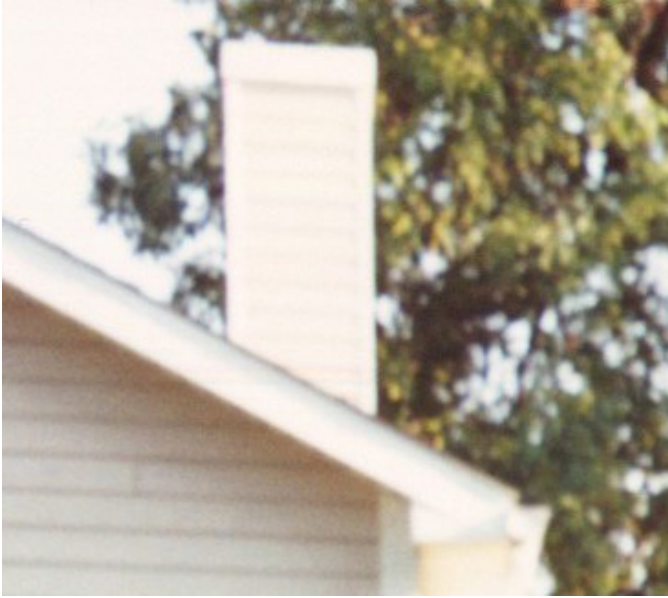
**Figure 8**  
Subject chase before fire.
