Journal of the

Vol. 34 No. 2 December 2017

Forensic Engineering Analysis of Alleged Construction Defects

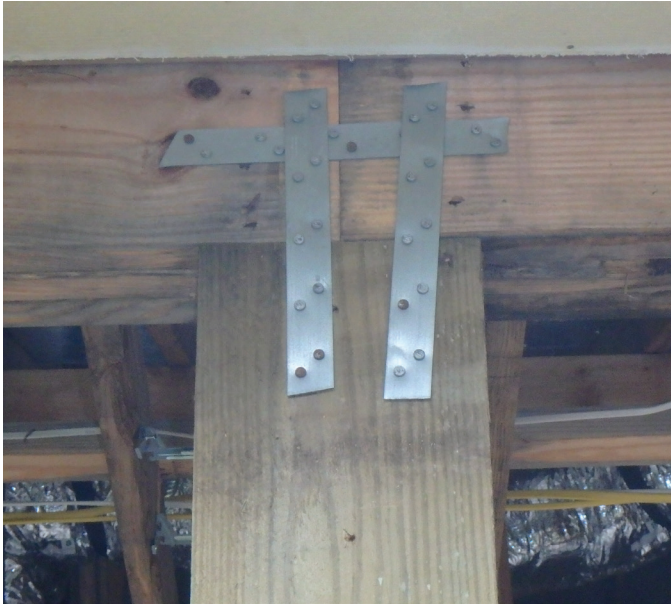
Figure 2
Defective connection.

Figure 2 shows a builder-caused defect where the column-to-beam connection was not constructed as it was designed.

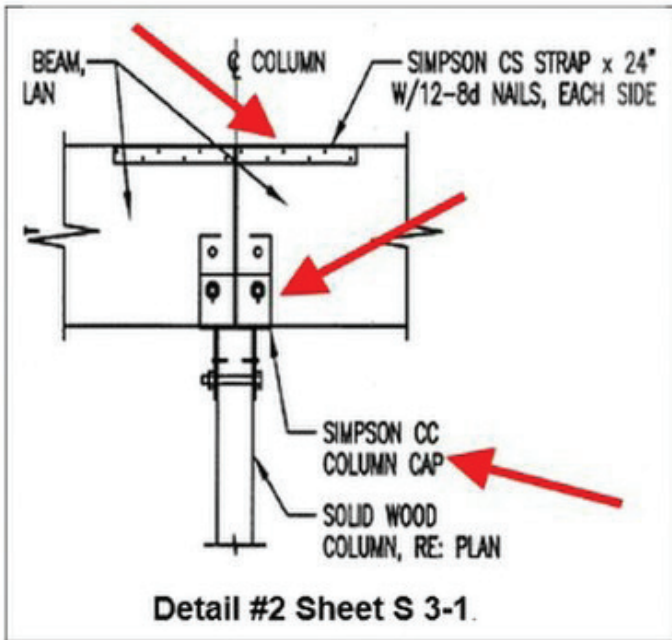
Figure 3
This is how the connection in Figure 2 was designed.

Figure 3 is the applicable drawing detail that specified the required column cap, which was not installed by the contractor. There was no mystery in the design, and there was no logical reason why the specified column cap was not installed by the builder. The possible future observable defect would be a distressed or failed connection after a wind storm of sufficient magnitude to stress the defective connection. **Figure 4** provides another example of a builder-caused defect where this post foundation was not constructed as designed — with the wood post being directly embedded in concrete. **Figure 5** shows the drawing detail that specified the required foundation configuration and anchor.

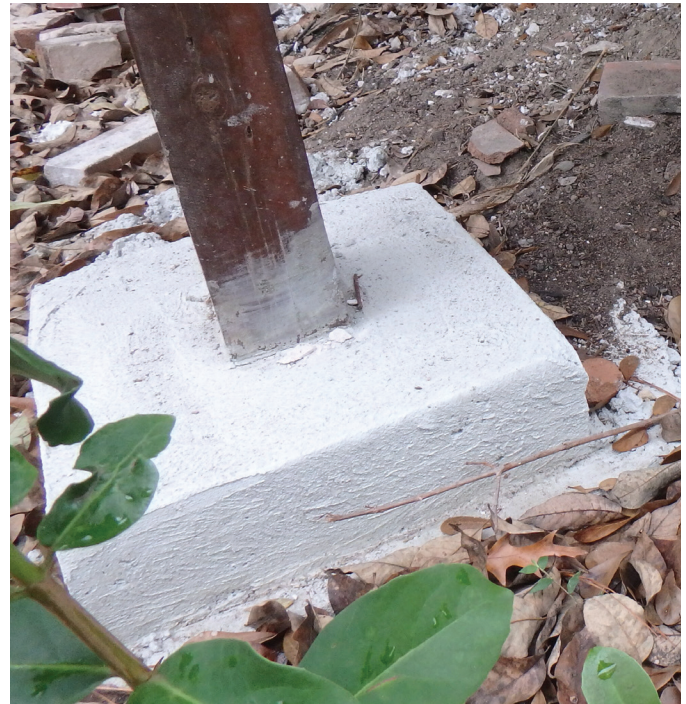
There was no configuration mystery because the design illustrated how the post was supposed to be connected to the concrete. The future defect will be a rotten column because water will seep through the bricks and not drain away from the wood post. These two examples show contractor mistakes that could lead to serious hidden damage during the building's life cycle.

Figure 4
Incorrect configuration.

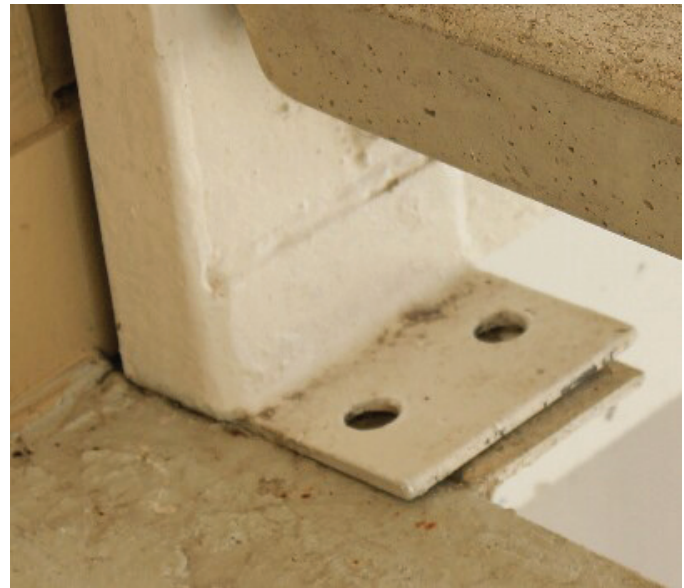
Figure 7
Missing bolts.

The following examples show what can appear to be defects caused by the builder, but that could have actually stemmed from some other cause. Figure 7 appears to show how the builder failed to install bolts in this flight of stairs. Or does it show that the bolts are missing six years

after construction, two years after a hurricane damaged the property, and after extensive repair work was done? The visual observation could lead to the conclusion that the builder failed to install the bolts. The detailed forensic evaluation, however, would look beyond what is visible. For example, if removal of the stairs was included in the hurricane damage repair scope, that would likely eliminate the original builder as the cause of these missing bolts.

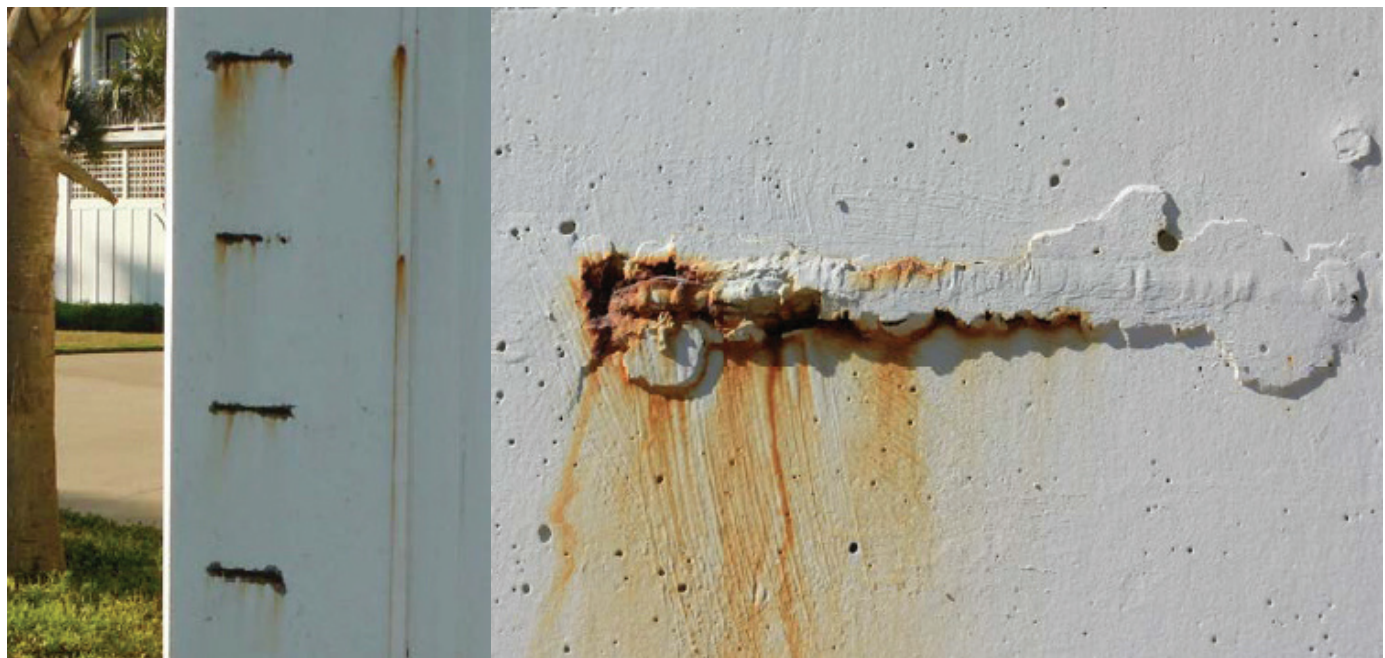
Figure 6 shows a condition where the contractor failed to provide sufficient concrete cover over reinforcing iron in a high-corrosion environment located near the Gulf of Mexico. Visual observations, coupled with investigation of project documentation, revealed how this mistake occurred. The contractor failed to detail and fabricate the horizontal reinforcing column bands correctly, which resulted in more than 500 columns being compromised because of insufficient concrete cover over the bands.

Since this was a corrosive environment near the beach, the lack of extra concrete cover as specified by the American Concrete Institute (ACI) for corrosive environments resulted in accelerated corrosion and deterioration.

Insufficient concrete cover over reinforcing iron results in corrosion.

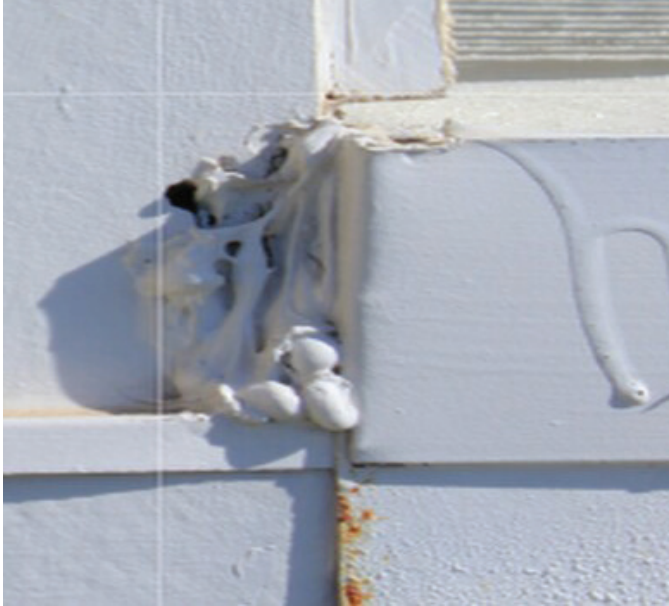
Figure 8
Questionable caulking.

Figure 8 demonstrates a non-workmanlike caulking application. Based on a visual observation, one could

conclude that the builder made a mistake, but that could be wrong. This could be a post-construction hurricane repair activity, the building could have been recaulked and painted, or a condominium owner could have done this. Interviewing the condominium owner, evaluating the layers of paint, researching condominium maintenance records, and considering other information (such as construction punch lists and hurricane repair scopes) could result in the conclusion that this is a post-construction mess not caused by the builder. These two examples show either simple construction defects or deficiencies that could have been caused by activities the builder was not responsible for. The forensic engineer must keep an open mind that will evaluate all information and then make conclusions based on that information.

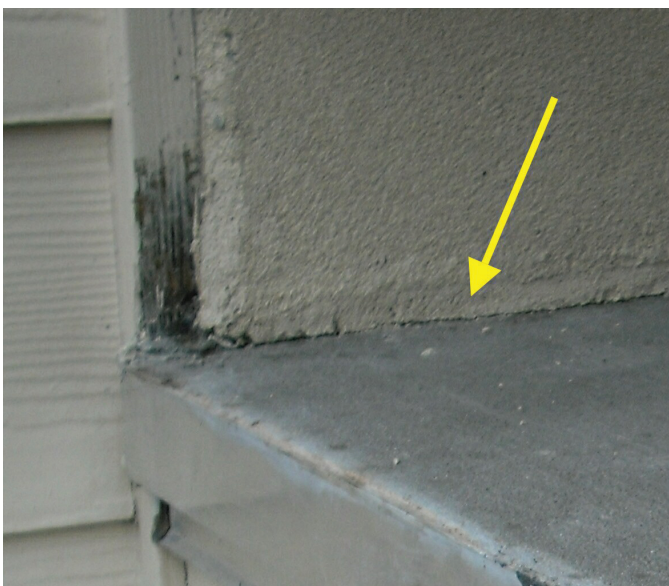
Figure 9
Stucco contacts patio.

One example of conflicting regulations is how the Americans With Disabilities Act (ADA) conflicts with the building code and results in a defect, as shown in **Figure 9**.

The ADA requires thresholds to be less than $\frac{3}{4}$ inches tall and even less in some cases. The typical condominium building threshold is designed for the ADA requirements. Expectably, a door frame will extend down to the threshold and floor. This results in what is shown in **Figure 9** — the bottom edge of stucco walls in contact with the paved patio floor surfaces (to support the door frame), which is contrary to the building code that requires 2 inches of clearance between the bottom of the stucco and paved surfaces. A forensic engineer, evaluating a building for construction defects, could conclude that because the stucco is in contact with the paved patio surface this is a construction defect caused by the builder. This would be an erroneous conclusion because the wall was constructed as it was designed. **Figure 10** shows the design of the exterior walls and patio material interface.

The “solution” is to raise the door threshold to the elevation of the top bottom plate and install a system of integrated door pan and wall flashing, but that would

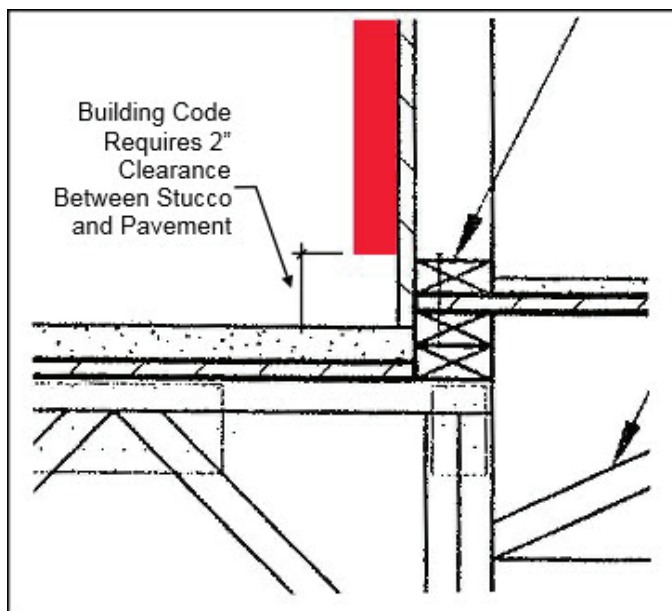
Figure 11 shows the code-required distance between the stucco and the patio, which is not possible unless a system of flashing was designed to cover the bottom plates and the bottom edge of the sheathing — something that would not be acceptable because the threshold elevation would have to be raised to allow continuous integration of the wall flashing with a threshold door pan flashing assembly to ensure the threshold would not leak.

Figure 11
Stucco Code requirement.

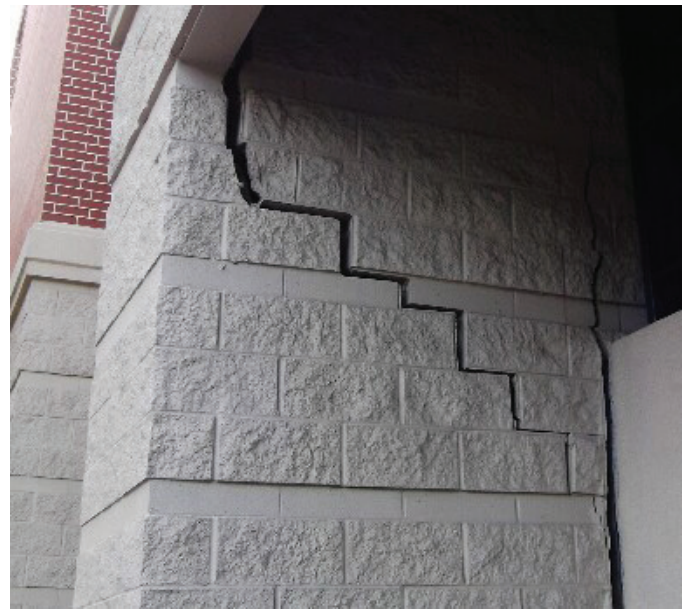
Figure 12 is an example of what was first thought by building owners to be a construction defect, but subsequent investigation and analysis determined the

Figure 12
Failing support walls.

failure was caused by a structural engineering design error.

The initial forensic engineering observations were of a failing structure that appeared to be collapsing in certain areas. The first possible cause investigated was whether underground utilities in the area were leaking and causing this failure. When an in-depth evaluation of the utilities was performed (using in-line cameras and other location equipment as part of the forensic analysis), the conclusion was that there were no utility leaks causing erosion or failure of the soil around the building.

The next phase of the forensic evaluation was to interview the structural engineer who was honest and admitted that the failure shown in Figure 12 was a design mistake because the backfilled soil around the building had insufficient strength for the load imposed by the bricks, concrete blocks, and supporting concrete footings. The conclusion of the structural engineer was that to prevent future collapse — and to stabilize the perimeter of the building — helical piers needed to be installed to provide sufficient supporting strength for the footings, concrete blocks, and brick veneer on the four-story building.

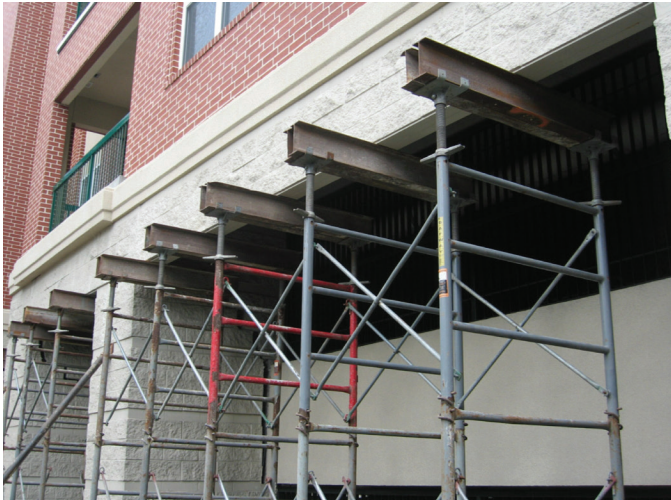
Figure 13 shows another design error that was discovered in addition to the failure shown in Figure 12. Figure 13 shows one of the numerous headers that were supporting open spans between the concrete block columns around the perimeter of the building. Other fractures observed at the corners required forensic evaluation

Figure 13
Over-spanded headers.

to determine the cause. The structural engineer reviewed the calculations with the forensic engineer and concluded that the headers were over-spanded for the capacity of the built-up steel header members, proving that this was a design error, not the responsibility of the builder.

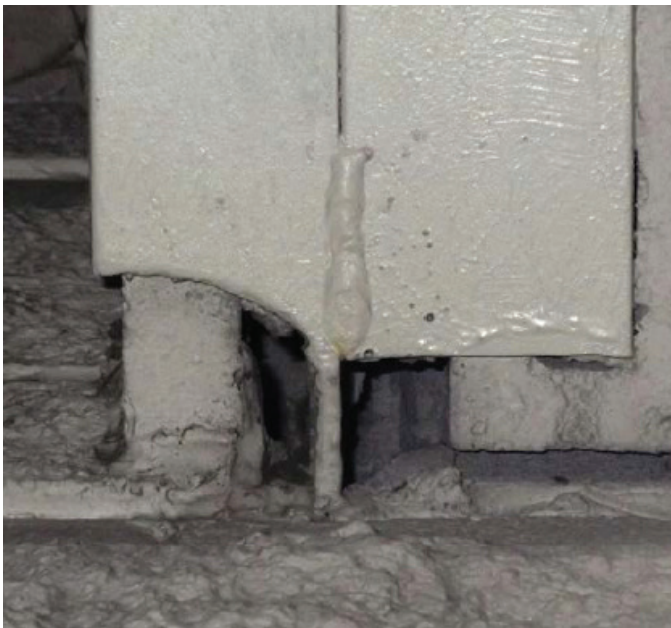
Figure 14 shows a combined design and construction error. The over-spanded header shown in **Figure 13** that was incorrectly designed by the structural engineer was also mistakenly cut by the contractor, which resulted in the header improperly bearing a sharp edge rather than the entire width of the member. The original design mistake and this construction error combined to create a design

Figure 14
Incorrectly cut header.

and construction defect; however, the over-spanded condition caused by the design mistake was the controlling defect because the bearing issue had not caused damage.

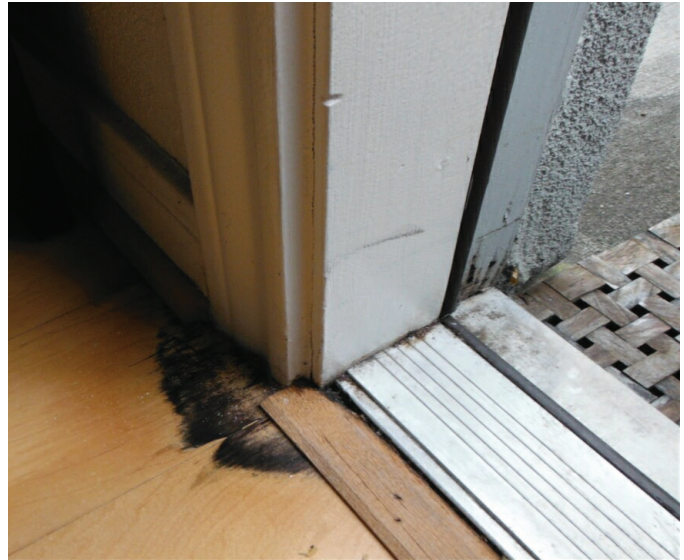
Figure 15
Floor damage.

Figure 15 shows what appears to be damage to a wood floor and door jamb from a leaking threshold and possible construction defect. **Figure 16** shows the wall base flashing just outside of the door is a deteriorated mess of rusted metal.

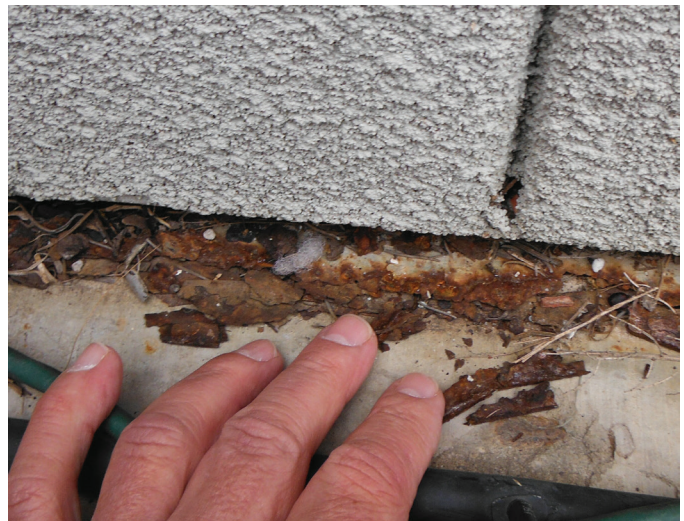
Figure 16
Rusted flashing.

conclusion. The owner of this condominium unit had an extensive collection of large potted plants and citrus trees on the patio that was serviced by a drip watering system, which resulted in a chronically wet patio. Additionally, the floor drain (located about 4 feet from this wall) was at a higher elevation, so water was not directed away from the flashing. Steel flashing is galvanized when it is manufactured, but when it is cut during fabrication, the exposed

edges are no longer as corrosion resistant as the surface. Normal industry standards are to install metal flashing without corrosion-protective measures on the edges. The solution to this problem was to use lead-coated copper flashing with soldered seams, which are more corrosion resistant than cut galvanized sheet metal. Lead-coated copper was not specified by the designer either because the designer was not aware of it or because it cost more money than the developer wanted to spend. Economics, the designer, the developer, the contractor, and the material provider all had a role in choosing the flashing material that failed.

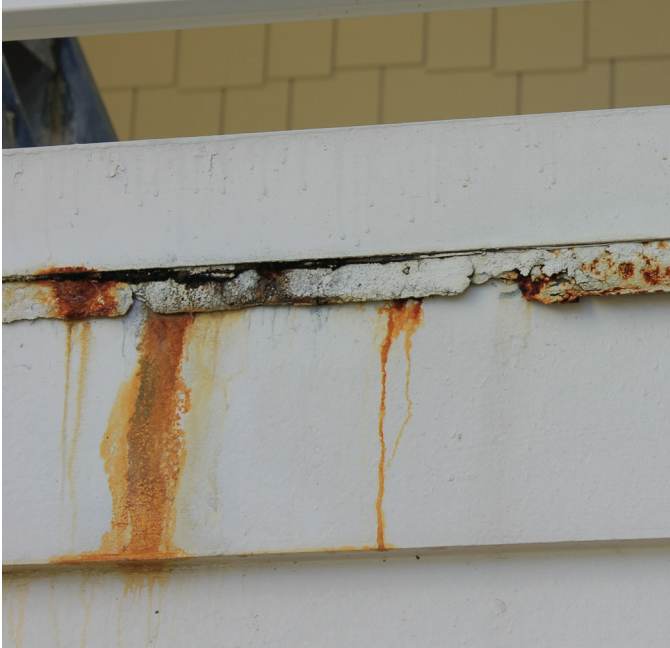
Figure 17
Rusted flashing.

Figure 17 shows a situation that was observed throughout a 28-building condominium near the beach. This was a disappointing situation for the condominium owners because the condominiums were only about six years old when this evaluation was performed. A cursory visual inspection could lead to the preliminary conclusion that either the wrong flashing material was specified by the designer or the builder failed to use the correct material. Metallurgical evaluation of flashing material that was not rusted showed the galvanizing code for seaward properties, which requires heavier galvanizing than what is used in buildings located away from the beach. In this case, the correct flashing was specified by the designer, but the builder ordered the wrong material.

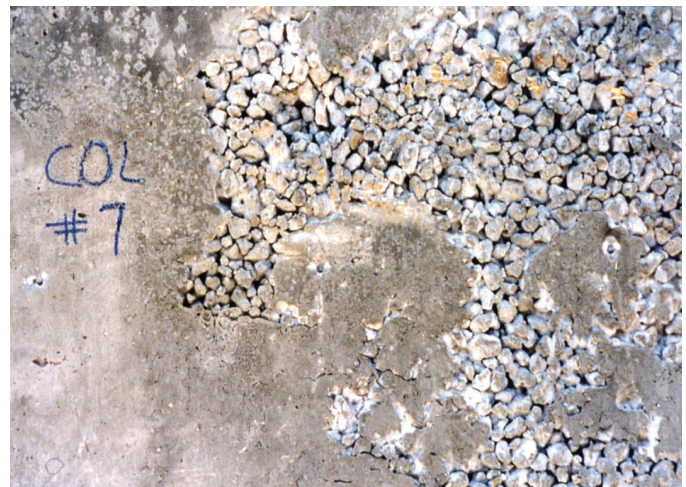
Close-up showing honeycombing and segregation of concrete.

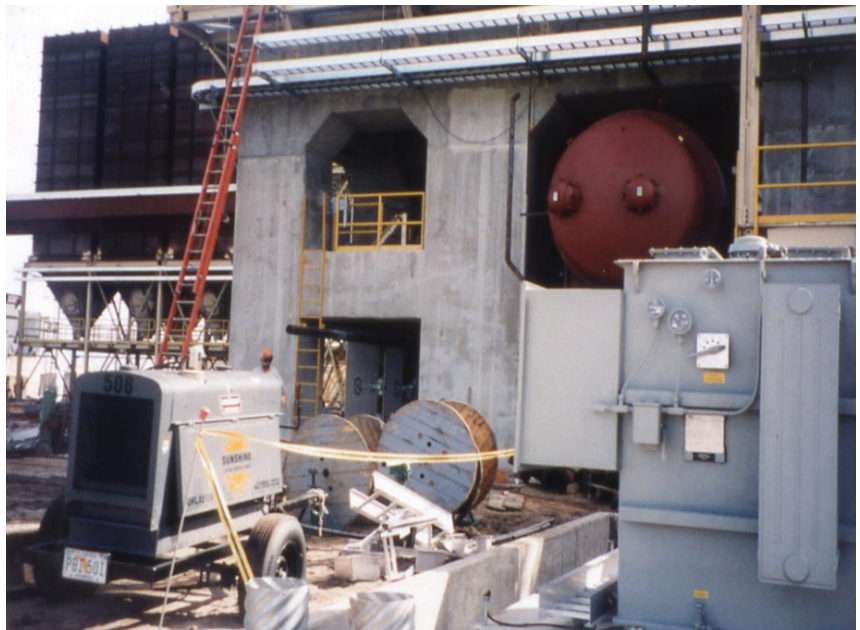
Figure 10
View of repaired STG structure.

- The final repair resulted in restoration of the STG structure to its originally planned and designed dimensions and design conditions, as depicted in **Figure 10**.

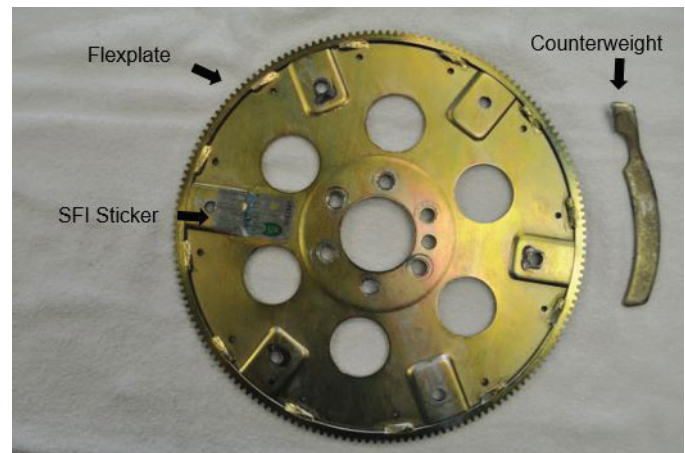
Figure 1
Subject flexplate with separated counterweight.

The subject flexplate (**Figure 1**) includes a stamped steel inner disc with the ring gear and counterweight welded to the inner disc. It was manufactured to work with an externally balanced Chevrolet-based 454 Cubic Inch Displacement (CID) engine. The flexplate was labeled with a SEMA Foundation Inc. (SFI)² 29.1 certification sticker.

flexplate inner disc by hand (manually), rather than using an automated process like the ring gear connection to the disc. As observed in **Figure 1**, the counterweight is detached from the flexplate assembly. Three welds were observed on the subject flexplate steel inner disc in areas that were intended to join the counterweight to the flexplate assembly. However, the welds between the flexplate inner disc and counterweight did not fully join and penetrate the counterweight during the welding process. The lack of weld penetration is clearly visible, as shown in **Figure 5**. It can be seen that between the arrows there is no significant melting consistent with the counterweight having been joined with the flexplate inner disc as a result of the welding process. The lack of penetration, melting, and joining of the two parts is a welding defect known as a “cold weld.” Because the product is coated with a gold-colored anti-corrosion material (zinc dichromate) after welding, certain welding defects, cracks, or disparities would not be visible to those handling the product after it was manufactured by Company D and prior to the counterweight separation.

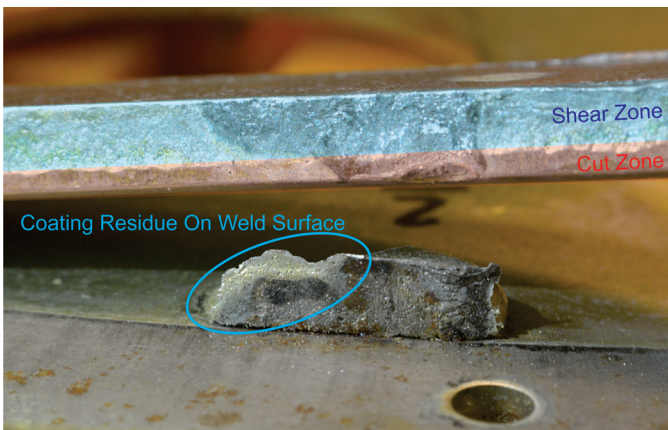
This shearing process creates two very distinct patterns on the edge of the counterweight, as shown in **Figure 6**. The portion of the part that is cut by the die has a clean and smooth edge as highlighted in red text in **Figure 6**. The portion that shears and separates from the stock material has a rough and unfinished surface, as highlighted in

Figure 6
Failed counterweight and weld — blue area indicates shear region; the red area indicates area cut by die; the gold coating found on the weld bead surface is circled in blue.

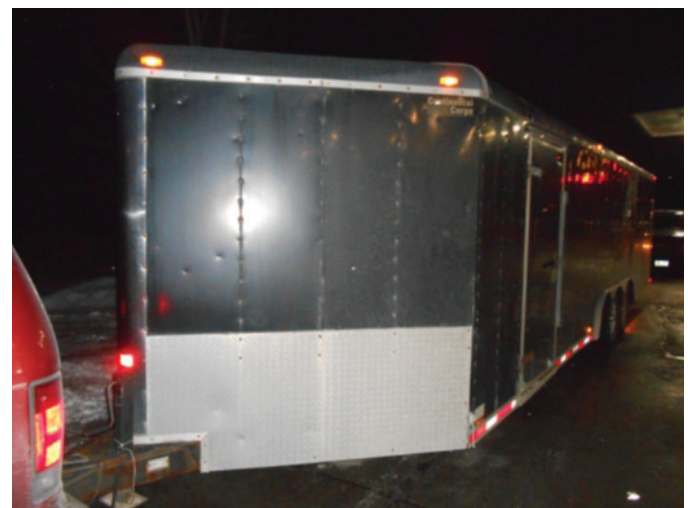
a snowmobile trip. The accident trailer with the failed wheel had three axles with a Gross Vehicle Weight Rating (GVWR) of 15,600 pounds. The southbound driver of the oncoming sedan was killed instantly as the wheel and tire struck the windshield header (the roof header buckled, and struck the driver in the head). The police diagram illustrating the accident is shown in **Figure 1**. The trailer is shown directly after the accident in **Figure 2**.

Figure 2
Accident trailer at a gasoline station; the left front wheel is missing.

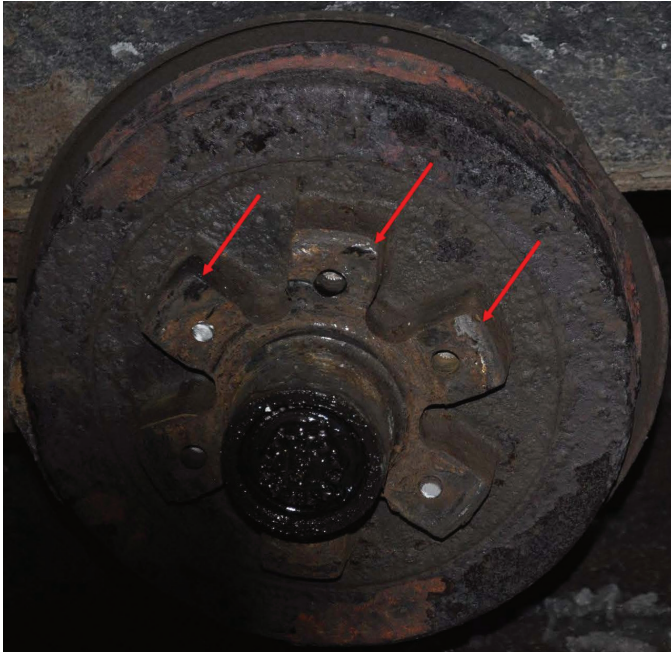
Figure 5 shows the trailer's left side front hub at the scene. Flaking rust plausibly diminishes the ability of the studs to provide the clamping force that fixes the wheel to the hub. This friction is necessary to prevent the wheel from slipping and rotating relative to the hub and damaging the lug studs. There are several high points that wore through the flaking rust near the periphery of each mounting interface. Three of these are called out with red arrows. This photo also documents that the grease cap was dislodged during the wheel loss. Five of the six fractured studs are visible in this photograph. Each shows a silver-colored fresh fracture surface. The two studs at 12 o'clock and 2 o'clock are broken below flush. The fracture surfaces of these two studs are in the vicinity of the stud splines. This indicates that the mounting studs were subject to damaging cantilever bending moments, and their mounting holes through the hub were distorted. Note: In this picture, the 6 o'clock stud is not visible, and the 8 o'clock stud has

Figure 5
Accident trailer left front hub at time of accident.

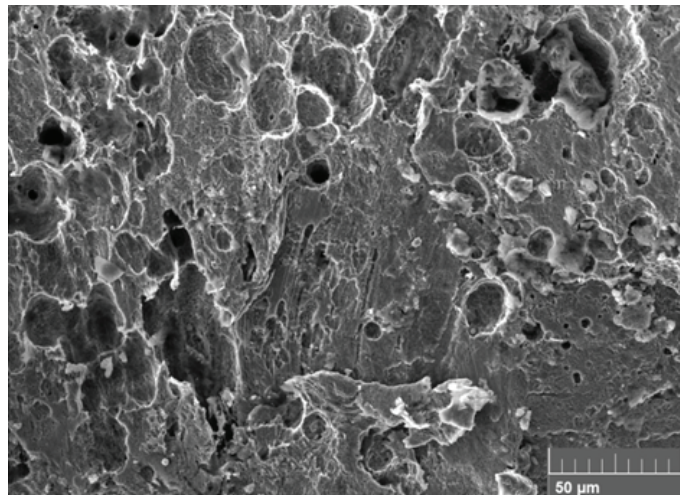
Figure 15
Corrosion pits caused by acid during cleaning.

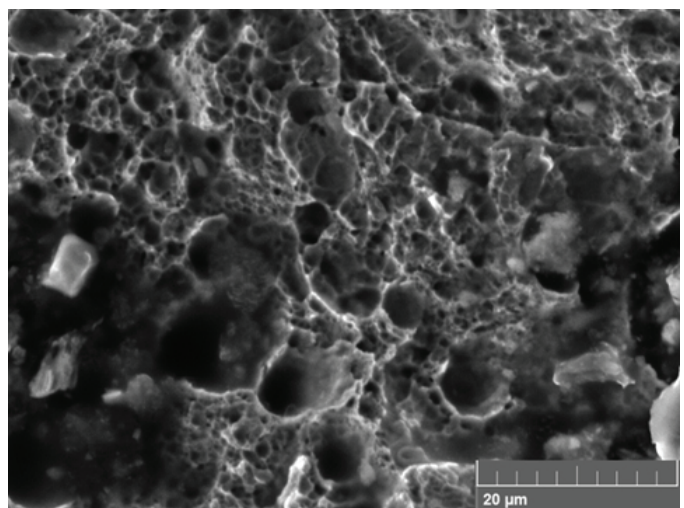
When examined, the cleaned fracture surfaces of the studs showed a variety of features, including residual corrosion products, rubbing of the fracture surfaces, overload dimpling, and fatigue marks. Three different stud SEM micrographs are now shown. The most frequent observation was “no fracture data,” as is shown in **Figure 15**. **Figure 16** shows a region of a stud with residual corrosion products and overload dimples. **Figure 17** shows what was found clearly in five of the six studs: fatigue crack marks. As for the sixth stud, which did not show clear

Figure 16
Overload fracture with some residual corrosion products.

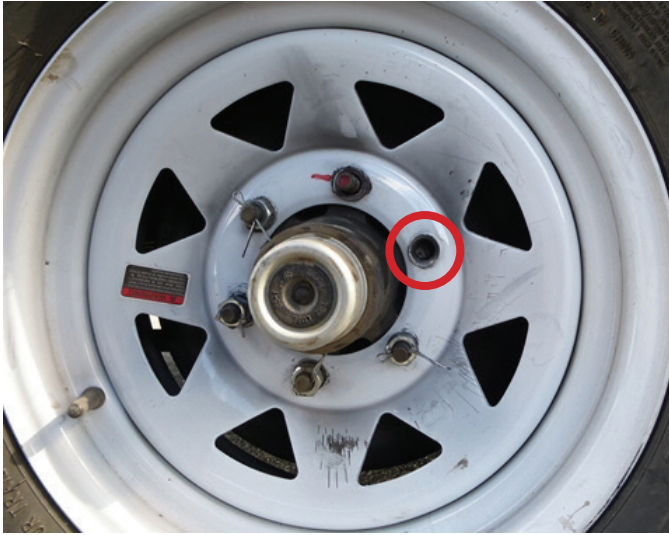
The wheel at the time of the suspension of the testing is shown in **Figure 19**. Notice that the one hole with the removed nut is marked in red and is at the 12:00 position.

Figure 19
Trailer wheel directly after first stud fracture showing the position of the fractured stud.
