Journal of the
National
Academy OF
Forensic
Engineers[®]

Vol. 35 No. 1 June 2018

On a Saturday afternoon in March of 2014, a low-order explosion occurred within a first-floor dwelling unit of a multi-tenant apartment building located in Georgia. Due to the explosion, the building sustained extensive damage, and the occupant of the unit of origin sustained serious burn injuries. This paper examines the origin and cause of the explosion.

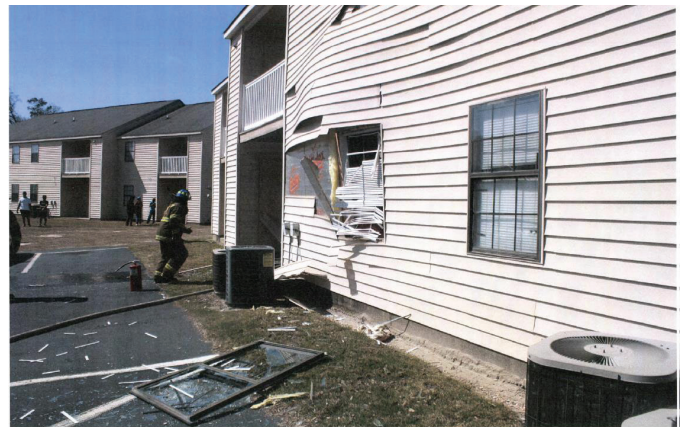
Figure 8

Exterior walls bulged. Window blown out.

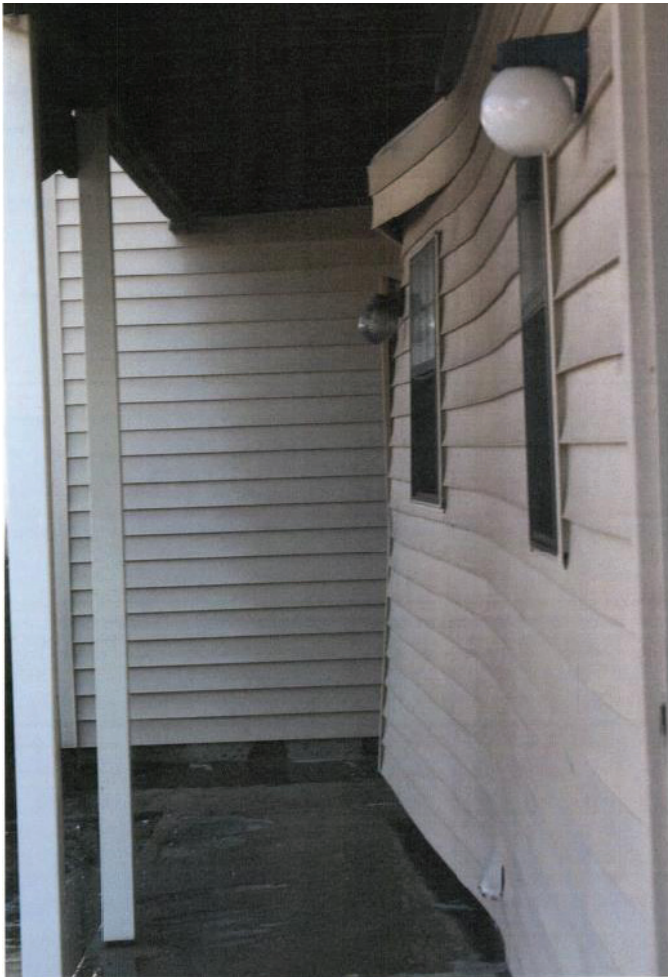
Figure 10
Exterior walls dislodged.

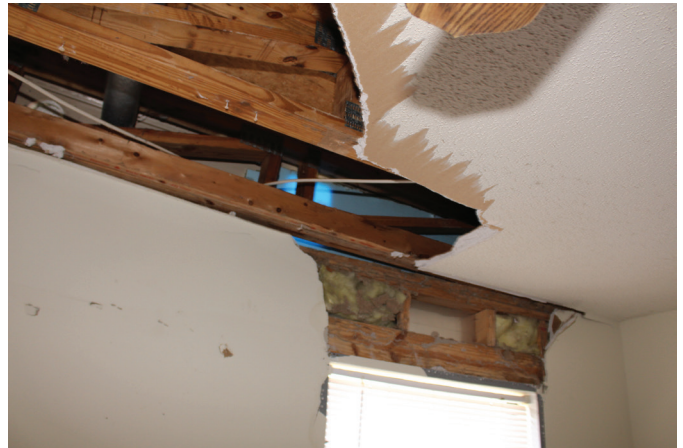
Figure 13
HVAC vent deformation and dislodgement.

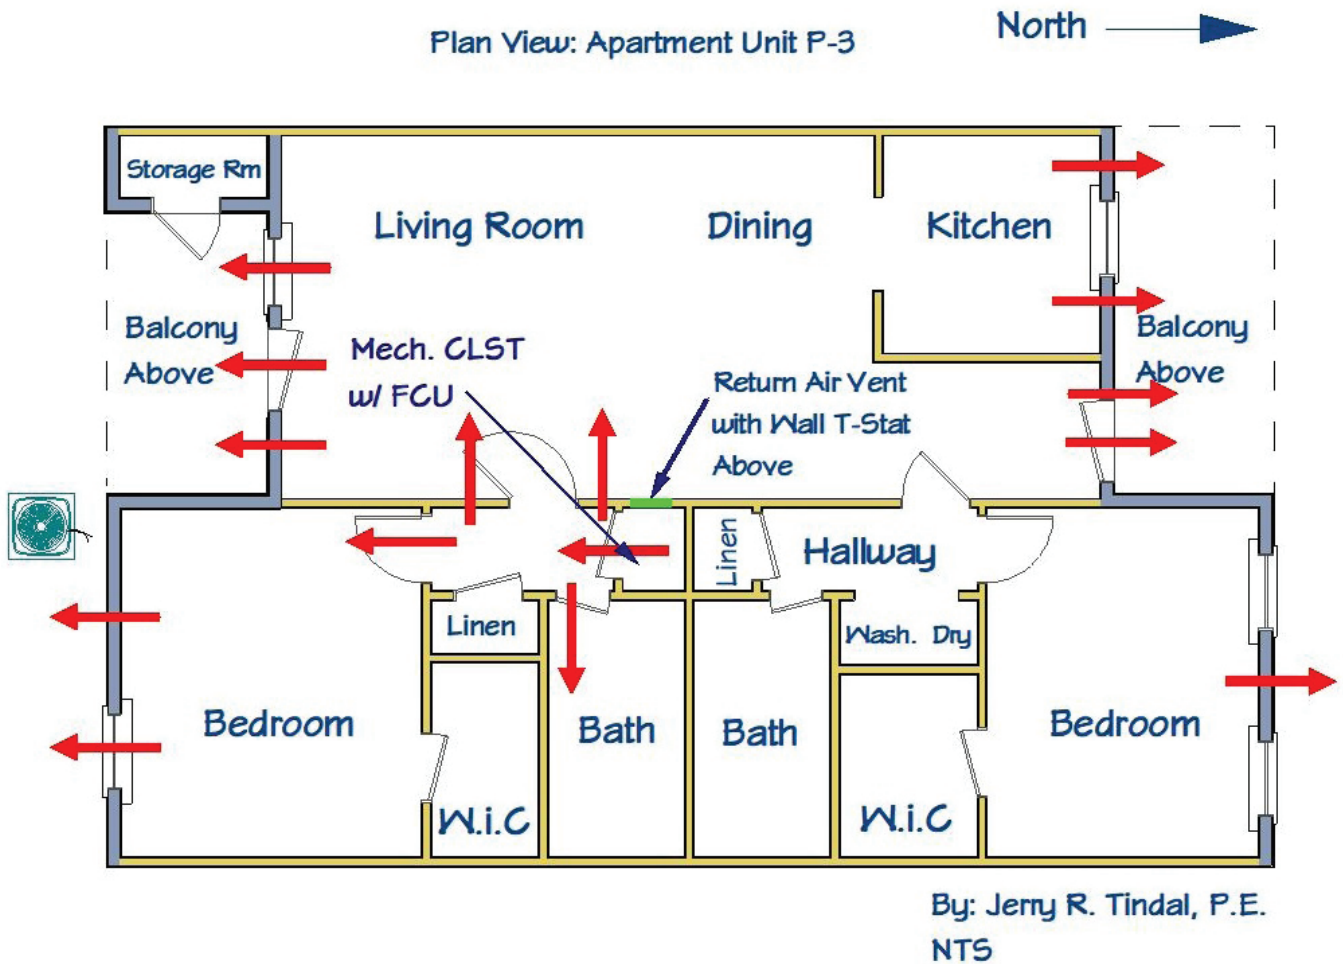
Explosion vector diagrams provide a useful tool for explosion dynamics analysis, origin identification, and illustration, as explained in NFPA 921 Section 23.15. An explosion vector diagram was constructed based on the blast patterns observed during scene examination. Blast patterns, fire patterns, and witness observations were consistent with an explosion originating in, or immediately adjacent to, the mechanical closet of P-3. **Figure 14** shows the explosion vector diagram.

Figure 14
Explosion vector diagram.

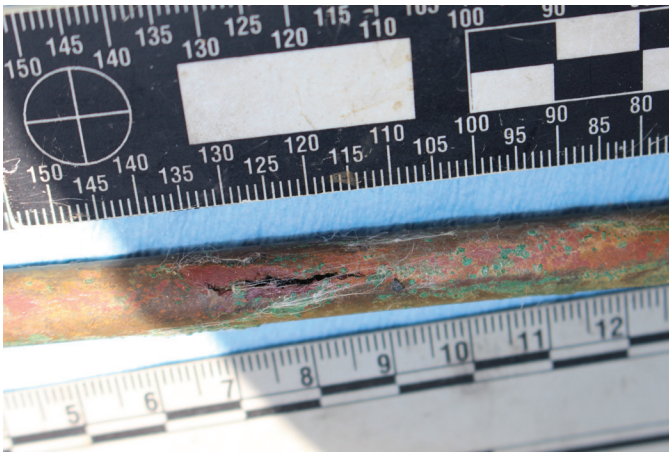
During excavation and extraction of the refrigerant line set, a single failure point in the liquid line piping was located inside the PVC conduit a couple of feet north of the exterior south wall. The failure manifested in the form of a bulging split or rupture in the wall of the piping, running parallel to the pipe axis. There were no other leaks or points of damage observed in the liquid line other than the single rupture point. In addition, there was no observed evidence of kinking, twisting, or bending that could potentially have been caused by explosion forces.. The refrigerant lines were primarily located inside of a protective PVC conduit and below the building concrete slab. No evidence of any substantial movement of the FCU or the refrigerant lines by the explosion was observed. The failure in the pipe was

The bulge in the pipe wall opening indicated the refrigerant line was under internal pressure at the time of the pipe failure. The internal pressure created a localized bulge in the pipe wall as the pipe failed at that point, split open, and released the refrigerant. **Figures 15 and 16** depict images of the failure point. Extensive metallurgical testing was not completed to determine the exact cause of the failure; however, such failures in refrigerant piping are engineering-foreseeable occurrences. Mechanical systems, including HVAC systems and their components, are subject to wear, tear, corrosion, and therefore eventual failure. Components, including piping, routed in the ground or through open conduits in the ground are subject to water submersion, salts, lawn chemicals, and other chemical contaminants.

Figure 15
Failure point in liquid line.

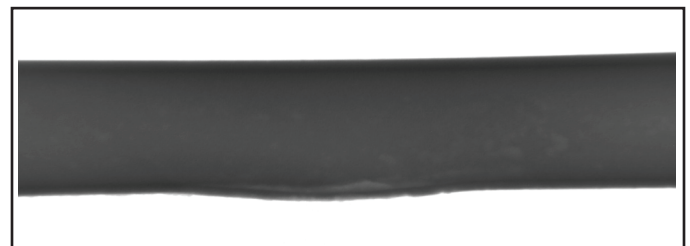
Figure 16
X-ray image of failure point bulge.

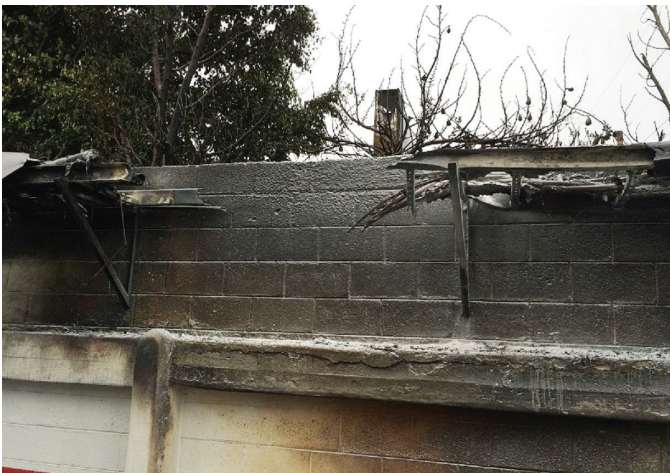
In 2014, a cable splice failure occurred in one of the power cables associated with the capacitor bank connected

Figure 7
Cable tray with cable splice failure.

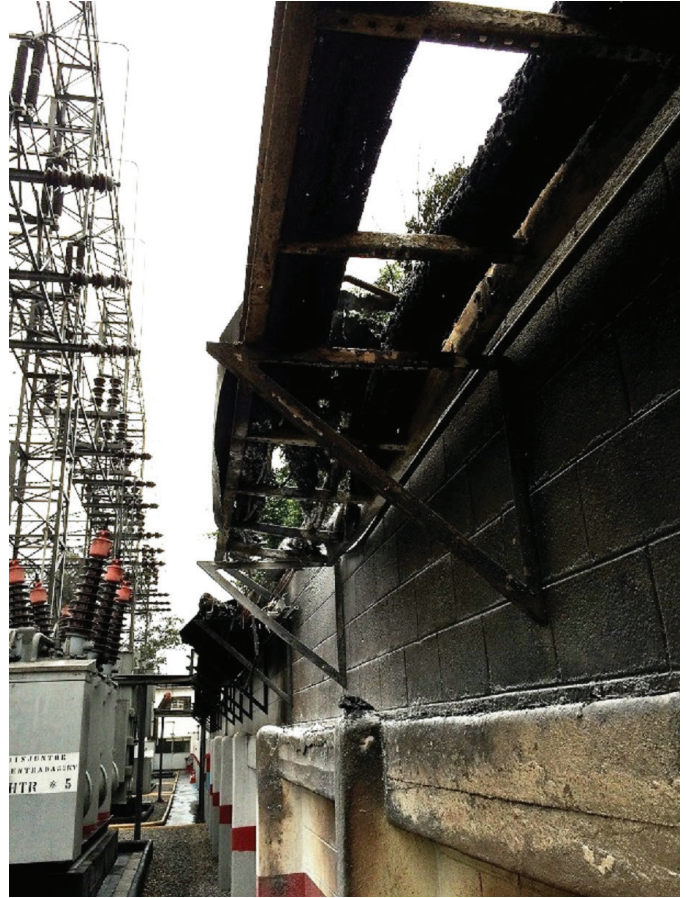
Figure 8
Cable splice failure.

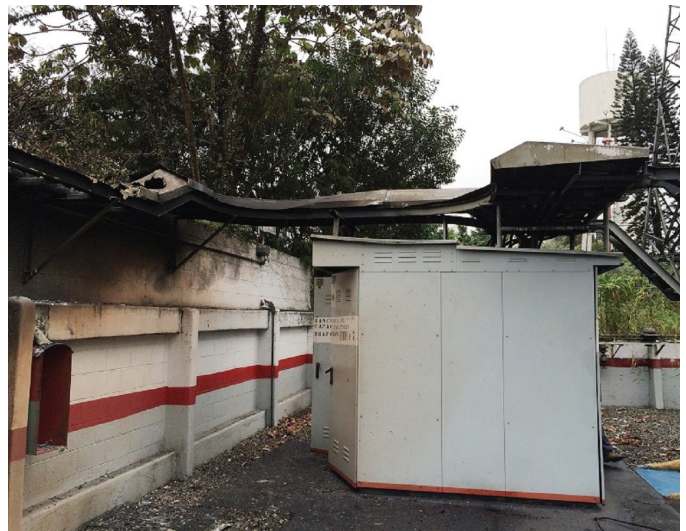
Figure 9
Cable tray with cable splice failure.

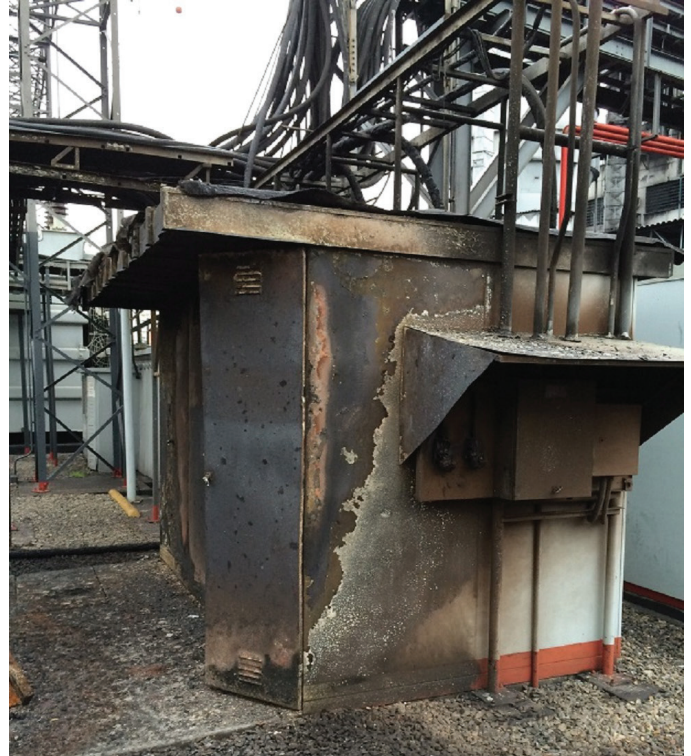
Figure 12
4.16kV switchgear fire damage.

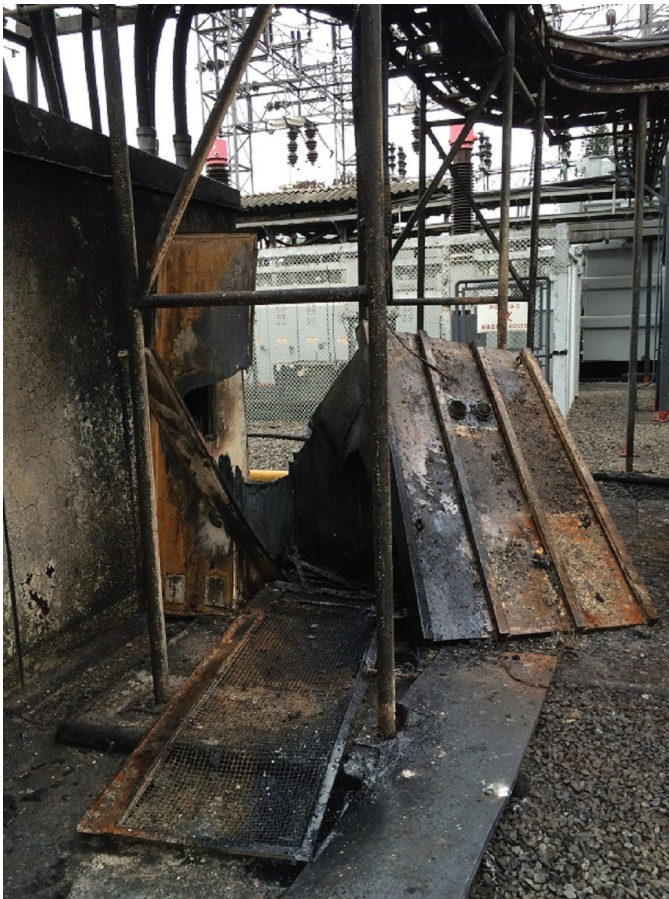
The fire in the cable tray caused the catastrophic failure of the entire 125 VDC control system in the substation. This prevented the 88kV and 4.16kV circuit breakers in the substation from providing the protection and control for all the equipment in the substation. The only

Figure 11
Cable tray fire damage.

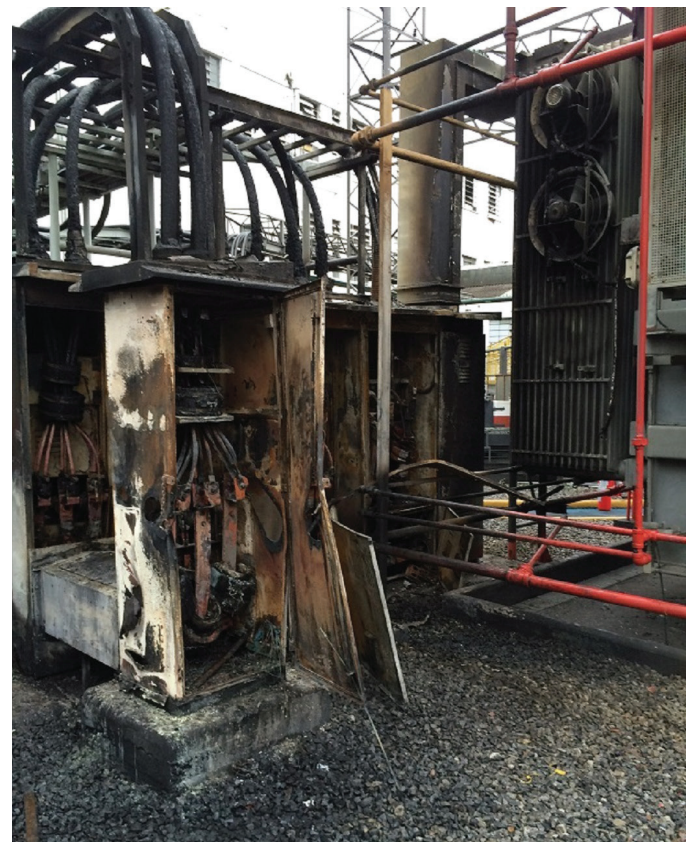
Figure 13
4.16kV switchgear damage.

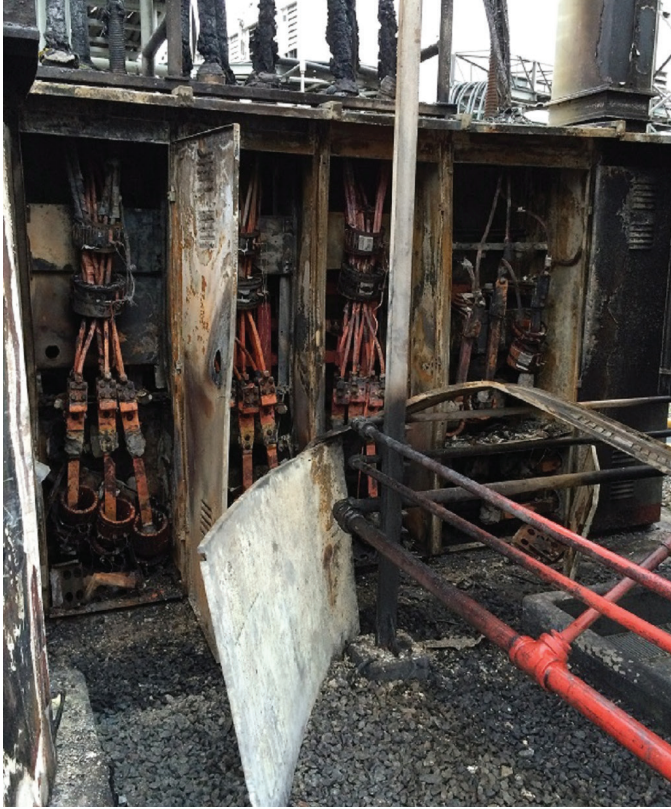
Figure 14
4.16kV switchgear fire damage.

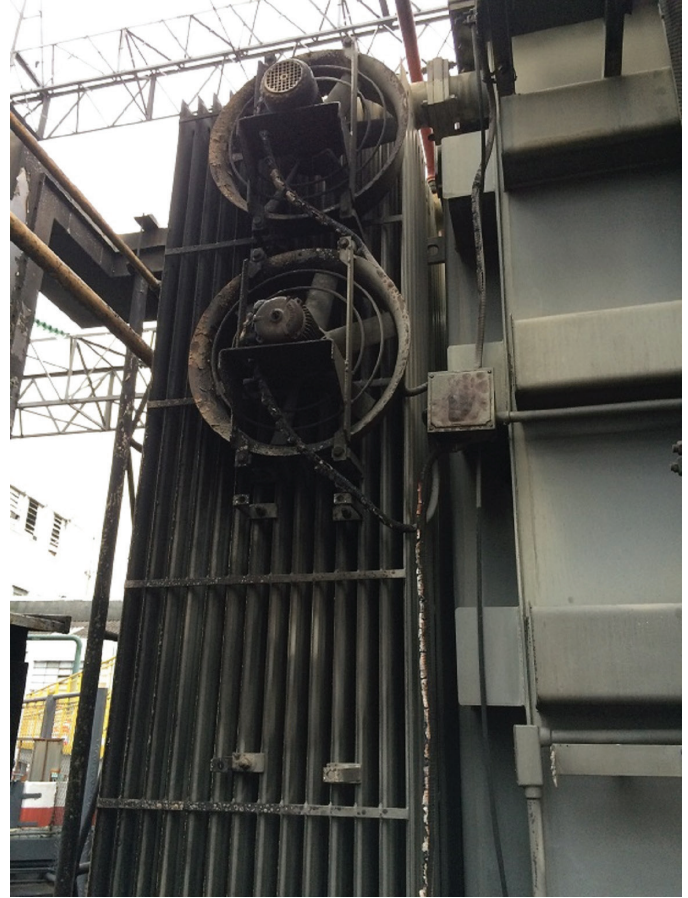
Figure 16
88kV - 4.16kV transformer damage.

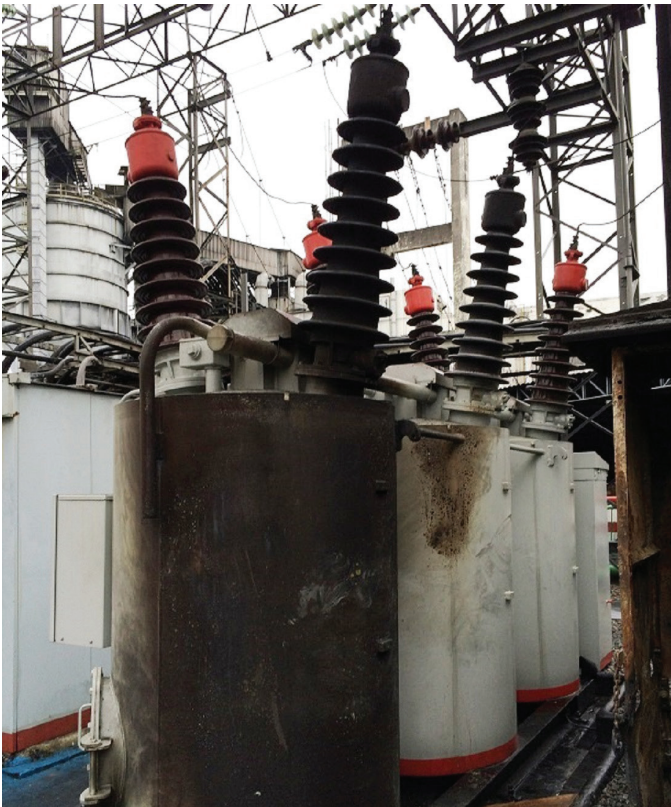
Figure 15
4.16kV circuit breaker damage.

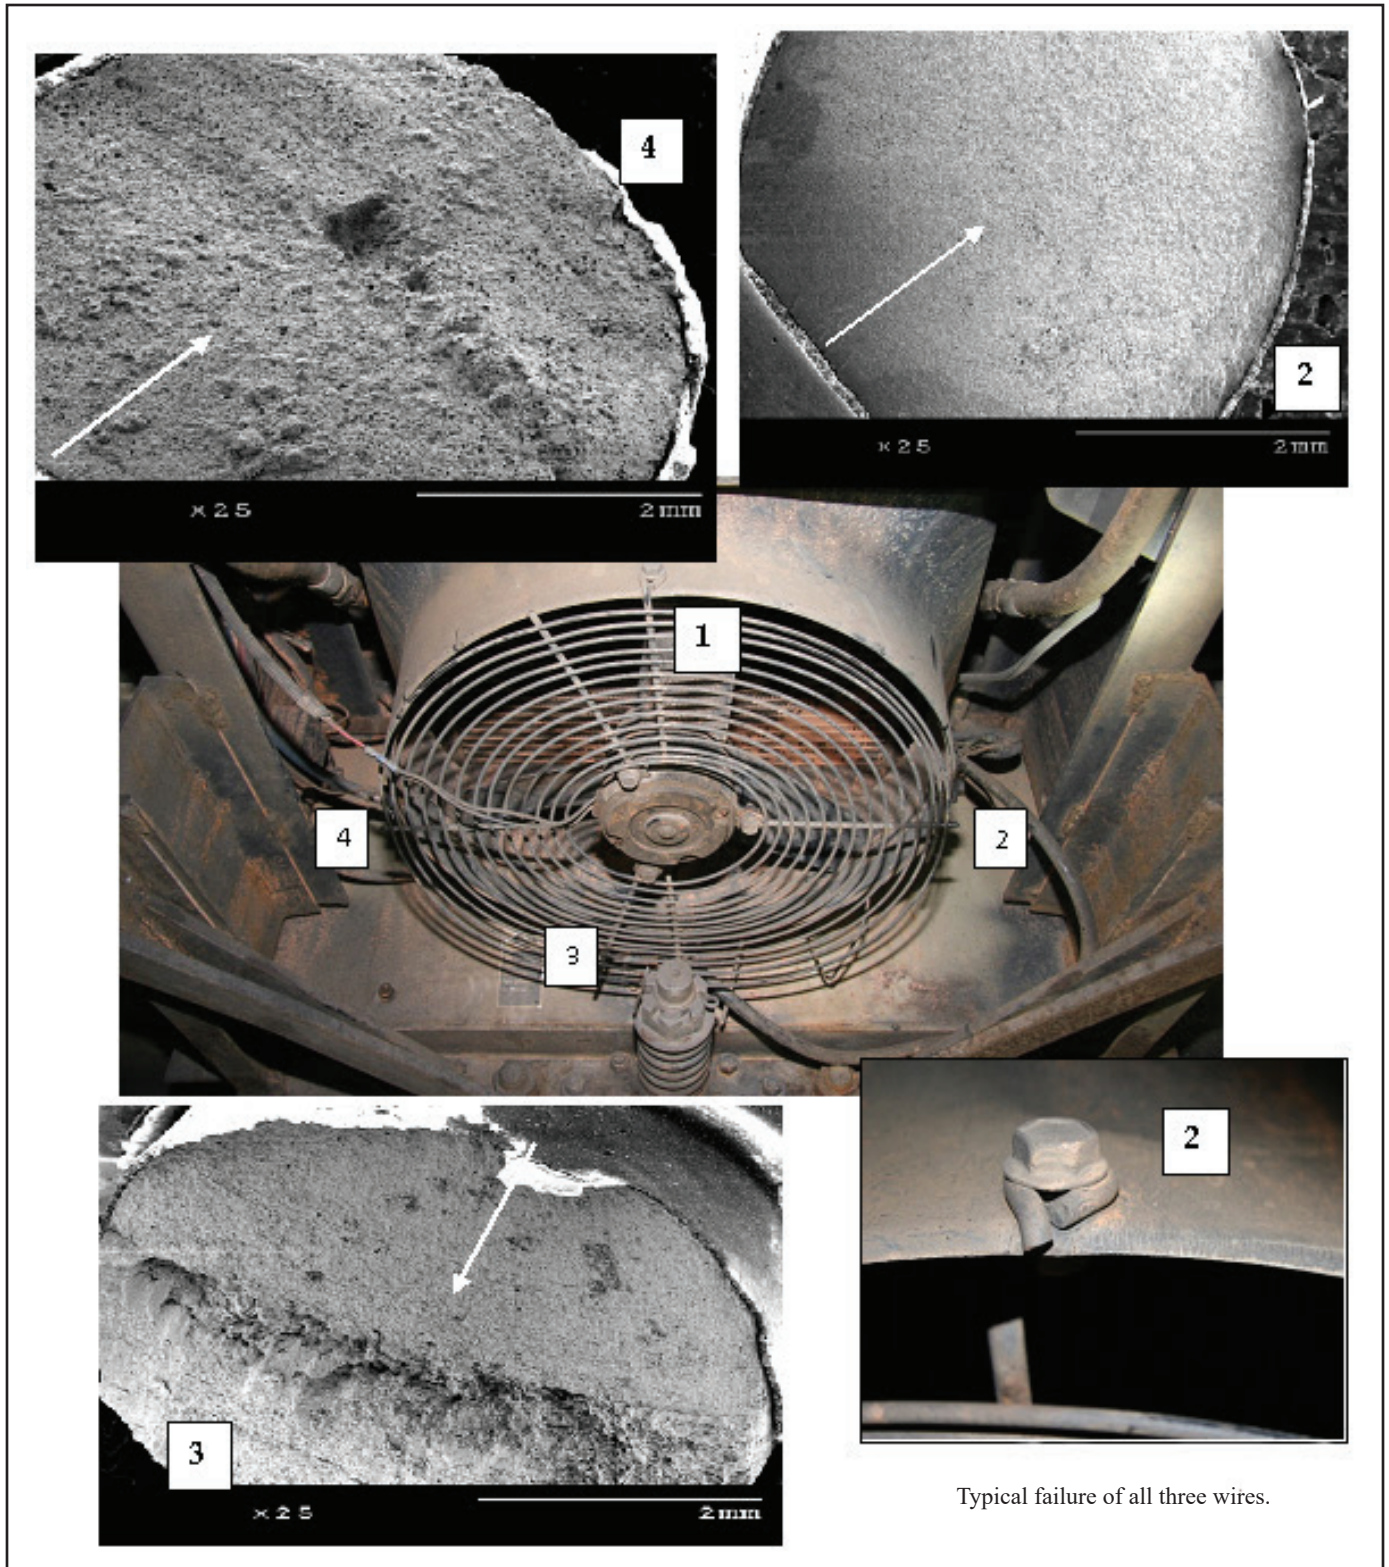
Figure 8

Typical failure of all three wires.

Subject fan shown in center with its four grill support wires identified as shown (1 – 4). SEM pictures of the fractured wires show their progression of failure by fatigue. Wire 1 is unbroken. Wire 2 broke with a flat fracture surface, indicating it broke first under the lowest load. Wire 4 exhibited the next most uniform fracture, indicating it failed second and wire 3 showed a fracture with higher loading and less uniformity, indicating it failed last after 2 and 4 were broken. The progression of failures suggests that maintenance had an opportunity to find the problem grill before it suffered its final failure.

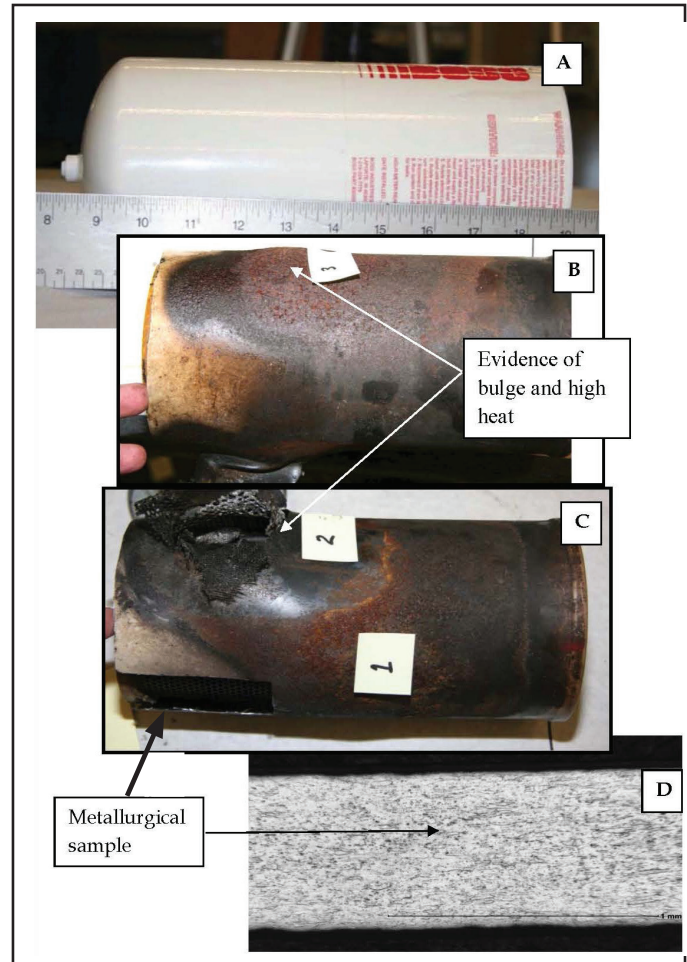
Figure 10

The coalescer showed heat damage and plastically deformed bulging at the location of the rupture as seen in **Figure 10**. The rupture was consistent with a localized hot spot failure. An analysis of the hoop stress on the coalescer is seen in **Figure 11**. The subject coalescer was capable of withstanding two to four times the maximum

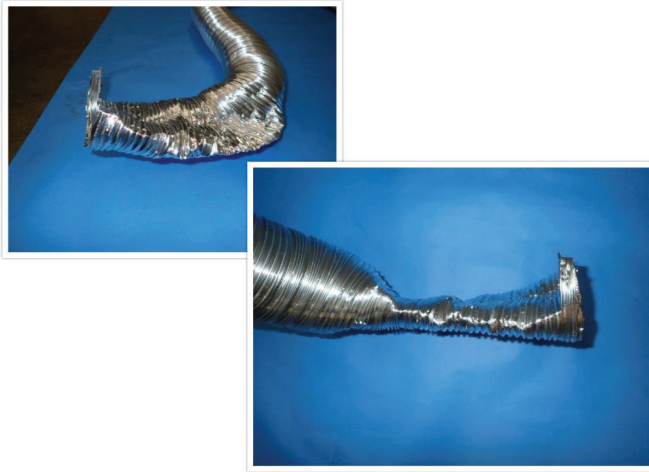
Figure 16
Crushed flexible metal duct.

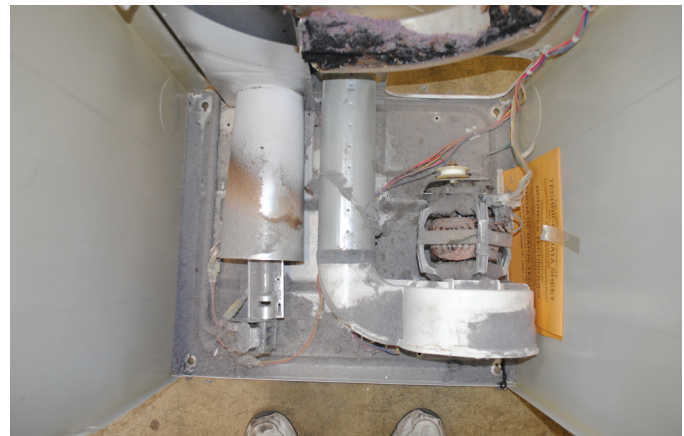
Figure 19
Accumulated lint in base of dryer.

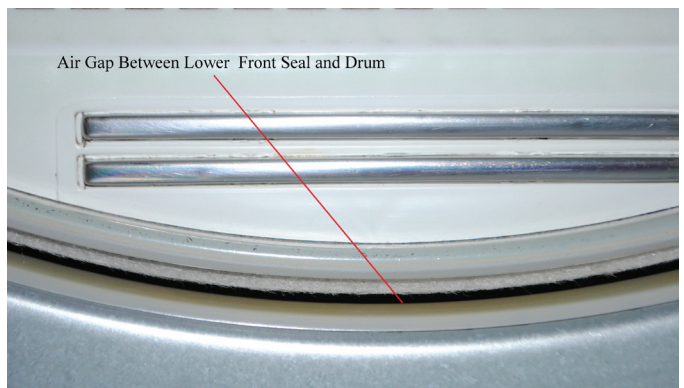
Figure 24
Gap created by crushed seal.

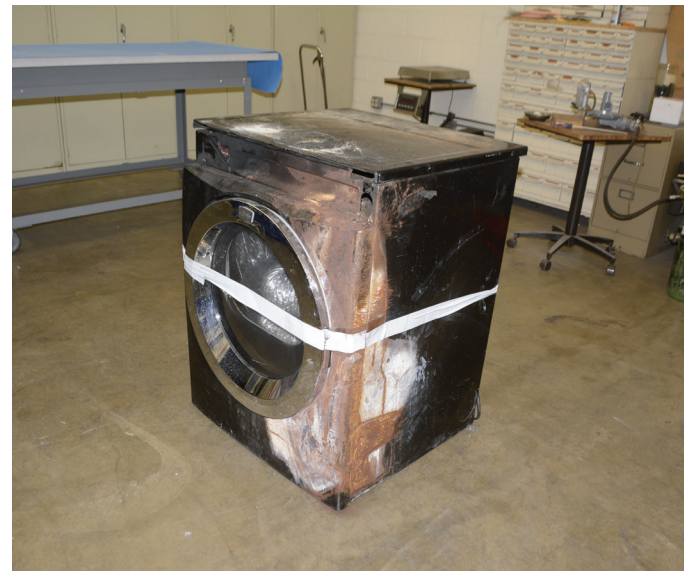
A fire occurred in a four-year-old natural gas fueled clothes dryer during operation (**Figure 28**). The fire was discovered and witnessed by the user several minutes after it had been placed in operation. Upon discovery of the fire, the user stopped the dryer and removed the unburned, wet load from the dryer. From a detailed lab exam of the dryer and other artifacts, it was determined that the fire resulted from ignition of lint within the dryer (**Figure 29**). The source of the ignition was the gas burner. The fire spread to the combustible plastic components, including

Figure 28
Dryer cabinet showing thermal damage from plastic fuel load.

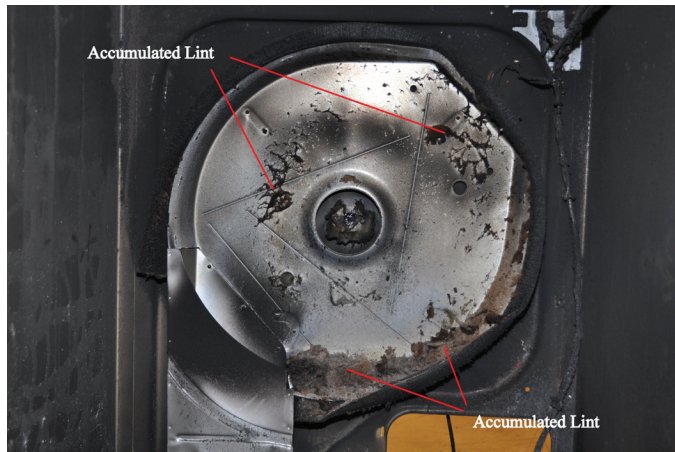
Figure 29
Heater pan of dryer showing accumulated lint.

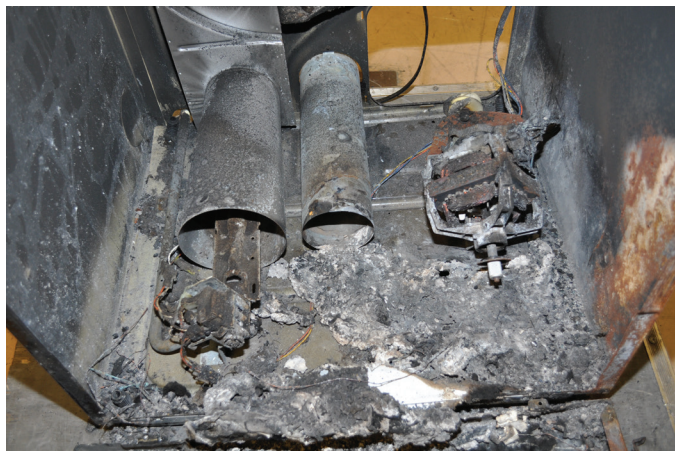
the blower and air duct, and most of those components were consumed (**Figures 30 and 31**).

Figure 31
Base of dryer showing mostly consumed combustible plastic components.

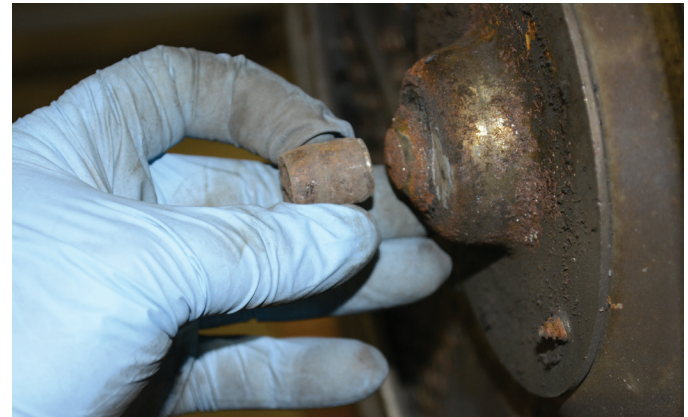
A 10-year-old electric ball hitch dryer started on fire while in operation. The homeowners witnessed the fire. Examination of the dryer determined that the rear drum support bearing had worn, permitting metal-to-metal contact between the rear drum support shaft and the bearing bracket (**Figure 33**). Eventually, the shaft was severed (**Figure 32**), and the rear of the metal drum baffle contacted the energized heating element. The resulting arcing

Figure 32
Severed ball hitch.

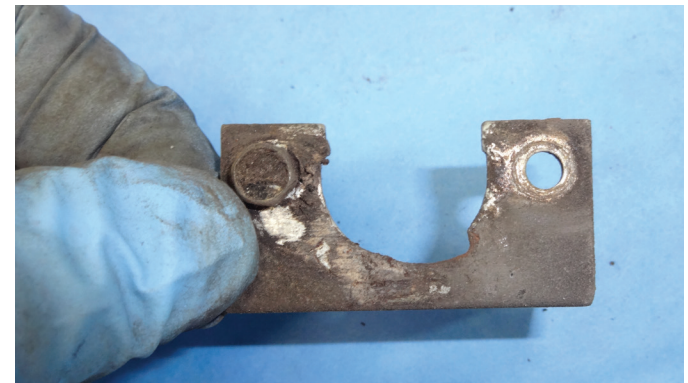
Figure 33
Wear on bearing bracket.

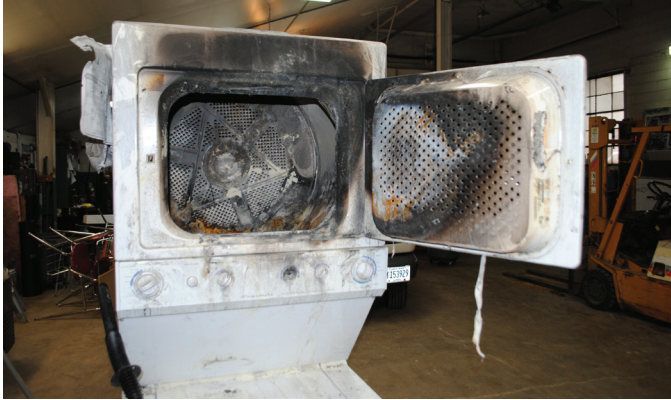
Figure 39
Fire-damaged dryer.

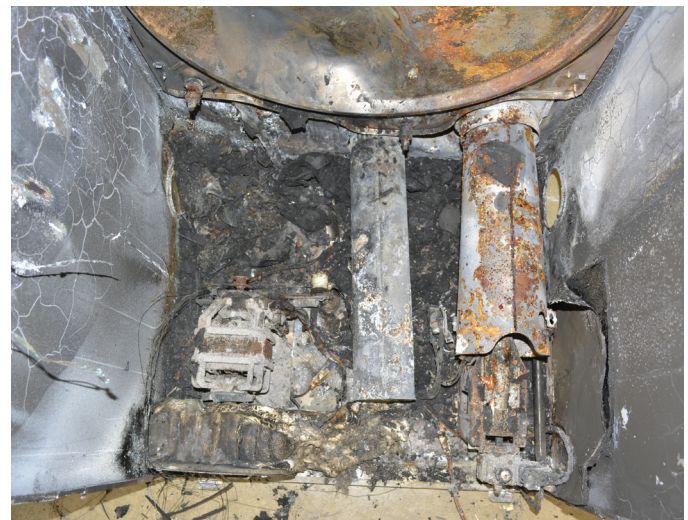
A user discovered a fire in an operating gas clothes dryer (**Figure 41**). When the fire was discovered, the load was not burning. A detailed lab exam of the dryer found a large amount of charred clothing items in the base of the dryer (**Figure 42**). A large section of the dryer drum at the

Figure 42
Dryer base.

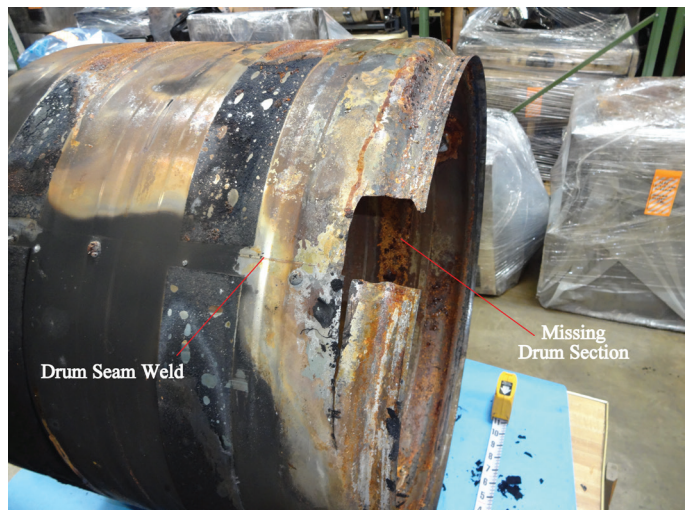
Figure 43
Rear edge of drum showing missing portion.

rear edge had detached from the drum (**Figures 43 and 44**). This missing section permitted small laundry items to fall into the dryer base near the burner assembly and onto the top of the burner tube where they were ignited. One edge of the fractured section was part of the longitudinal drum seam weld.
