Journal of the
National
Academy OF
Forensic
Engineers[®]

<http://www.nafe.org>

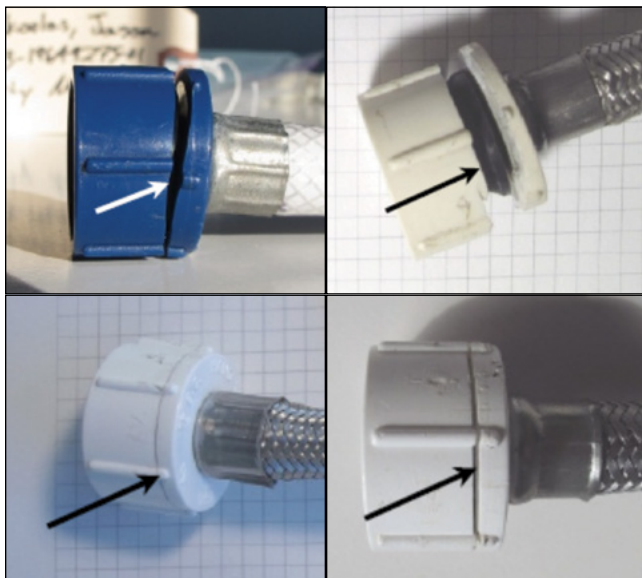
Figure 1
Failed coupling nuts.

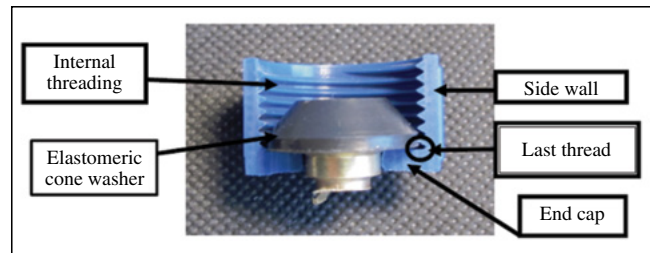
Figure 2
Cross-section of nut assembly.

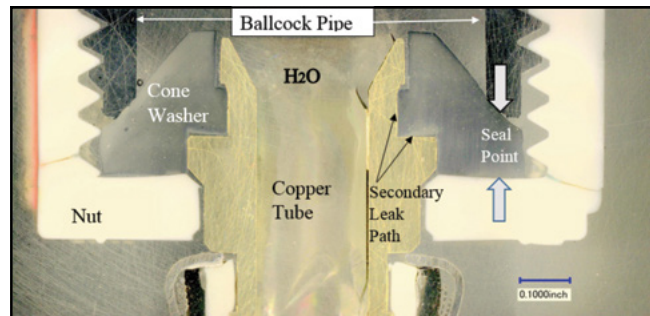
Figure 3
Cross-sectioned failed connector nut assembly.

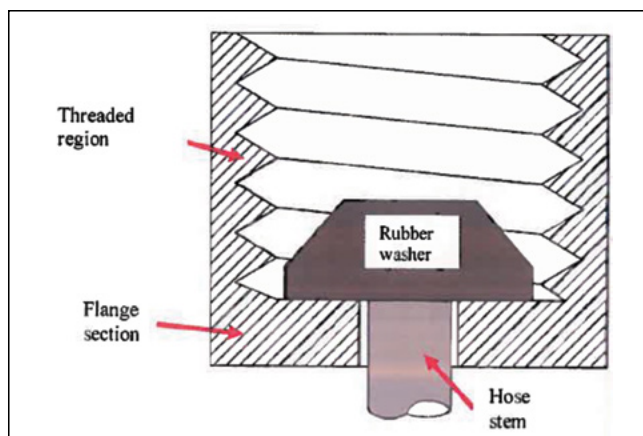
The counsel for the plaintiff claimed that the design of the nut was defective because the threads inside the nut formed a stress riser at the critical stress location, causing the nut to fracture when tightened. The sketch shown in **Figure 4** was produced by the plaintiff expert and was purported to accurately represent the nut design. Their expert cited plastic molding design guides that recommended against sharp corners and threads that end without tapering or rounding as design flaws.

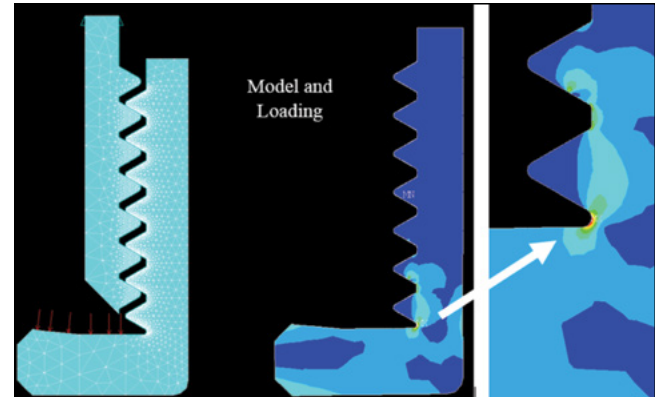
Figure 6
Finite element model of nut.

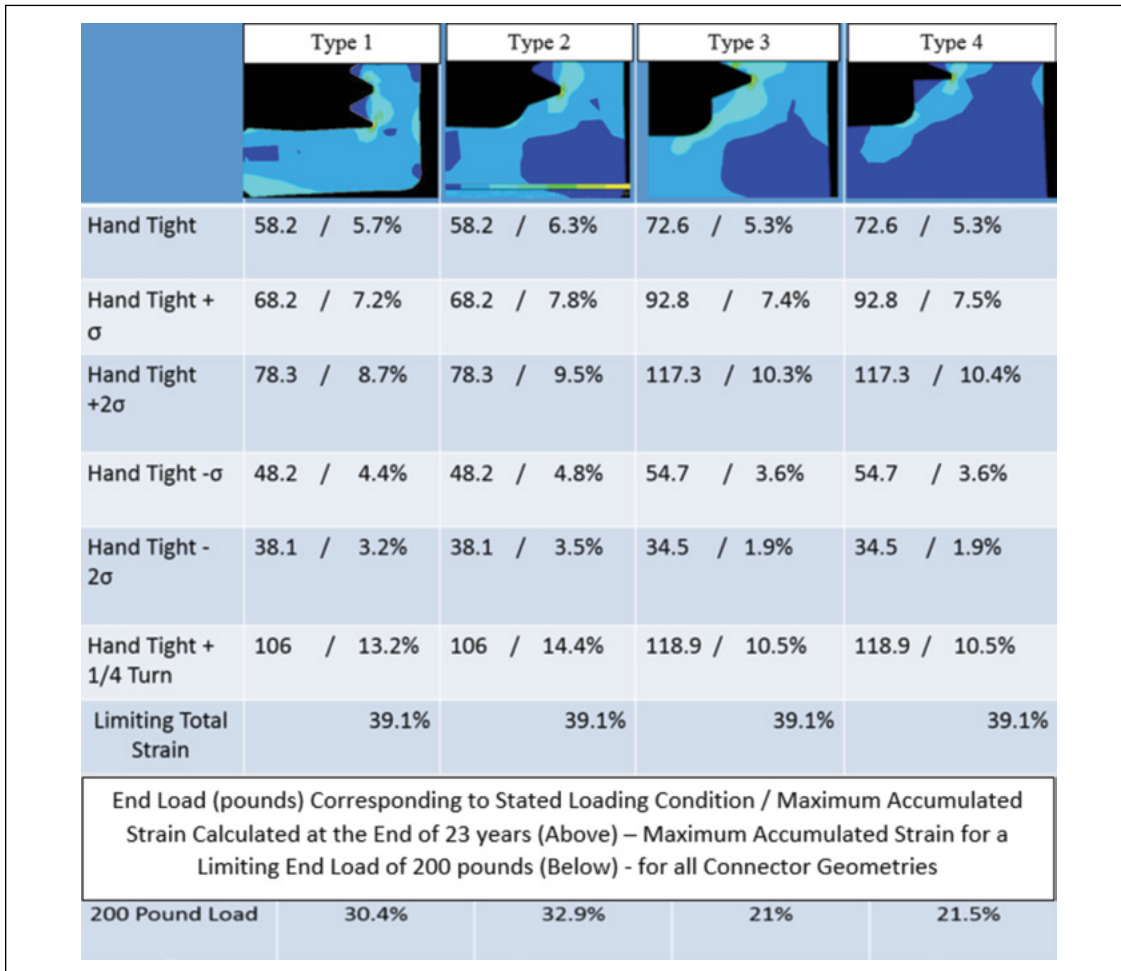
Figure 7
Maximum strains for various loading conditions.

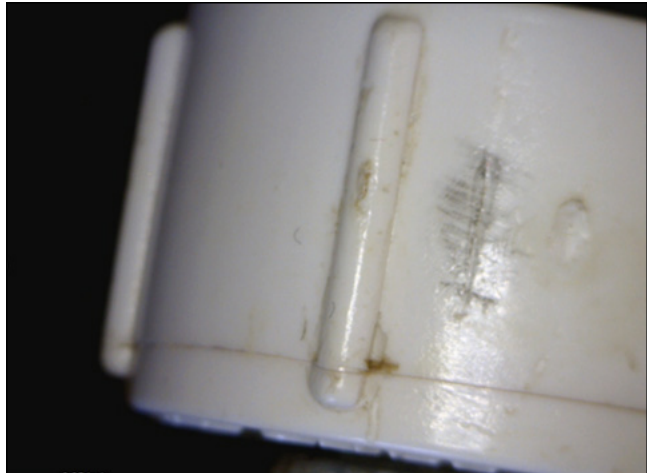
Why overtighten the nut? One reason they may be overtightened is when an old connector develops a leak, or when it is removed and reinstalled. When compressed for years under high stresses, the rubber

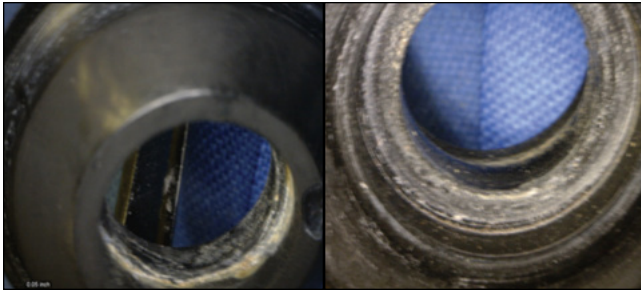
a leak through this path. **Figure 9** shows a cone washer taken from a failed nut. Note the calcium deposits on the inside and bottom surface of the cone washer. This indicates that leakage had occurred for quite some time through this secondary leak path. The user apparently continued to tighten the nut, hoping to stop the leak and finally caused the nut to fail.
