Journal of the
National
Academy OF
Forensic
Engineers[®]

Forensic Engineering Analysis of Vehicle-Pedestrian Impact Using EDR Data and Reconstruction Software

By Michael Kravitz, P.E. (NAFE 451F)

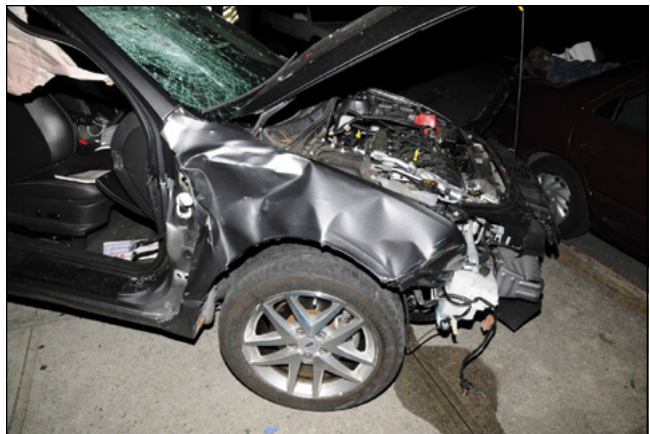
Figure 3

Defendant's vehicle in rest position on sidewalk. Notice the spider pattern on the windshield, which is a classic indication (as noted in the medical examiner's report) that the pedestrian's head struck the windshield at that point.

The pedestrian's head came in contact with the windshield, as observed by the spider pattern (see **Figure 3**), which appears to be bowing outward, on the passenger side of the defendant's vehicle. This bowing was probably caused by contact with the tree on the driver's side as the vehicle rotated into the tree.

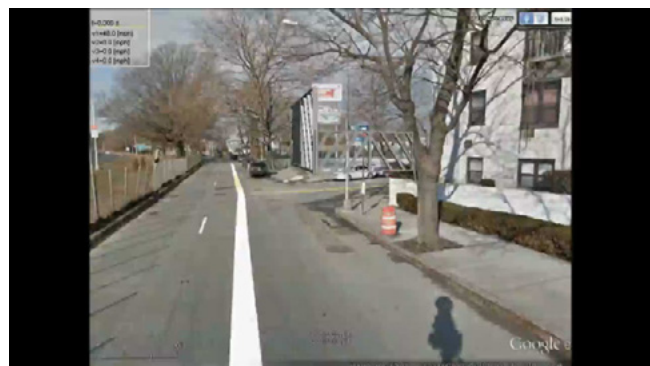
Figure 8

This shows the path of the vehicle as it moves from the roadway onto the sidewalk and into the fence and tree.

The motion depicted was created by inputting the CDR longitudinal accelerations, steering angles, and speeds into PC-Crash sequences.

At the corner, the software allowed the placement of a model tree and model fencing into which the defendant's vehicle crashed (see **Figure 8**). Somewhere along the vehicle's path the pedestrian was struck. Through iteration, the pedestrian's rest position was determined and agreed with the location of the body rest position as represented by police photographs. The software showed the pedestrian's head impacted the windshield as indicated by the scene photographs. After impact with the vehicle, the pedestrian was projected into the chain-link fence of the adjacent ball field and fell onto the sidewalk in the rest position. Using Virtual Crash software, iterations were performed of the vehicle-pedestrian impact.

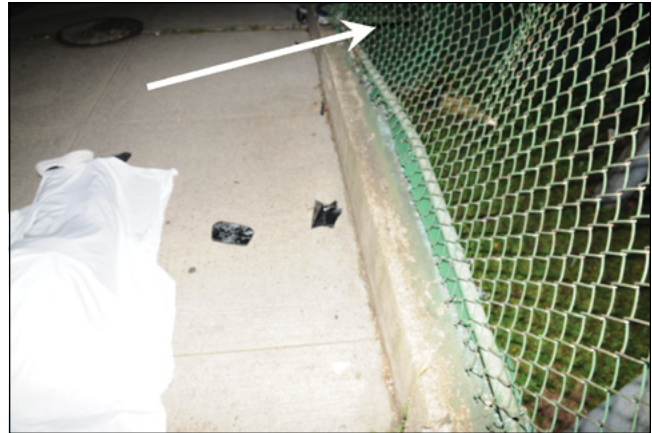
Figure 9

Pedestrian rest position. Notice the indentation of the chain-link fence where pedestrian struck as a result of her trajectory from the vehicle into the fence. The arrow shows the indentation into the chain-link fence.

Additionally, the pedestrian was not standing on the sidewalk when struck by the vehicle because there was not enough distance for her to be carried by the vehicle and strike the fence, as shown in **Figure 9**. The carry time of the pedestrian is approximately 200

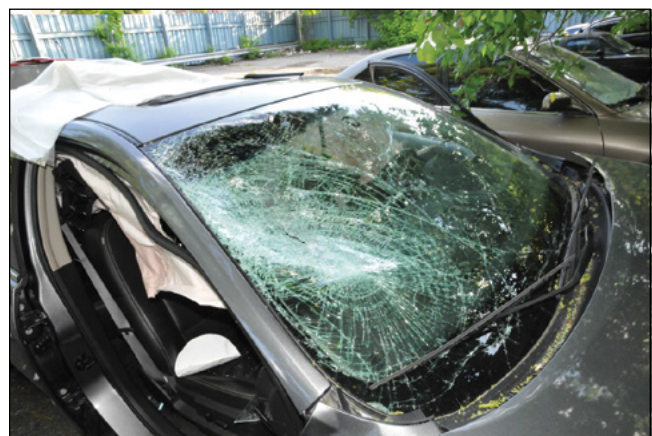
Figure 11

The spider pattern of the passenger side of the windshield shows where the pedestrian's head struck the glass. Also shown are the deployed side airbags.

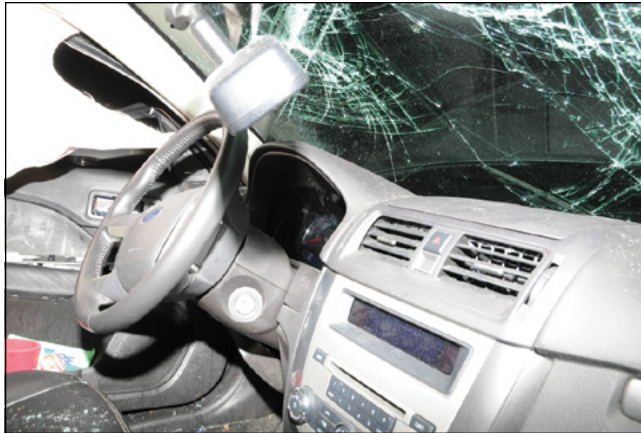
Figure 12

The interior of the vehicle shows that the front airbags were not deployed.

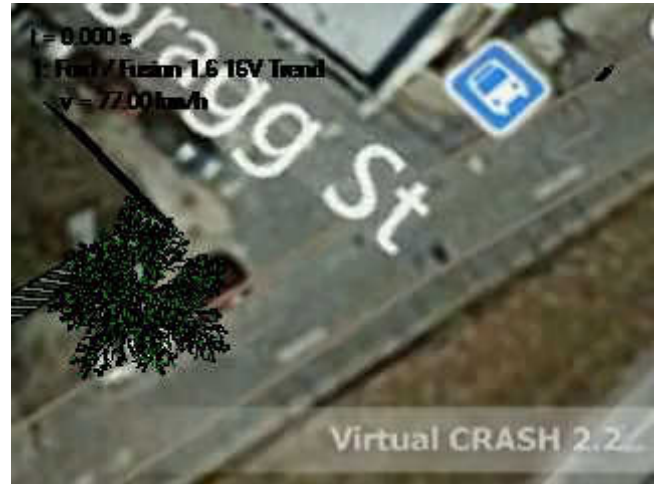
Figure 21

Closer view of the pedestrian being struck by the vehicle.

northwest corner sidewalk. **Figures 22** through **29** are identical with the head striking the windshield at the same location. This shows that had the pedestrian been struck while standing on the sidewalk, the windshield pattern would have been the same, but the pedestrian would have come to rest along the service road instead of where she came to rest on the sidewalk (as indicated in **Figures 20, 21, 30, and 31**).

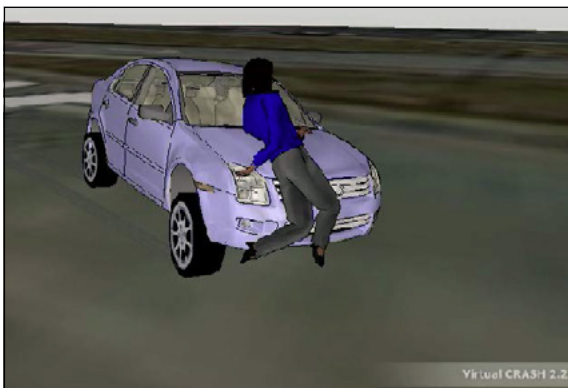
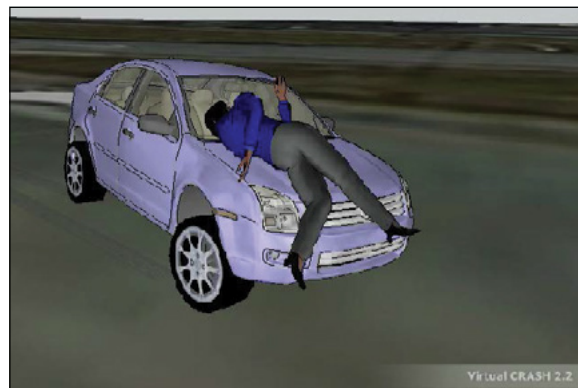
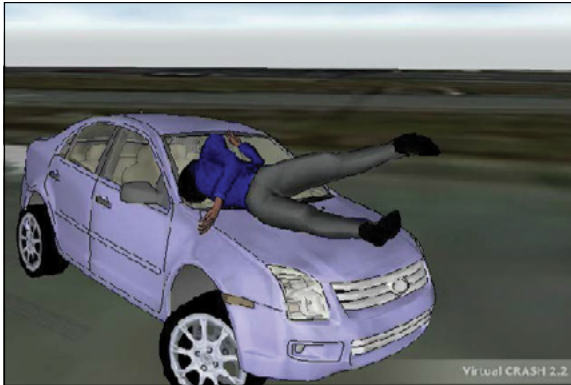
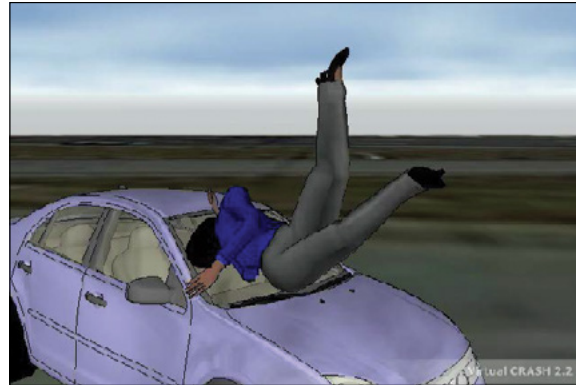
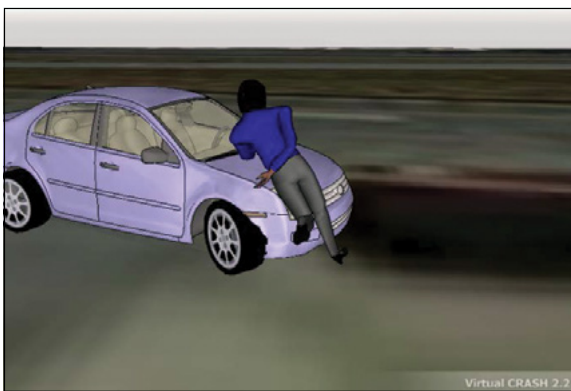
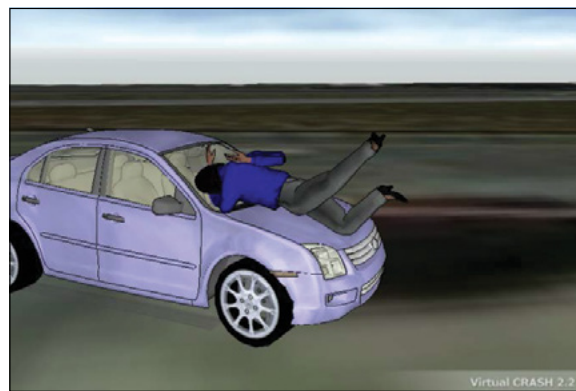
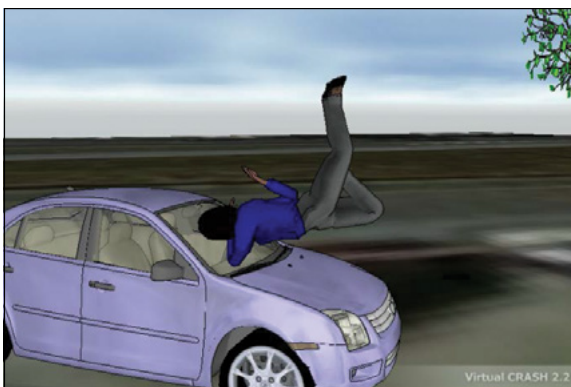
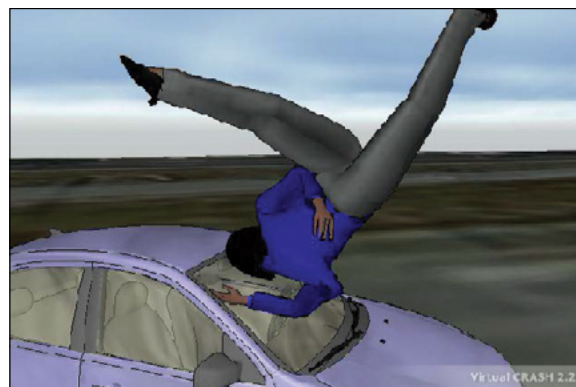
Below is a series of consecutive images taken from the prepared video depiction of the position of the pedestrian head strike on the windshield. **Figure 22** through **Figure 25** are images taken from Virtual Crash simulation software that show where the pedestrian was struck relative to the vehicle. Similarly, **Figure 26** through **Figure 29** show where the pedestrian would have been struck relative to the vehicle if she was struck on the sidewalk, if she were standing on the

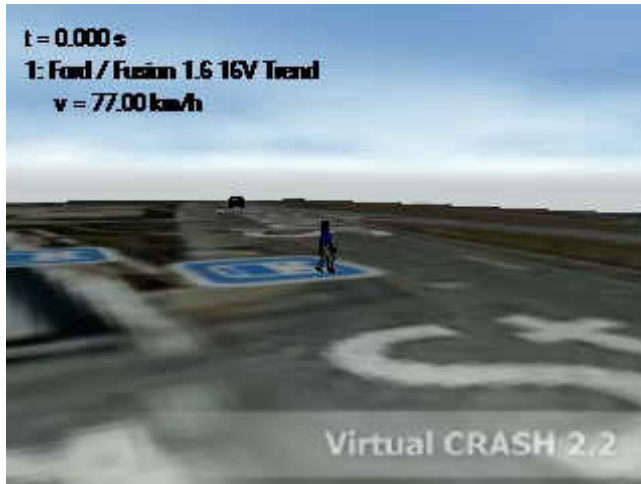
Figure 30

Video of pedestrian being struck in street near bus stop and projected into the fence.

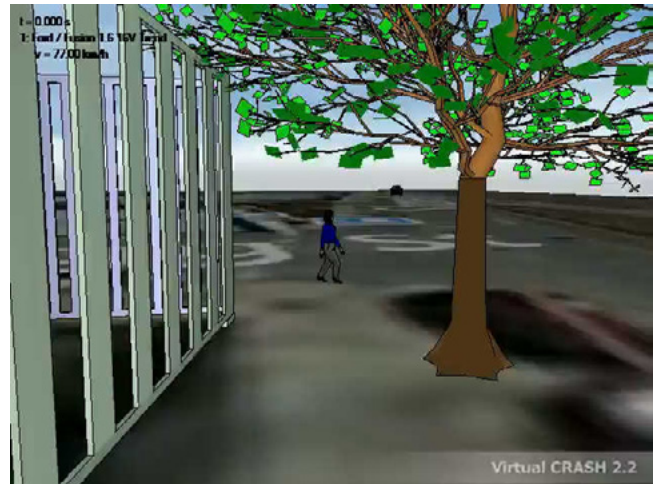
Figure 31

Video of pedestrian being struck on the northwest corner sidewalk as opined by the prosecution expert.

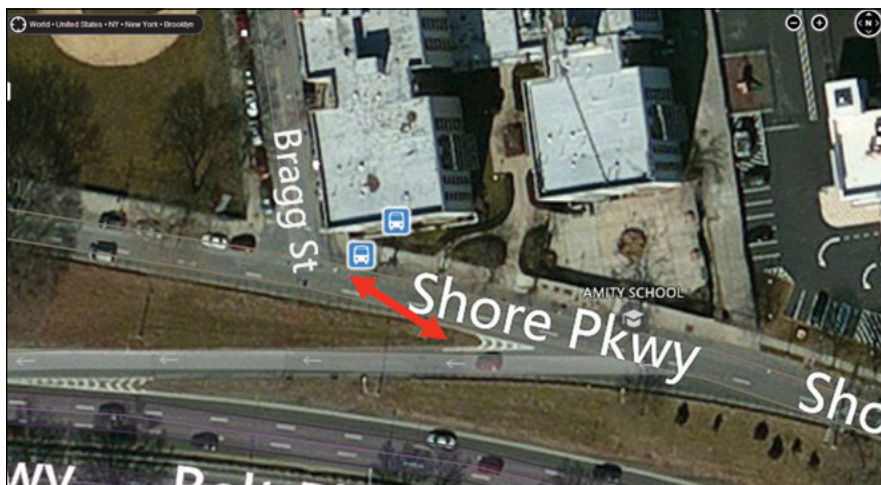
Figure 34

Image of pedestrian being struck in street near bus stop.

After sentencing, the author was informed of the negotiation between the prosecutor and defendant's attorney that resulted in the DWI plea. The defendant's attorney discovered that the pedestrian had a psychological illness, and it was noted in her records by her doctor that she wished to commit suicide by walking in front of a vehicle. She gave this statement to her psychiatrist 10 days prior to the accident. It was surmised by the defendant's attorney that she wanted to walk onto the service road that night. The on-ramp entrance to the parkway was a short distance from where she was struck, as indicated by the arrow (see **Figure 34**).
