Forensic Engineering Investigation of a Three-Vehicle Accident

By *Martin E. Gordon, P.E. (NAFE 699M)*

An accident involving three vehicles resulted in serious injuries to one of the drivers. It was alleged that the driver was injured because both of the other operators were inattentive and made driving errors. Through the use of electronic data retrieval and computer crash simulation, it was shown that only one of the non-injured drivers made a driving error.

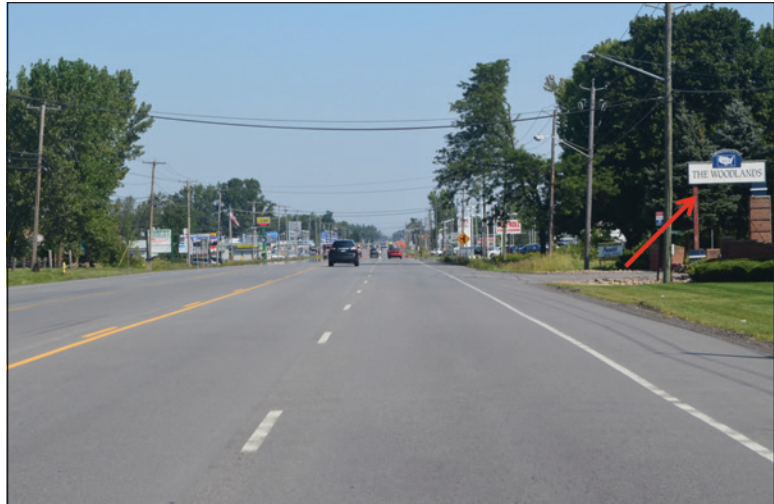
to obstructed. Roadway conditions were dry. The accident occurred during the daytime in a 45 mph to 55 mph transition regulatory speed zone southbound and a 55 mph to 45 mph transition regulatory speed zone northbound. Businesses and a few residences were located on both sides of the highway, which consisted of two 12-foot-wide travel lanes and a 4-foot-wide outside shoulder in each direction separated by a 12-foot center two-way left turning lane. **Figure 1** shows the highway looking in the northbound direction.

Figure 1
NY Route 78 looking northbound.

The driver of a silver 2000 Saturn was pulling out of a modular home residence (The Woodlands – shown in **Figure 1**) and collided with a black 2011 Toyota Camry traveling northbound in the right travel lane on NY State Route 78. As a result of the collision, the Toyota Camry crossed the left northbound lane as well as the center two-way left turning lane and was involved in a subsequent impact with a black 2008 Chevrolet Impala traveling in the southbound left travel lane. During the first collision, the forensic engineer determined from photographic evidence and vehicle inspections that the Saturn’s front bumper contacted the right front wheel of the Camry. During the subsequent impact, the Camry and Impala met essentially head-on, involving the full-frontal widths of the Camry and Impala.

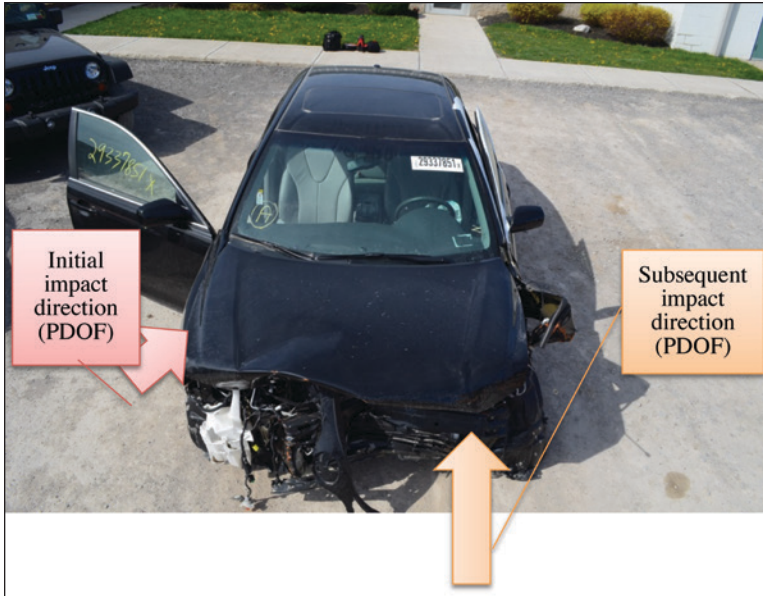
Figure 3
Damage to Camry.

A physical inspection of the Camry indicated significant crush damage to the front of the vehicle. Damage at the front right corner of the vehicle indicated that the initial impact with the Saturn was focused at this location. The Camry was first impacted by the Saturn at a 1 to 2 o'clock position. The physical crush found in the vehicle inspection for the initial impact is consistent with the airbag ECU data PDOF information. The relatively uniform crush along the remaining portion of the front of the vehicle also agreed well with airbag ECU data PDOF information. In other words, the subsequent impact with the Impala was at the 12 o'clock position relative to the Camry. **Figure 3** indicates the Camry damage and PDOF.

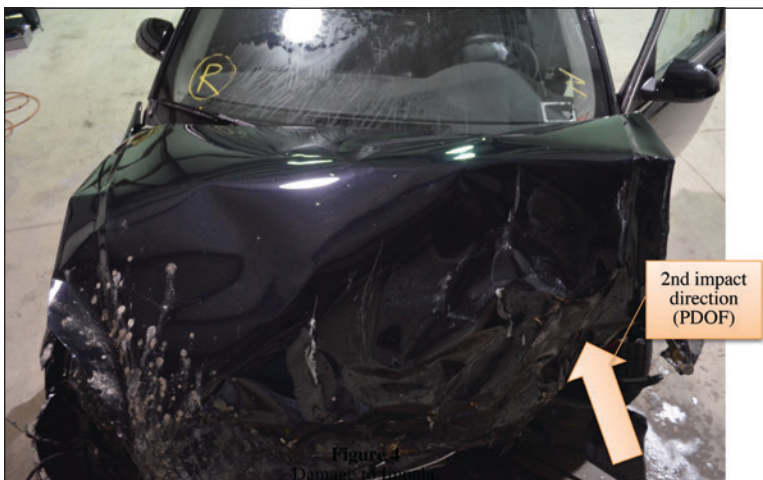
Figure 4
Damage to Impala.

A physical inspection of the Impala indicated significant crush damage at the front left corner of the vehicle. This indicated, by this forensic engineer's judgment, an impact that was from the 11 to 12 o'clock position relative to the Impala. This correlated well with the airbag SDM data collected from the Impala. The SDM data provided lateral and longitudinal accelerations that were used to calculate the PDOF directions. Inside the vehicle, it appeared as though a liquid (perhaps coffee) was splashed about the front seating area and dashboard. **Figure 4** provides vehicle damage and PDOF for the Impala.

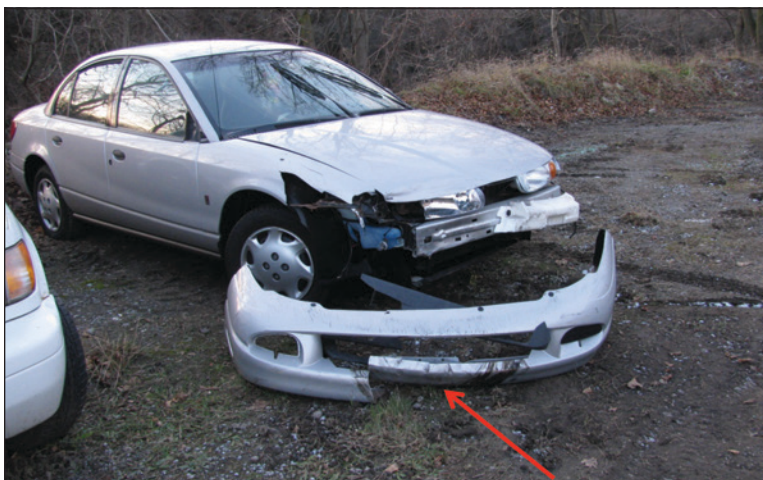
Figure 5
Damaged Saturn (note wheel mark on bumper).

Photos of the Saturn indicate tire contact with the front bumper. **Figure 5** shows the damaged Saturn.

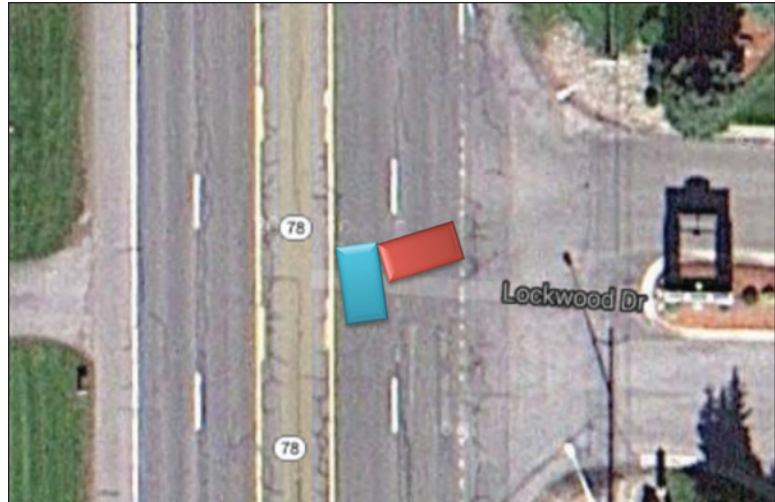
Figure 6

Using PC-Crash and airbag ECU, data locations and orientations for the initial and subsequent impacts were estimated. **Figures 6 and 7** provide these locations and orientations.

Determined probable location and orientation of the Saturn (red) and Camry (blue) during the initial impact.

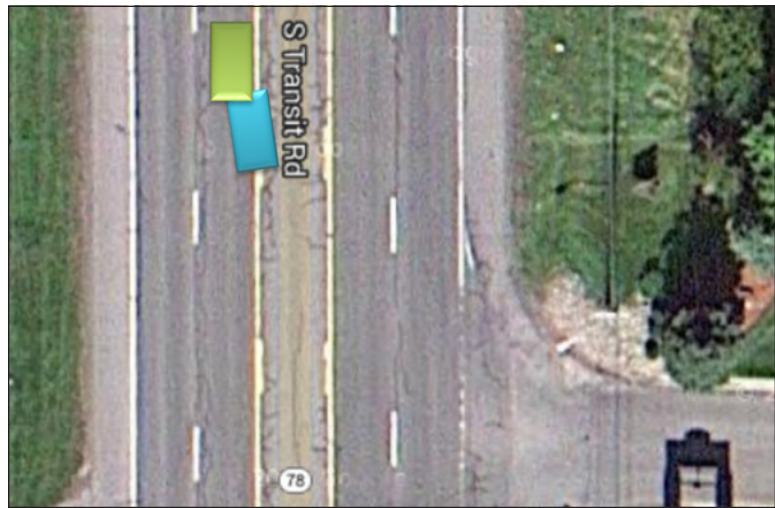
Figure 7

Determined probable location and orientation of the Camry (blue) and Impala (green) vehicles at the subsequent impact (from PC-Crash simulation and airbag ECU data).

- After colliding with the Saturn, the Camry proceeded to subsequently travel through the center two-way left turning lane into the southbound oncoming traffic. The Camry traveled approximately 78 feet (2.1 seconds) between the initial impact and the subsequent impact (determined from airbag data, PC-Crash, and kinematic calculations).
