# Forensic Engineering Tools and Analysis of Heavy Vehicle Event Data Recorders (HVEDRs)

By Jerry S. Ogden, PhD, PE (NAFE 561F) and Mathew Martonovich, PE (NAFE 968M)

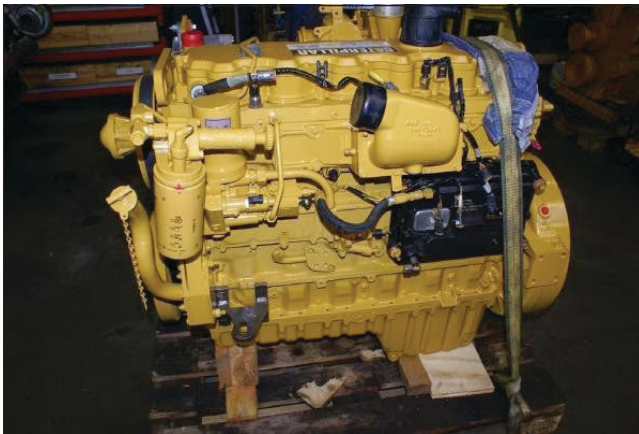
**Figure 2**

Typical Caterpillar ECM location.

by Navistar, which are accessible using Navistar ServiceMAXX software. A single ECM generally located on the left side of the engine block manages most downloadable Caterpillar engines (**Figure 2**). Caterpillar engines have three generations of ECMs with accessible HVEDR data; ADEM II, ADEM 2000/III, and ADEM IV.

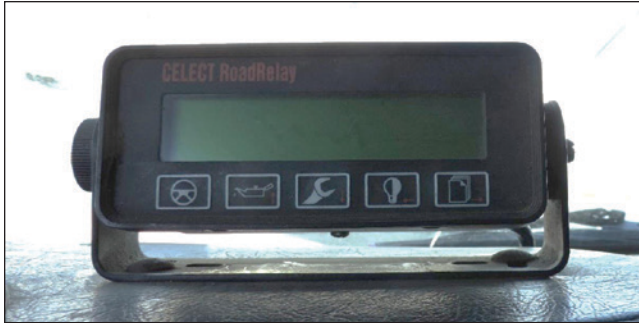
**Figure 4**  
Cummins Road Relay.

using Cummins PowerSpec. *Panic Stop* records on a RoadRelay 4 and 5 contain 59 seconds of pre-trigger data and 15 seconds of post-trigger data recorded at 1 Hz. The trigger threshold for a *Panic Stop* is a deceleration rate of 9 mphps ( $\approx 0.41g$ ) — the same as a *Sudden Deceleration Record*. On a RoadRelay 3, the *Panic Stop* record reports 45 seconds prior to the trigger and 15 seconds post-trigger. The trigger threshold on a RoadRelay 3 is user programmable.

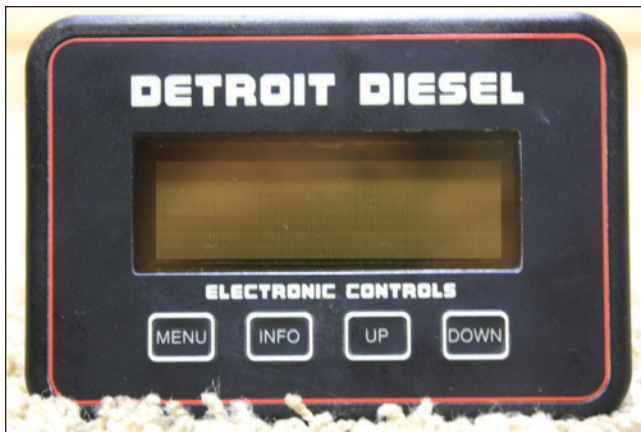
**Figure 5**  
Detroit Diesel ProDriver.

Similar to Cummins RoadRelay, Detroit Diesel offered the ProDriver computer. ProDriver can contain up to 5 *Hard Brake* records and a *Last Stop* record. For a *Hard Brake* event, ProDriver reports 90 seconds prior to and 30 seconds after a trigger event. The driver can manually trigger a snapshot for ProDriver by pressing a button. When a Snapshot is manually triggered, a record of the 2 minutes prior to activation of the snapshot button will be recorded<sup>1</sup>. ProDriver was discontinued in 2010, and is not widely equipped on vehicles.

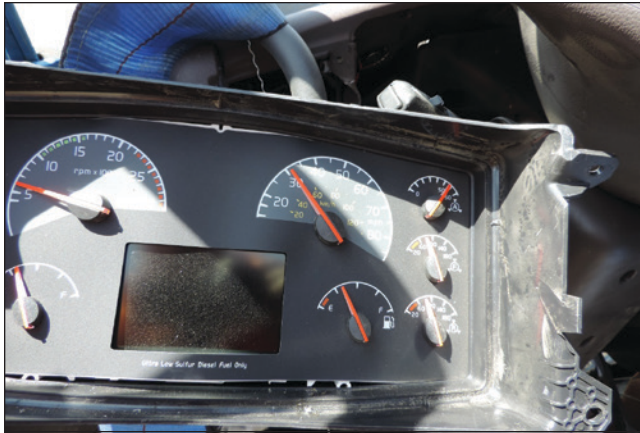
**Figure 6**  
Mack/Volvo instrument cluster ECU.

Mack trucks. The EECU is located on the left side of the engine block, whereas the VECU is located within the cab, generally near the passenger-side kick panel. The Instrument Cluster ECU is usually integrated into the instrument cluster, and the entire instrument cluster must be removed and sent to the authorized provider for a benchtop download (**Figure 6**).

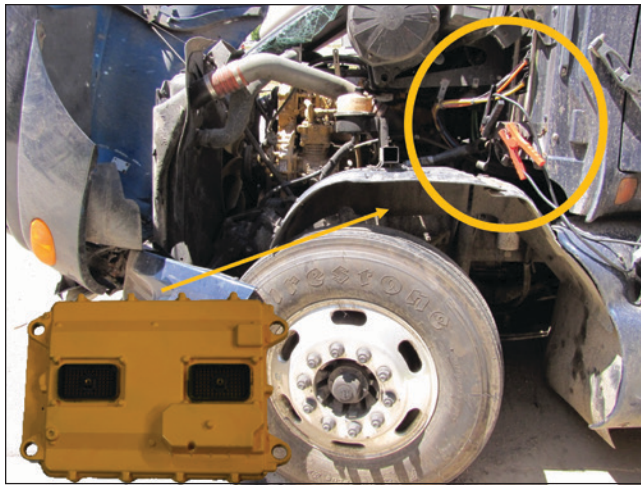
**Figure 10**

Power supplied through main power terminal;  
location of HVEDR.

Emergency personnel cut the power supply cables from the service batteries of the Kenworth. However, the authors were able to provide power to the vehicle using a high-amperage jump box connected to the main power terminals located on the driver's side firewall inside the engine compartment, as shown in **Figure 10**. The Kenworth Caterpillar engine was equipped with an ADEM IV generation Caterpillar HVEDR, located on the driver's side of the engine block at frame rail height, also shown in **Figure 10**.
