Vol. 34 No. 1 June 2017

# Forensic Engineering Analysis of Traffic Signal Timing and Speeds Prior to Collision by Rule-Based Triage of Indirect Video

By Daniel P. Couture, PEng (NAFE 951M)

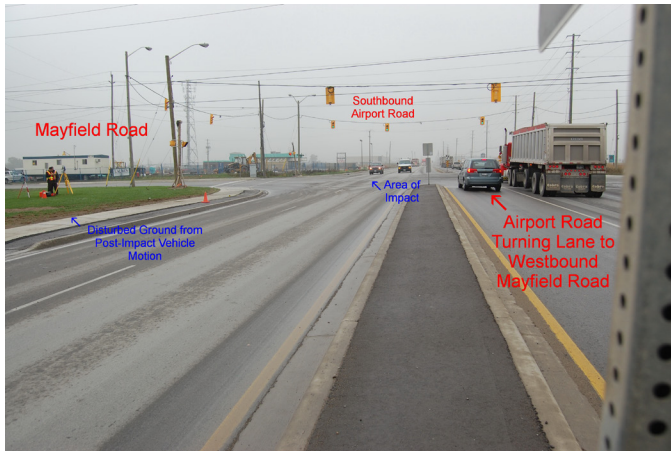
**Figure 5**

View looking north to the intersection of Mayfield Road and Airport Road.

Northbound Airport Road was similarly configured, that is with a left turn bay, two through lanes, a right turn bay, and two through lanes north of the intersection. North- and south-bound portions of the highway were separated by a concrete median in the approaches to the intersection. This northward view is shown in **Figure 5**.

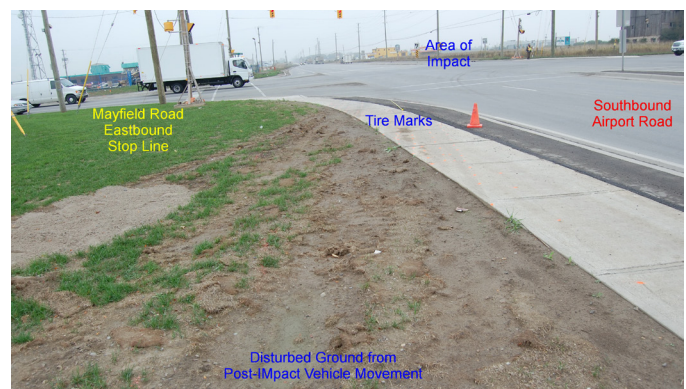
Figure 7

View to the northeast along the path of post-impact vehicle movement.

police officers. Tire marks extended from 6 meters (20 feet) beyond the gouge to the positions at rest. Tire impressions were seen in the soft ground on the lawn of the station, as shown in **Figure 7**.

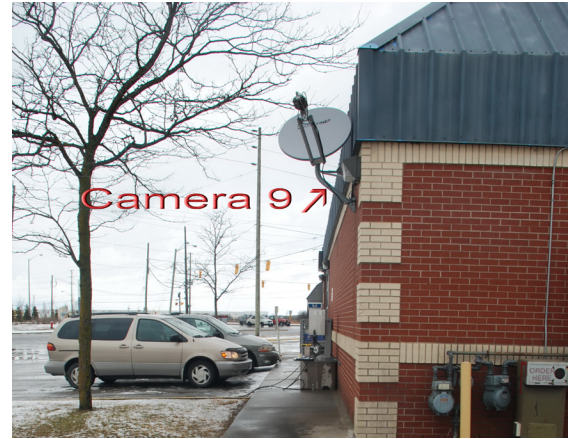
**Figure 14**  
Camera 9 was mounted at the southwest corner of the restaurant.

Camera 9 was located by the air pump at the rear of the restaurant building, as shown in **Figure 14**. The videograph from Camera 9 became available during litigation proceedings, which provided an opportunity to do a motion and time analysis of the positions of the vehicles. The footage was studied with a video player program (DVR.exe, version 1.4.1.23).

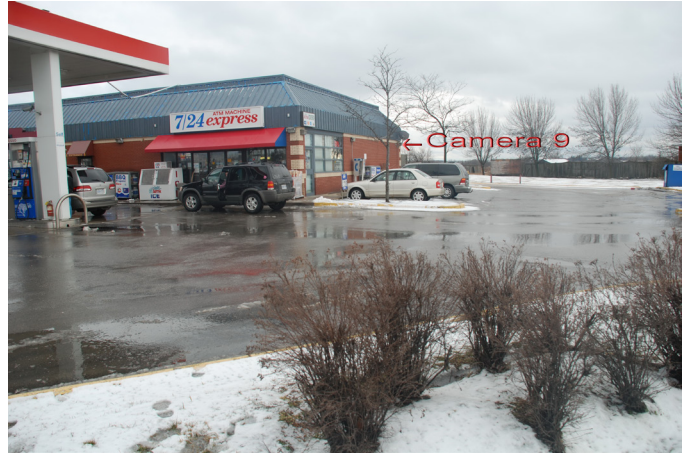
Figure 15

View toward Camera 9 from the south edge of Mayfield Road.

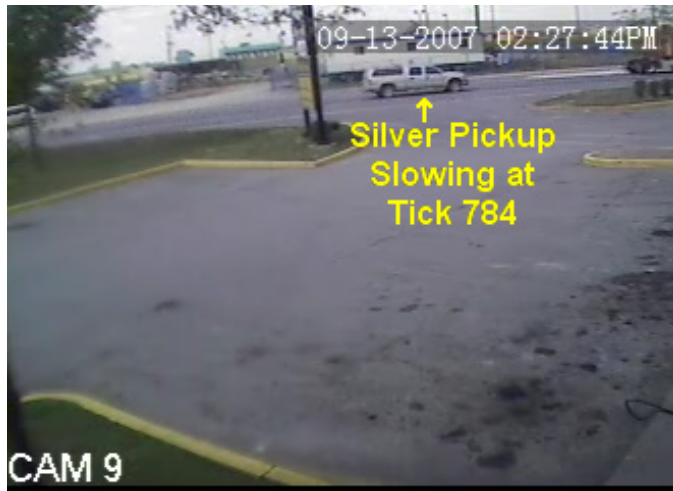
**Figure 19**  
Silver pickup slowing at Tick 784.

eastbound silver-colored pickup traveling through and slowing down at Tick 784 (**Figure 19**), followed by an eastbound black sedan that slowed down near the right frame edge after Tick 796 (**Figure 20**) and stopped at Tick 822 (**Figure 21**).

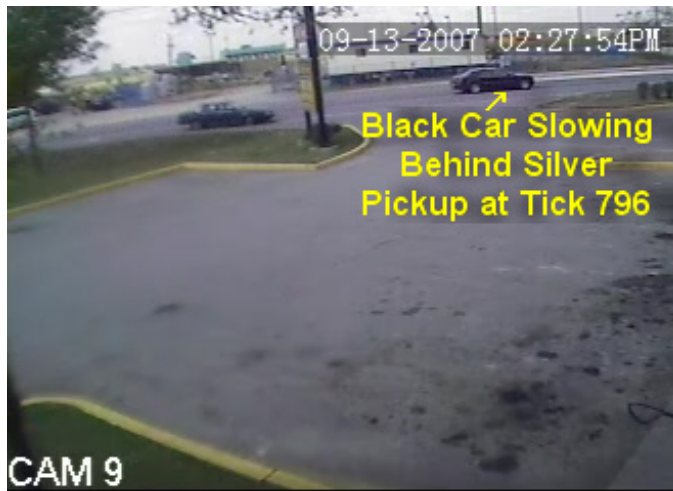
**Figure 20**  
Black car slowing at Tick 796.

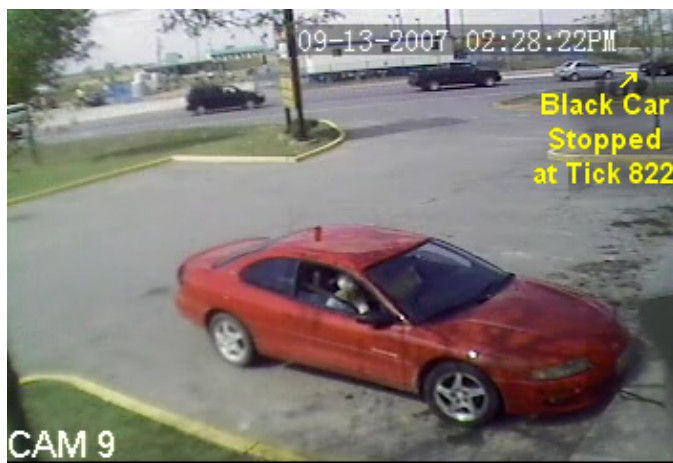
**Figure 21**  
Black car stopped at frame edge at Tick 822.

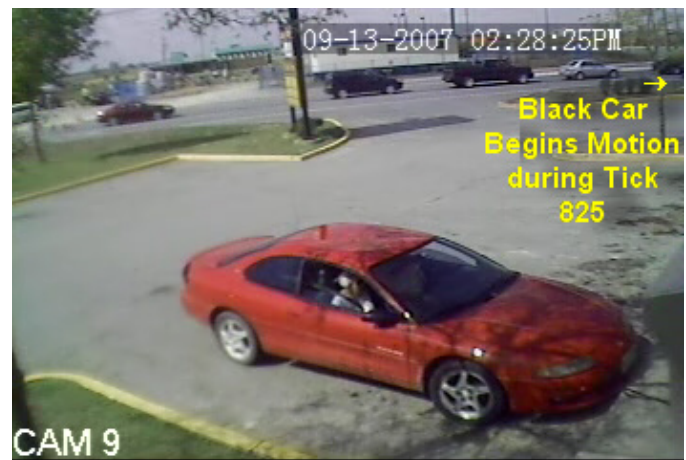
**Figure 23**  
Black car begins motion eastbound during Tick 825.

At Tick 825, the black car was observed (see **Figure 23**) beginning to move in response to a green signal (at 2:28:25.4). Using the criteria in SAE 2001-01-0045<sup>1</sup> (see **Appendix A**), which gave 1.4 to 1.5 seconds as an un-anticipated response to a signal for the first vehicle and actual observations of second vehicle behavior in line, the black car was estimated to have moved ahead from 2.2 to 3.0 seconds after the green ball appeared for eastbound traffic. There were no clearing vehicles proceeding to finish their turns westbound from northbound at this time.

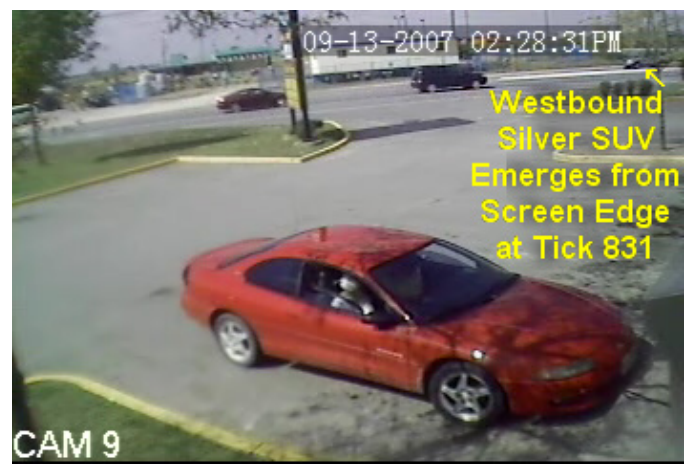
**Figure 24**  
First westbound vehicle emerges from the right side of frame at Tick 831.

At Tick 831, the first of three westbound vehicles can be seen (**Figure 24**) at the edge of the frame at 2:28:31.4. It was assumed that this vehicle was first in line, at a position that was 53 meters (174 feet) east of where it can be

first seen in the videograph. Using the single-frame analysis technique, the speed of this vehicle was calculated to be from 45 to 50 km/h (28 to 31 mph), which was consistent for acceleration from a stop, using the SAE 2001-01-0045 guidelines. It was then estimated that the earliest this vehicle could appear on screen was from 7.1 to 8.0 seconds after the green signal for westbound Mayfield traffic.

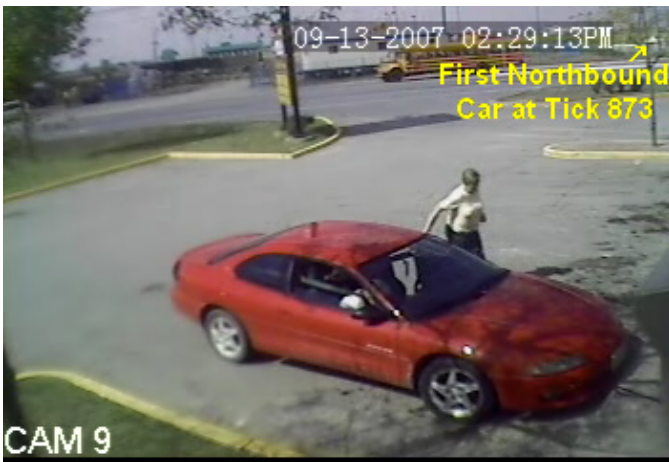
**Figure 25**

First northbound vehicle seen at tick 873.

At Tick 873, (or 2:29:13), there were three northbound vehicles in the videograph that had traveled about 73 meters (240 feet) north of the northbound stop line. One is seen in **Figure 25**.

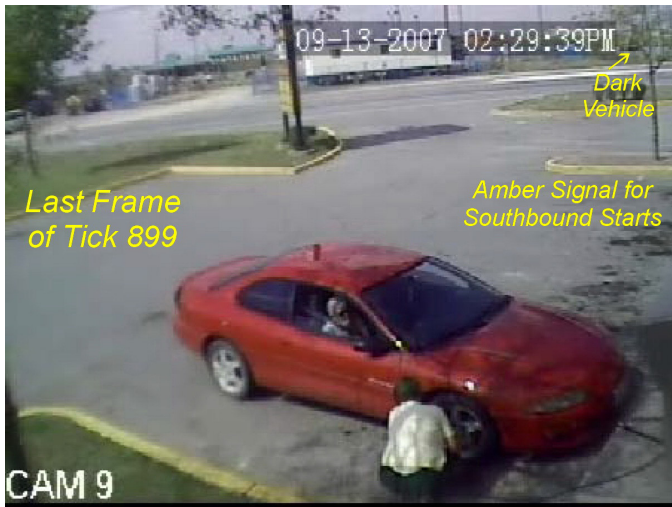
**Figure 27**

Dark vehicle traveling southbound at the end of Tick 899.

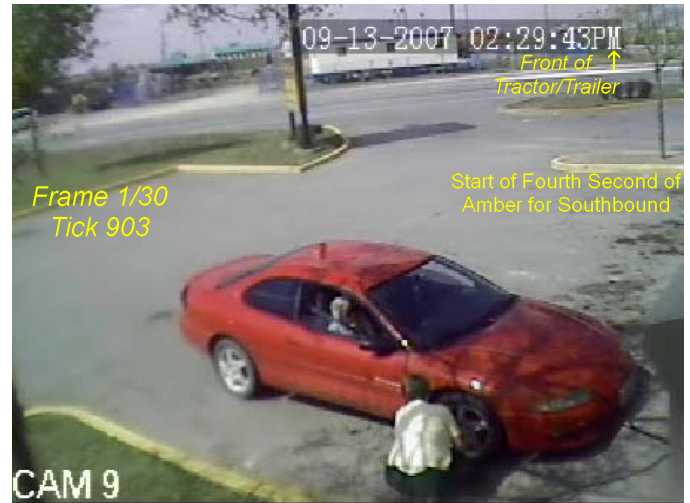
**Figure 29**

The front of the tractor/tractor becomes visible behind the time stamp edge at Tick 903.

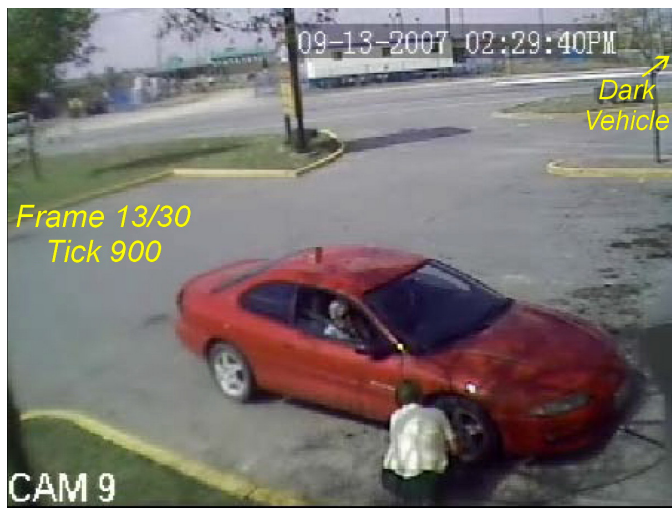
**Figure 28**

The dark vehicle leaving the frame at midpoint of Tick 900.

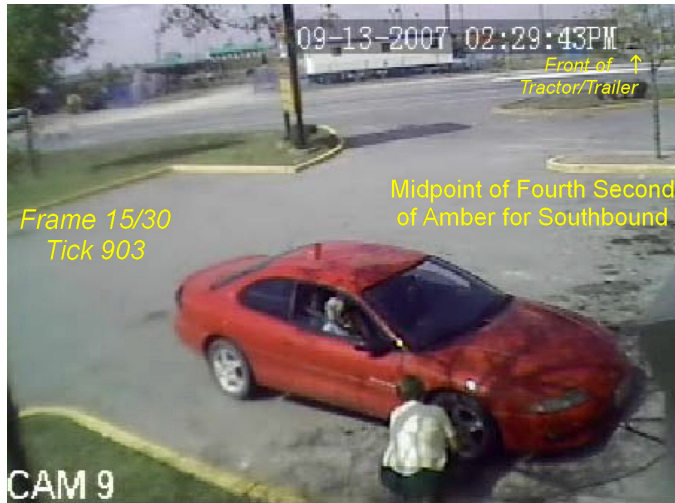
**Figure 30**

The front of the tractor/trailer emerges by the time stamp at the midpoint of Tick 903.

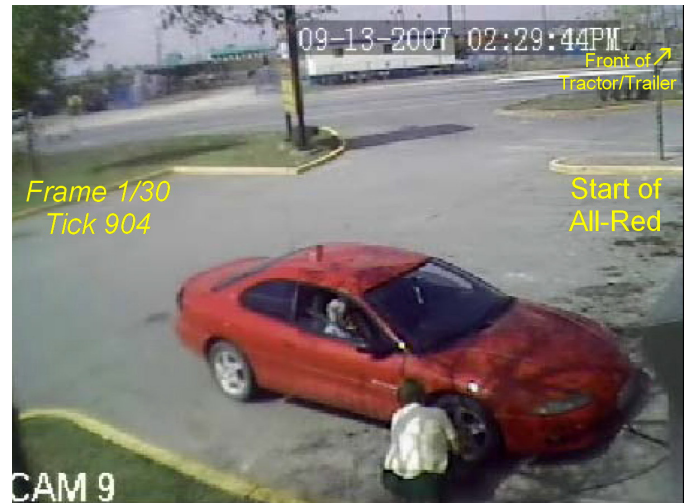
**Figure 31**

The front of the tractor trailer at the start of all-red, Tick 904.

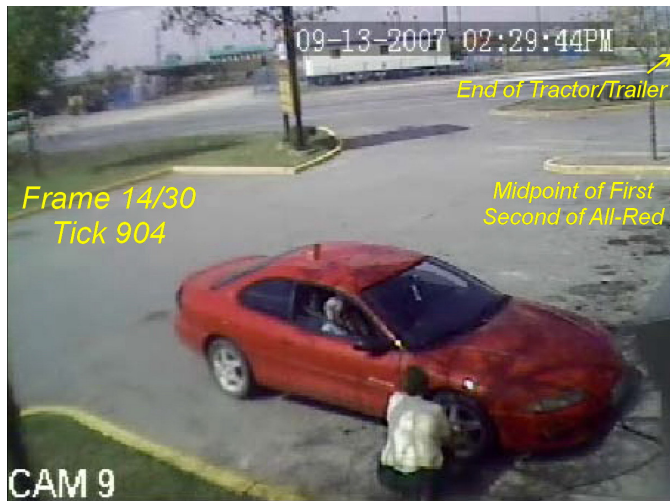
**Figure 33**

At the midpoint of Tick 904, the first second of all-red, the end of the tractor/trailer is at the edge of the screen.

From the videograph, the back of the tractor/trailer at the eastern limit of the camera view at 2:29:44.6 can be seen, and given its length of just over 20 meters (65.6 feet), its front end would be at the southbound stop line when it is in Lane 1, as shown in **Figure 37**. At its calculated speed, the tractor/trailer would take another second to travel to the area of impact to the south along the demarcation between Lanes 1 and 2. However, the phase cycle analysis indicated that at Tick 904, 2:29:44, the signal had turned to all-red. Thus, if the truck is entering the intersection boundary at 2:29:44.6 or later, it must have done so in the second portion of the all-red signal. The collision engagement began at 2:29:45.5 during Tick 905, for a vehicle speed of 71 km/h (44 mph) or 19.6 meters per second (64.3 feet/sec). This is within the 2<sup>nd</sup> second of all-red for the northbound/southbound phase.

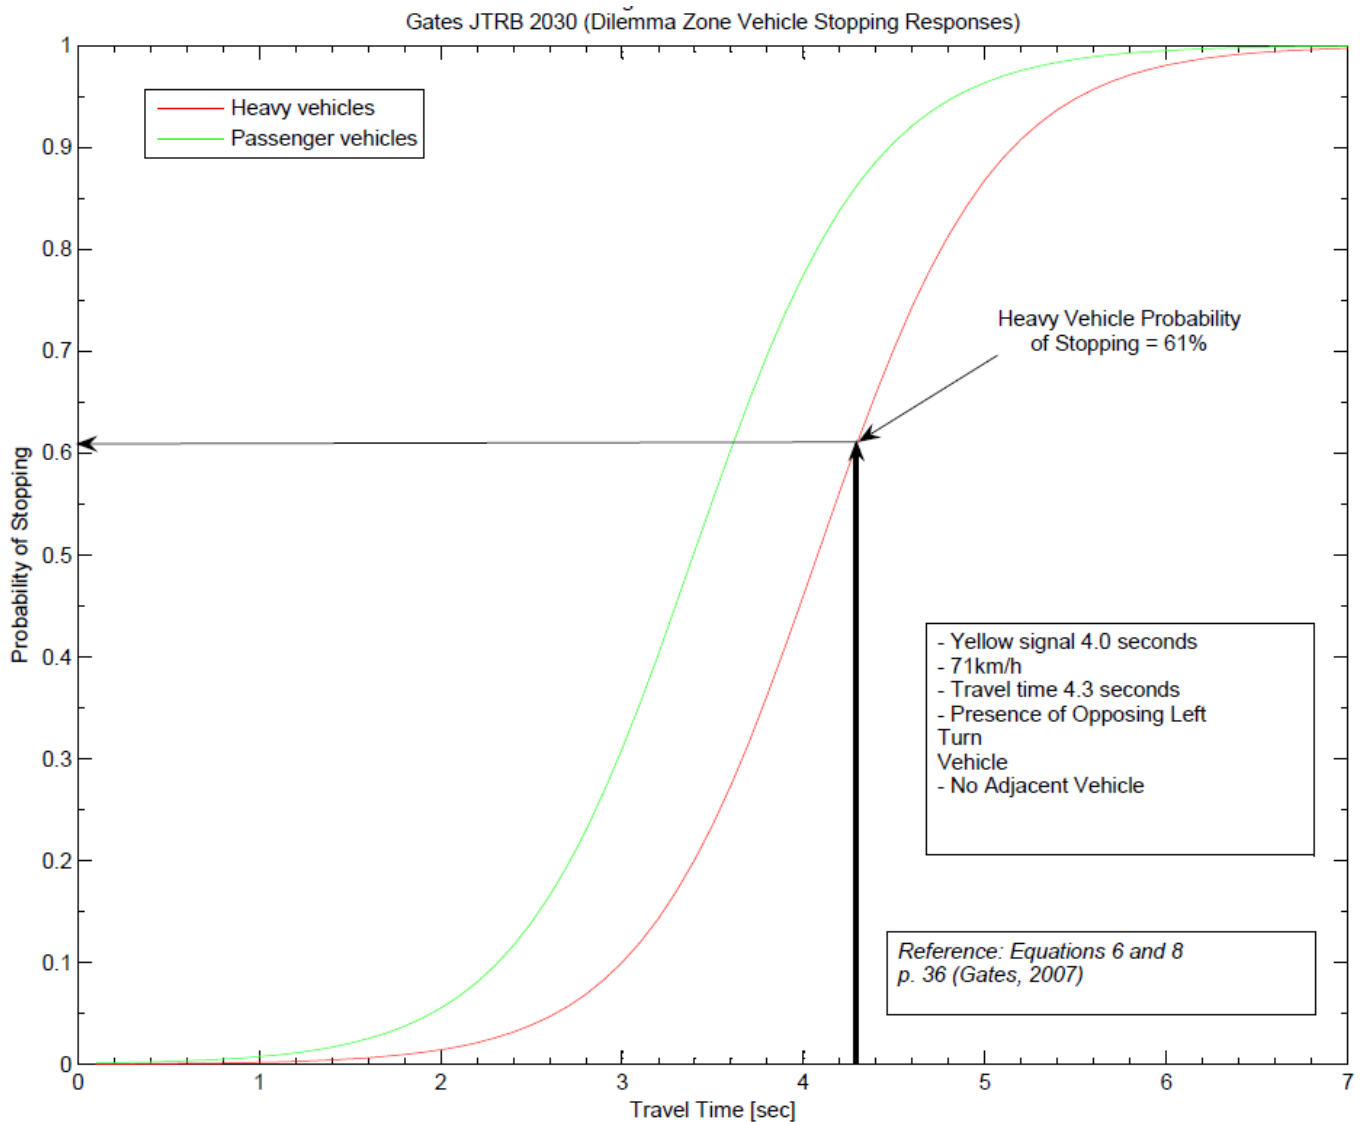
**Figure 38**

Heavy and passenger vehicle stopping probability from logistic regression.
