Vol. 34 No. 1 June 2017

Solid Fuel-Burning Appliance Fire Investigations

By Joseph G. Leane, PE (NAFE 524F)

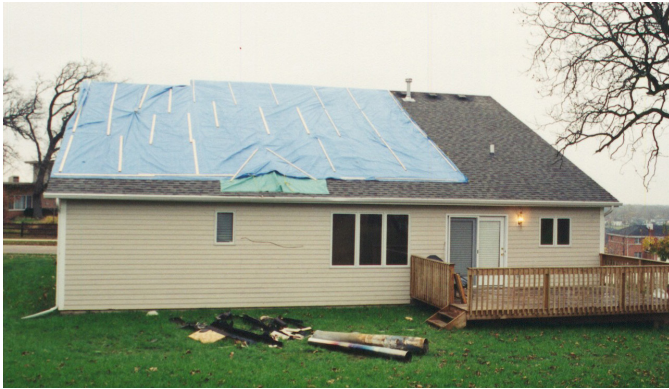
Figure 1

Rear of house showing chimney and chase debris in yard.

Investigation: The house had been recently completed, and the owners occupied the house in April of the same year (**Figure 1**). At that time, a factory-built fireplace and chimney system was installed in a chase in the corner of a family room (**Figure 2**). The chimney was a double-wall type. When the homeowners used the wood-burning fireplace for the first few times that spring, they smelled burning wood in an attached garage. They did not use the fireplace during the summer, and had a natural gas log set installed in September. Between the gas conversion and the date of the fire, they had used the gas fireplace several times. The use of a natural gas log set in the fireplace did not eliminate the necessity for the fireplace and chimney to comply with the original relevant codes and standards.

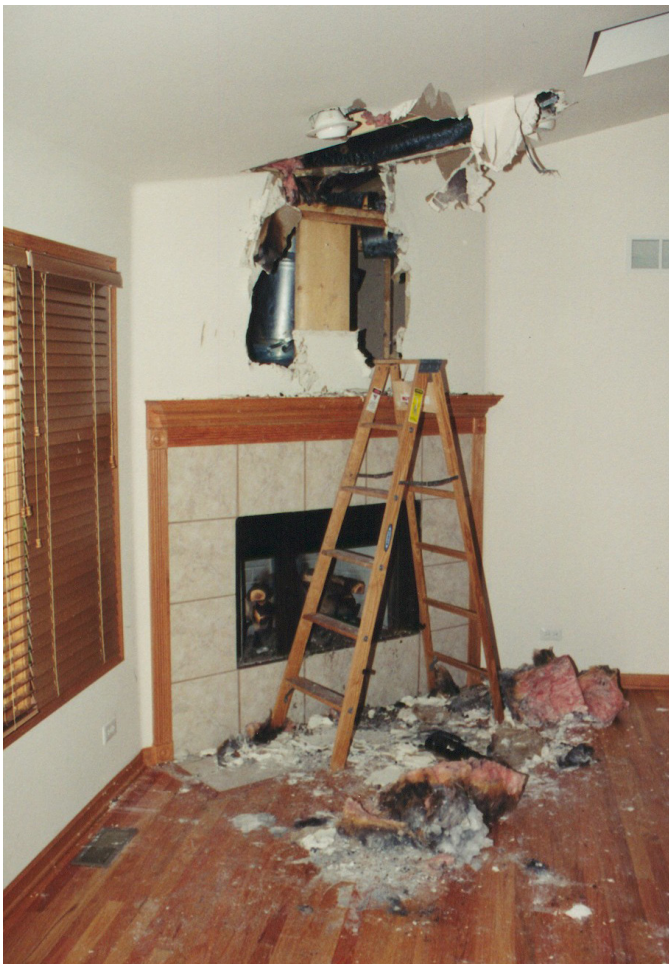
Figure 2

Family room showing fireplace and chase.

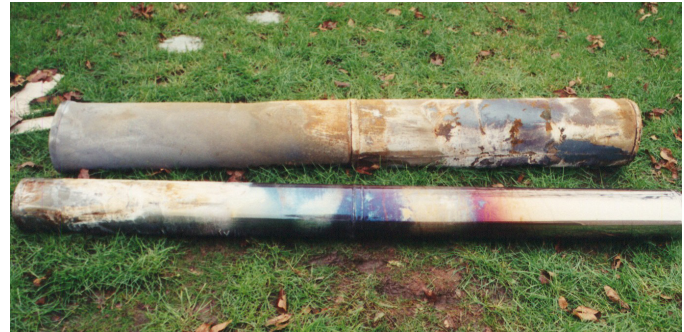
Figure 3

Chimney pipes in yard.

The sections of chimney pipe and remnants of the wooden chase were found to be lying in the backyard. No termination cap was found for the top of the chimney. Discoloration of the chimney pipes indicated that they had gotten very hot (**Figure 3**). The chimney had extended through a vertical wooden chase. The configuration of the chase and chimney were documented in detail (**Figure 4**). Those components had sustained substantial damage from the fire and extinguishing activities of the fire department. Modeling the configuration of the chimney and chase revealed that the top of the chimney pipe did not reach the top of the chase (**Figure 5**). Further, heat patterns and nails at the top of the chase suggested that a plywood cover might have been located over the opening at the top of the chase.

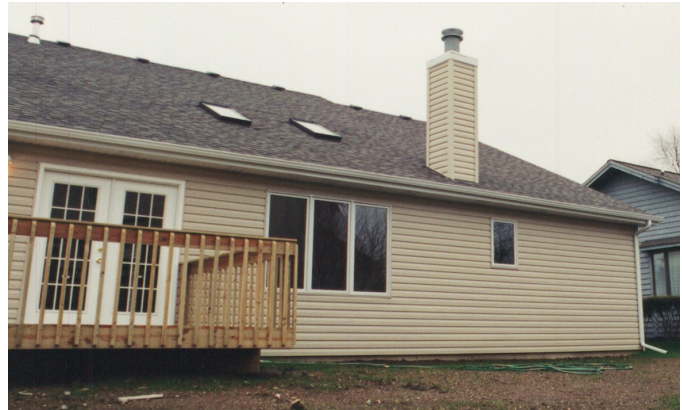
Figure 6

Exemplar house showing chimney chase.

An inspection of an exemplar house that had been constructed by the same builder revealed that the upper portion of the fireplace chimney and rain cap clearly extended above the top of the wooden chase (**Figures 6 and 7**).

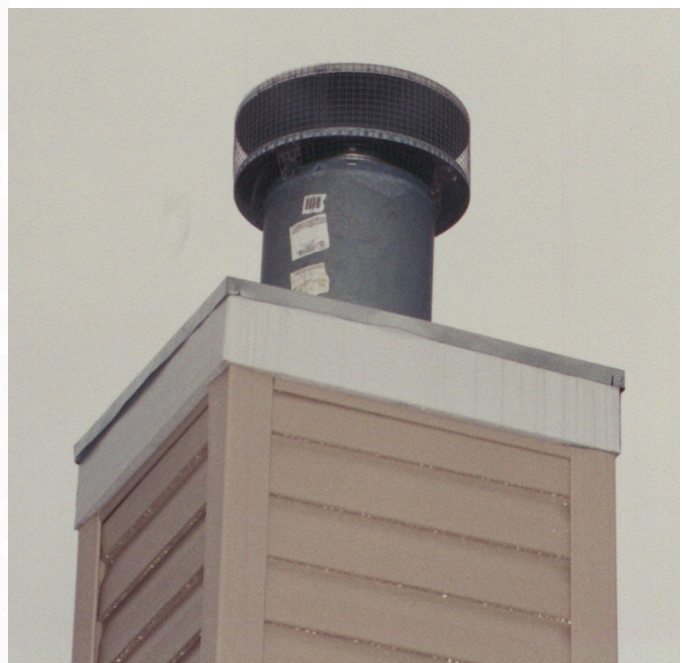
Figure 7

Exemplar chase showing chimney and termination cap extending above.

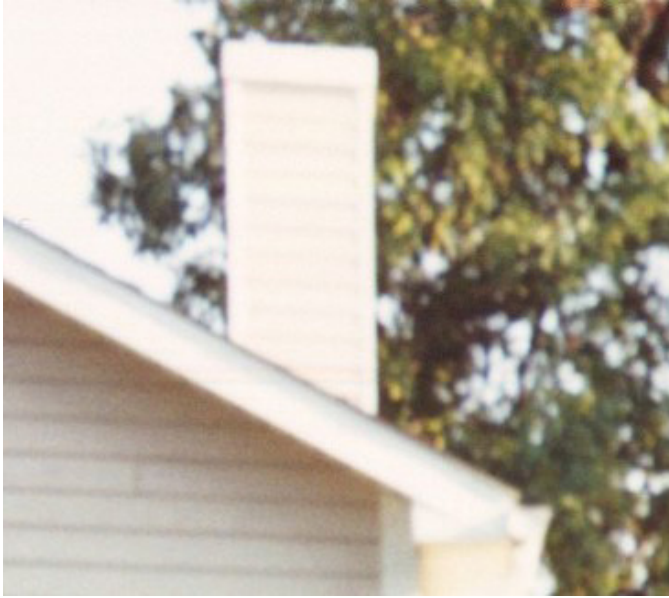
Figure 8
Subject chase before fire.

During the investigation, a next door neighbor produced a photograph from a party that had occurred in their backyard that summer (**Figure 8**). The photograph showed the subject chimney chase in the background, and clearly showed that nothing extended from the top of the chase. In other words, no fireplace chimney pipe and/or rain cap extended from the chase.

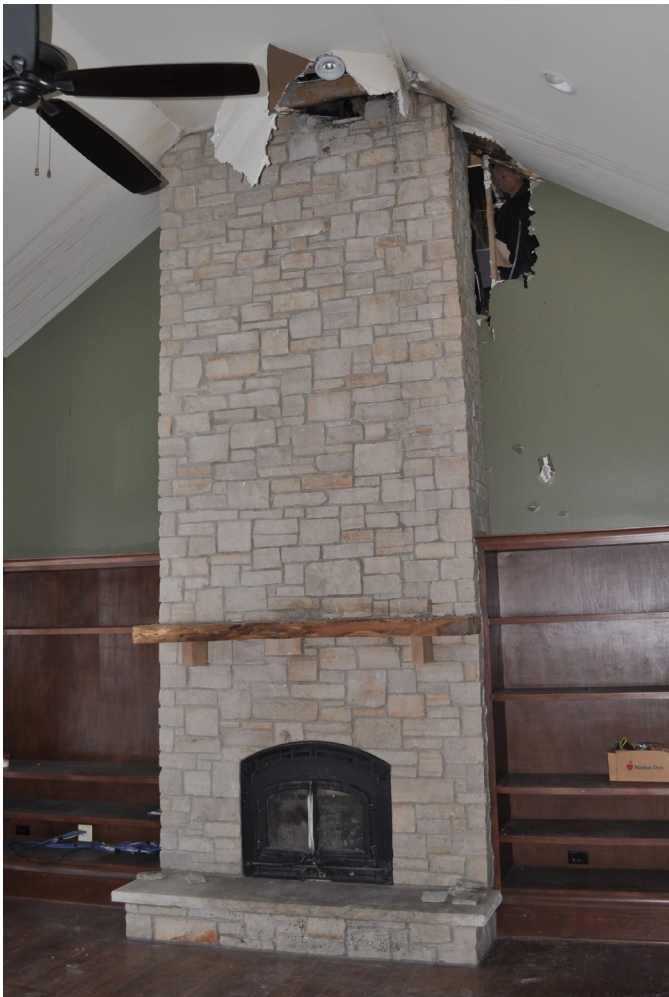
Figure 9
Family room showing fireplace and chase.

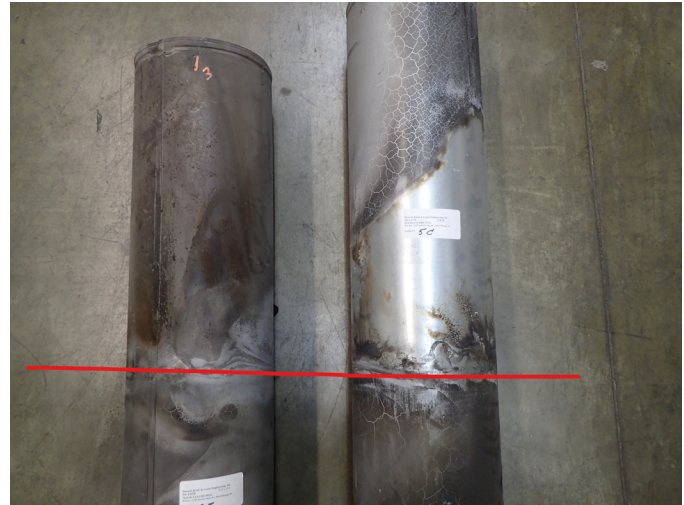
Figure 11

Fire patterns on the exterior surface of the subject chimney pipe, directly above the firestop spacer shelf, indicated an area of relatively intense heat located within a larger triangular shape, which was an area originally covered with insulation that burned away during the fire (**Figure 11**). A light coating of ash was located on the interior surface of the inner pipes of those sections. The termination cap contained black-colored deposits and loose material.

On the second (unused) parallel factory-built chimney, the portion located directly above the upper firestop spacer contained a “protected area” that was not heat/fire damaged. The maximum height of that protected area was approximately 18 inches above the firestop spacer. A pile of cellulose insulation had been located there during the fire, and protected that portion of the chimney section

Subject (left) and unused (right) chimney pipes. Red line indicates original firestop spacer shelf position.

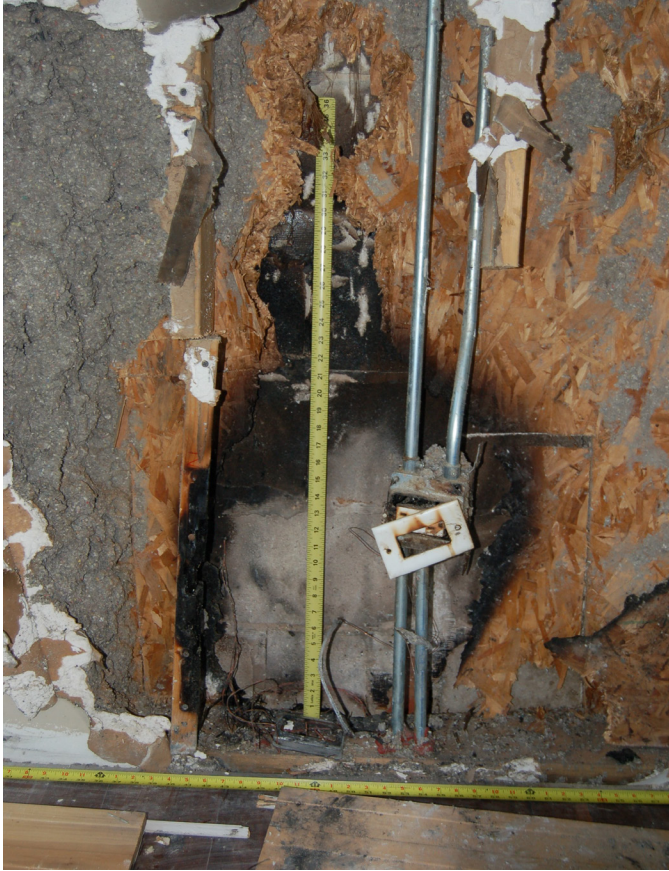
Figure 14

Fire damaged wall common to outdoor fireplace.

Investigation: The east wall of the family room, common to the outdoor fireplace, had sustained fire damage (**Figures 13 and 14**). The frame wall was located directly adjacent to (and in contact with) the masonry rear wall of the fireplace. This frame wall was comprised of: house wrap fabric, 1/2-inch OSB sheathing, wood 2x6 studs on approximately 16-inch centers, cellulose blown-in insulation in the stud spaces, and 1/2-inch drywall (interior surface). The OSB sheathing was contacting the masonry at the rear side of the exterior fireplace. A burn pattern

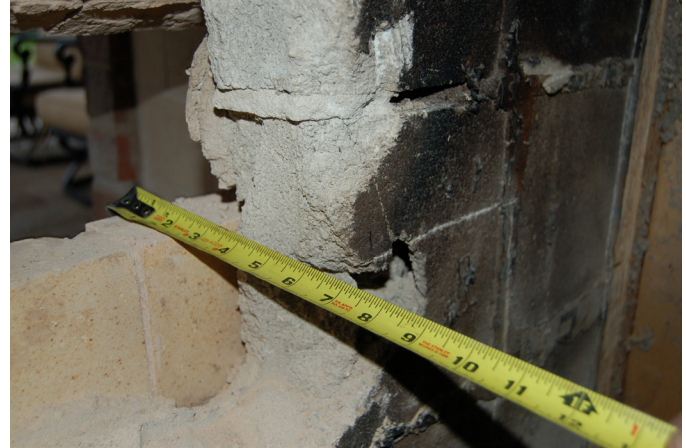
Figure 15

A portion of the rear wall of the fireplace was removed, which provided access to the entire cross-section of the rear wall of the fireplace (**Figure 15**).

The overall thickness of the rear wall of the fireplace was measured and found to be about 7 inches. It was comprised of a 2½-inch-thick single row of firebrick, which was the back wall of the firebox, and a 3½-inch-thick single row of concrete masonry units (CMUs). A gap measuring between ¾ and 1 inch, between the CMUs

Rear wall of fireplace with portion removed, showing dimensions.

and firebrick, was partially filled with mortar. Electrical components within that wall were inspected by an electrical engineer and eliminated as a cause.

Conclusion: The subject fire was caused by heat energy from the firebox of the outdoor fireplace conducting through the rear wall of the masonry fireplace and igniting combustible building materials directly adjacent to, and in contact with, the masonry wall. The construction of the masonry fireplace and wall was improper, dangerous, and a fire hazard. The construction violated the standard NFPA 211 and the local building code. The 7-inch thickness of the masonry back wall of the fireplace was less than the minimum required 8 inches. The OSB sheathing of the interior wall was contacting the inner surface of the masonry wall for zero clearance to combustibles, which was less than the minimum required clearance of 4 inches. The thickness of the back wall and the absence of an air space clearance to combustibles provided much less thermal resistance between the firebox and the combustible wall than the building code required. This permitted an unsafe elevated temperature of the combustible wall, which resulted in its ignition.
