Vol. 34 No. 2 December 2017

Forensic Engineering Comparison of Two Masonry Cladding Systems

By Derek A. Hodgin, PE (NAFE 733S)

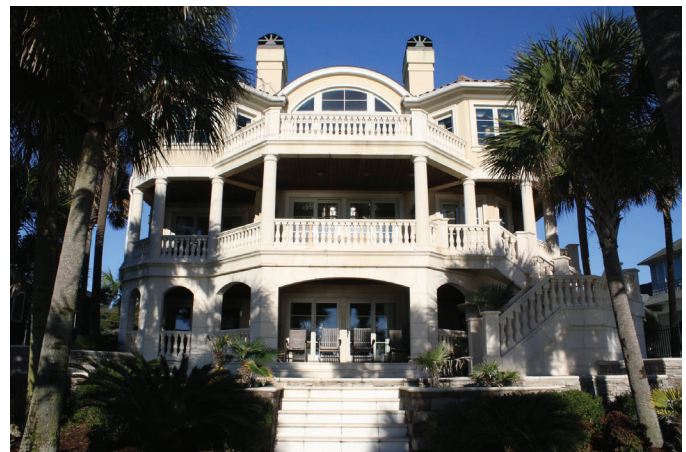
Figure 1

A large oceanfront home was constructed in Myrtle Beach, SC, in 2006. The house was required to be constructed in accordance with the 2003 International Residential Code (IRC 2003). The exterior walls included a combination of cast stone panels and conventional stucco. The cast stone panels were installed on the first floor and on the oceanfront balconies on the second and third floors. The remaining walls were clad with conventional stucco. Cast stone trim panels were used to surround the windows and doors on all three floors. **Figure 1** shows the oceanfront elevation of the subject home.

Oceanfront elevation of subject residence.

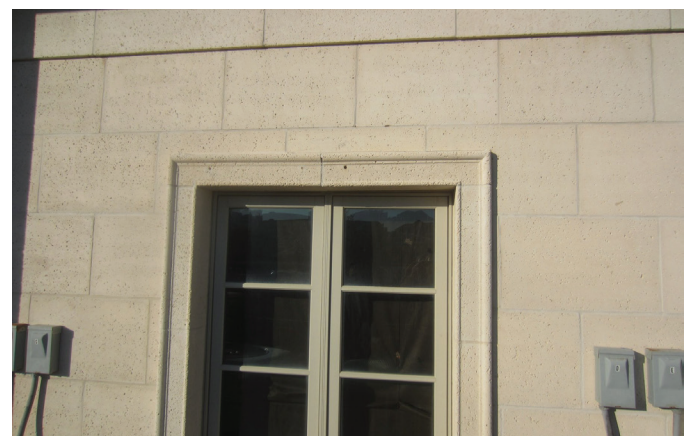
Figure 6

As previously introduced, the subject oceanfront residence in this case study was constructed in Myrtle Beach, SC, in 2006. The applicable building code was the 2003 IRC. The exterior walls of the subject residence were clad with a combination of cast stone panels and conventional stucco. The cast stone panels were installed on the first floor and on the oceanfront balconies on the second and third floors (**Figure 6** and **Figure 7**). The remaining walls were clad with conventional stucco. Cast stone trim panels

Cast stone panels installed on first floor.

were installed around the windows and doors on all three floors.

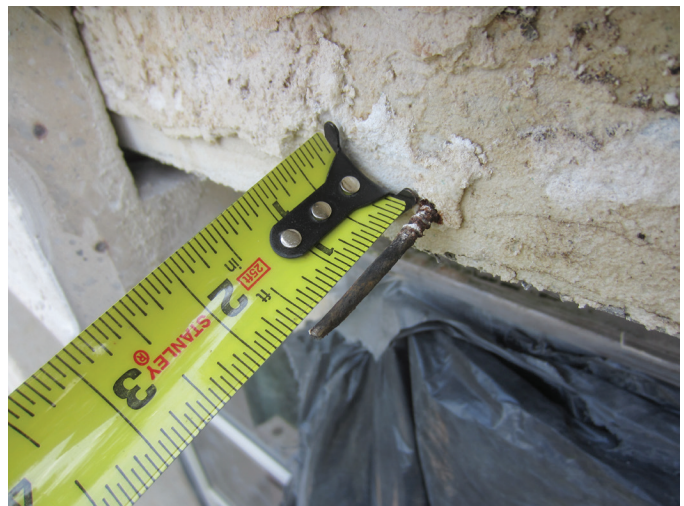
Figure 9

Masonry screw used to attach a cast stone panel.

- The water intrusion that occurred during the short service life of the subject structure had resulted in corrosion of the steel masonry screws. However, these screws were installed for temporary support of the veneer units while the adhesive mortar was setting. Therefore, these

screws are unnecessary and because their continued presence may cause aesthetic rust spots, they should be removed.

- The existing steel masonry screws should be removed from the existing cast stone veneer units.
