Vol. 35 No. 1 June 2018

Forensic Engineering Investigations of Residential Clothes Dryer Fires

By William R. Keefe, PE (NAFE 481M)

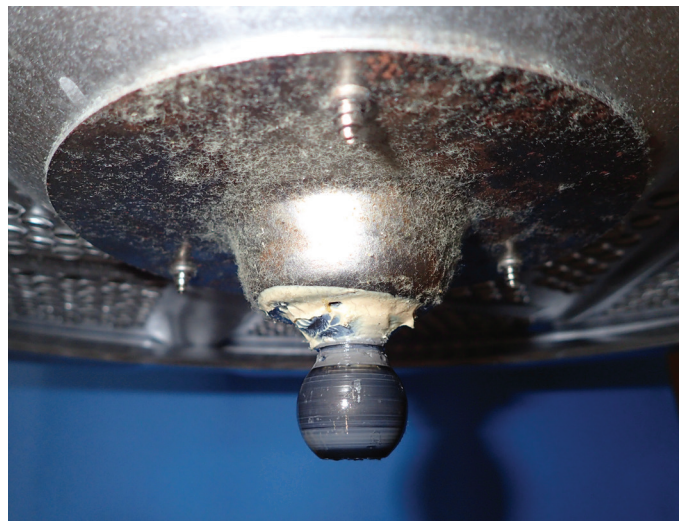
Another dryer configuration is commonly known as a ball hitch or closed-back drum dryer. In a ball hitch dryer, the rear end of the drum is enclosed by a perforated metal sheet, which rotates with the drum. The front end of the drum is supported by the front cabinet panel. The rear end is supported by a rear drum support shaft and ball hitch, which extends from the center of the rear side of the drum (**Figures 8 and 9**) to a support bearing (**Figure 10**) on the rear wall of the cabinet. In one gas-heated ball hitch design, a burner tube is located at the lower left portion of the cabinet base. A heat duct extends upward from the burner discharge to a heater pan, located on the rear side of the drum. The heater pan is a vertically oriented shallow cylinder located on the rear side of the drum (**Figure 11**). Heated air and combustion products flow from the burner into the heater pan and then through the perforations in the rear side

Ball hitch.

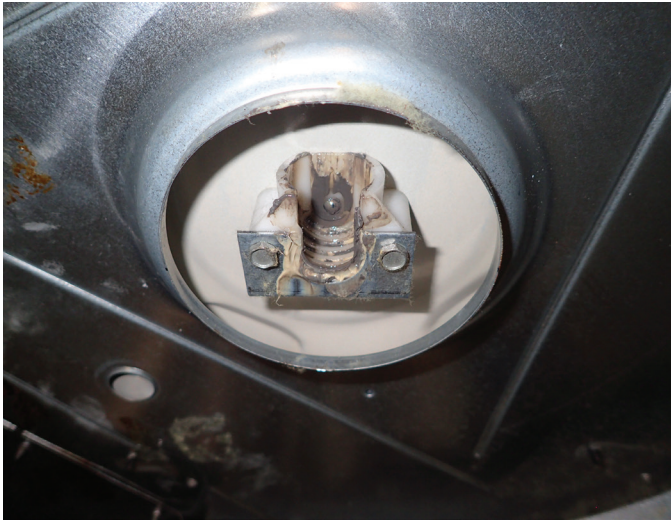
Figure 10
Rear bearing assembly.

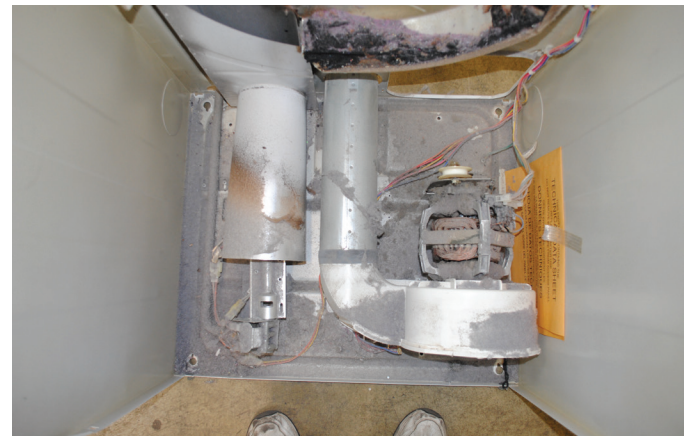
Figure 19

Accumulated lint in base of dryer.

Exemplar dryers can be examined to determine lint accumulation patterns and the amount of lint accumulated in a dryer. The gas dryer shown in **Figures 19 and 25** was in operation for eight years by a family of four. In that time, the interior of the dryer cabinet was not cleaned. The total weight of accumulated lint in the dryer at the end of that eight years was 0.256 pounds. In a similar model gas dryer operated for more than 10 years, with no

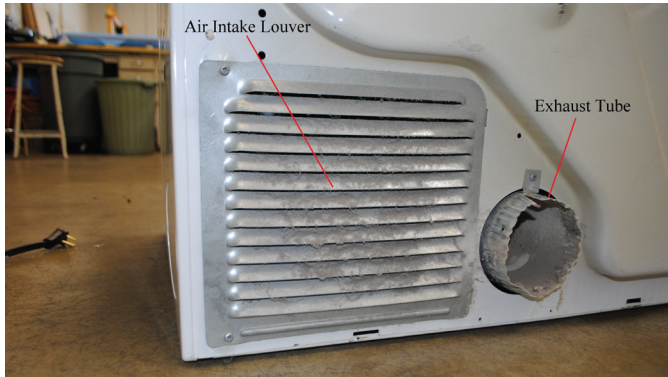
Figure 21
Exhaust tube and air intake louvers.

air intake openings are located on the back of the dryer near the first exhaust duct connection to the dryer. This has the potential to draw lint-laden exhaust back into the dryer cabinet through the air inlet louvers (**Figure 21**).

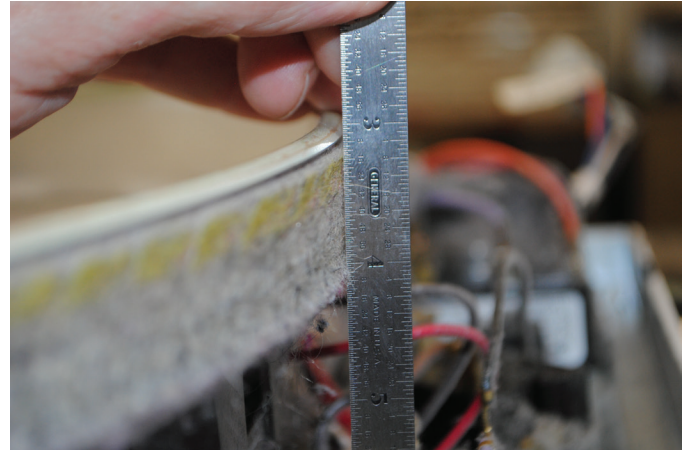
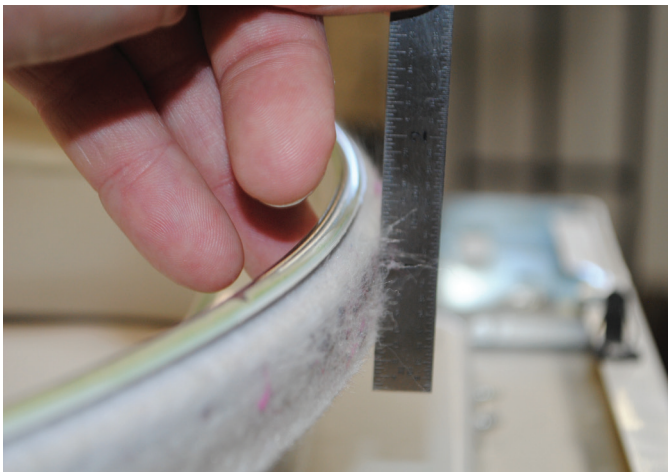
Figure 23
Crushed seal.

Figure 22
Non-crushed seal.

Figure 24
Gap created by crushed seal.

Air leaks at seals on the negative pressure side of the blower (upstream of the blower) can also lead to additional lint accumulation within the dryer and alter the patterns of lint accumulation within the dryer. For example, a leak at the front drum seal will permit air from the dryer cabinet to enter the front end of the drum. This air leaking into the drum will displace air that is normally pulled through the burner or heater box and through the rear of the drum. A large leak could result in increased temperatures upstream of the drum. In ball hitch dryers, this reduced air-flow can cause additional lint accumulation behind the drum. A leak at the seal between the air duct (lint chute) and blower will have a similar effect. A leak at seal on the negative pressure side of the air stream will also act like a vacuum, pulling lint laden air to the leak. That can result in an abnormal accumulation of lint around the seal.

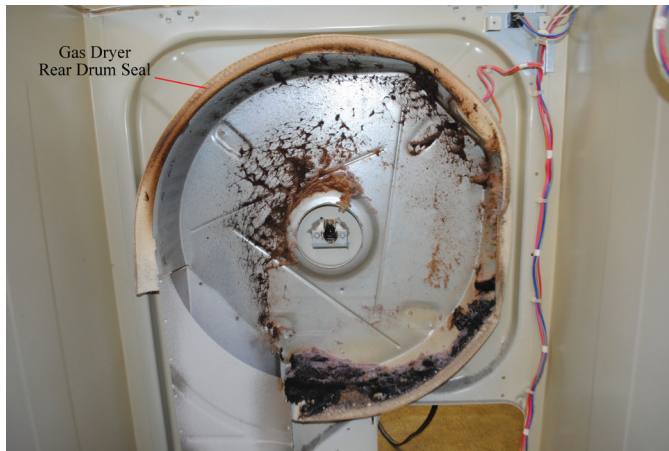
Figure 25

Charred lint in the heater pan of a ball hitch dryer.

Ball hitch-style dryers are equipped with a heater pan behind the drum. Lint can accumulate in the heater pan of ball hitch dryers. Larger accumulations occur in gas ball hitch dryers than in electric ball hitch dryers due to the presence of a seal between the heater pan and rear of the drum on the gas dryers (**Figure 25**).

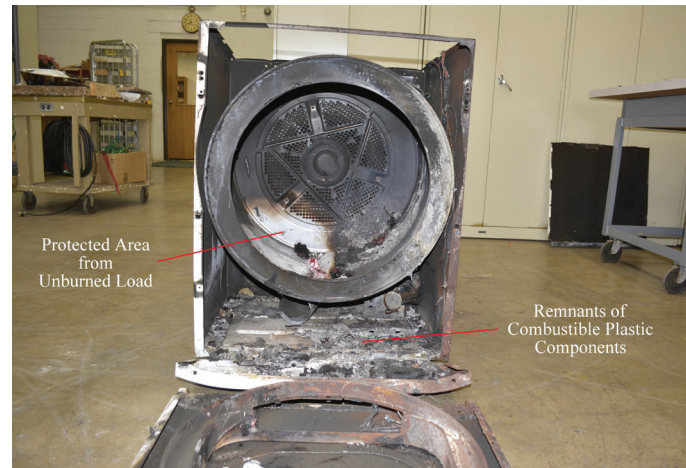
Front of partially disassembled electric dryer.

Heater pan of electric ball hitch dryer showing heating element and accumulated lint.

A fire occurred in a four-year-old electric dryer during operation about 15 minutes after a drying cycle was started. The fire was witnessed by the user. The dryer vent system complied with the manufacturer's installation instructions. The dryer load consisted of a twin size fleece blanket. The blanket was minimally damaged by the fire. From a detailed lab exam of the dryer and other artifacts, it was determined that lint was ignited by the energized electric heating element and spread the fire to the plastic components. Most of the combustible plastic components, including the blower and air duct, were consumed (**Figures 26 and 27**).

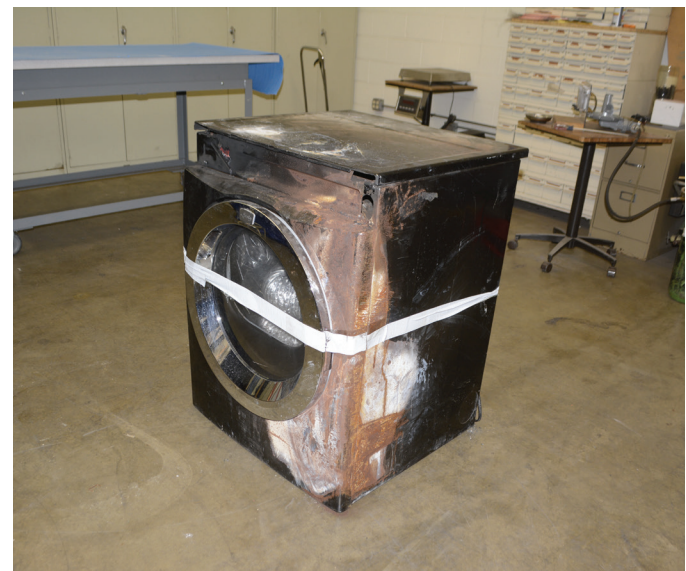
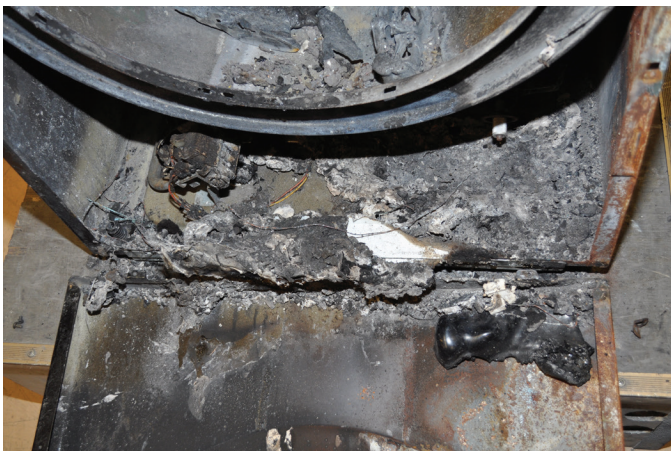
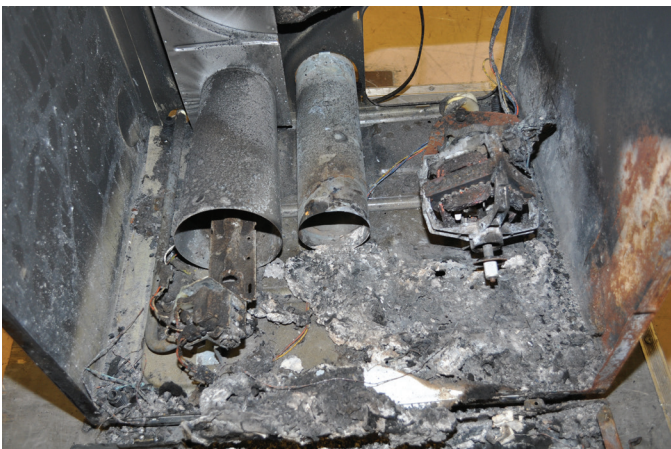
Dryer cabinet showing thermal damage from plastic fuel load.

Heater pan of dryer showing accumulated lint.

Base of dryer showing mostly consumed combustible plastic components.

A fire occurred in a four-year-old natural gas fueled clothes dryer during operation (**Figure 28**). The fire was discovered and witnessed by the user several minutes after it had been placed in operation. Upon discovery of the fire, the user stopped the dryer and removed the unburned, wet load from the dryer. From a detailed lab exam of the dryer and other artifacts, it was determined that the fire resulted from ignition of lint within the dryer (**Figure 29**). The source of the ignition was the gas burner. The fire spread to the combustible plastic components, including

the blower and air duct, and most of those components were consumed (**Figures 30 and 31**).

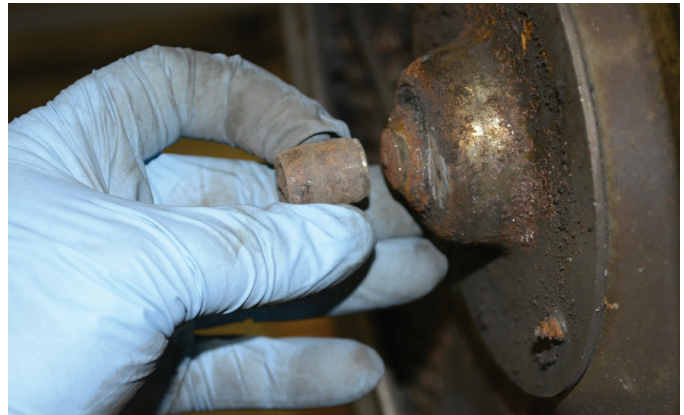
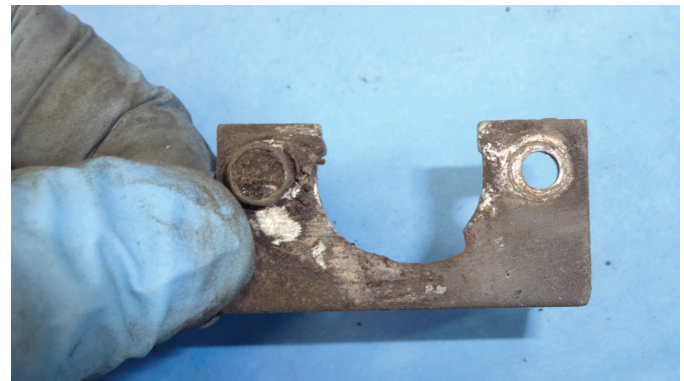
Severed ball hitch.

Wear on bearing bracket.

A 10-year-old electric ball hitch dryer started on fire while in operation. The homeowners witnessed the fire. Examination of the dryer determined that the rear drum support bearing had worn, permitting metal-to-metal contact between the rear drum support shaft and the bearing bracket (**Figure 33**). Eventually, the shaft was severed (**Figure 32**), and the rear of the metal drum baffle contacted the energized heating element. The resulting arcing

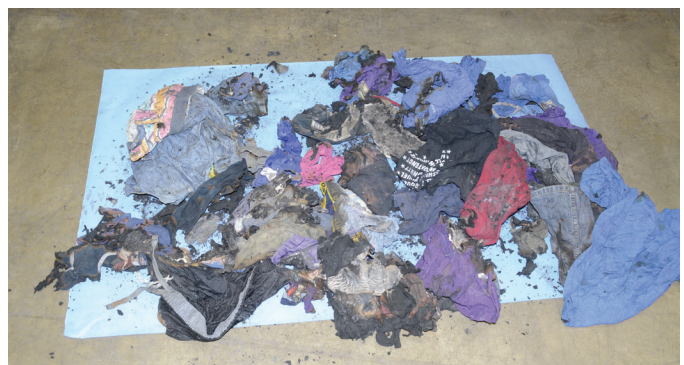
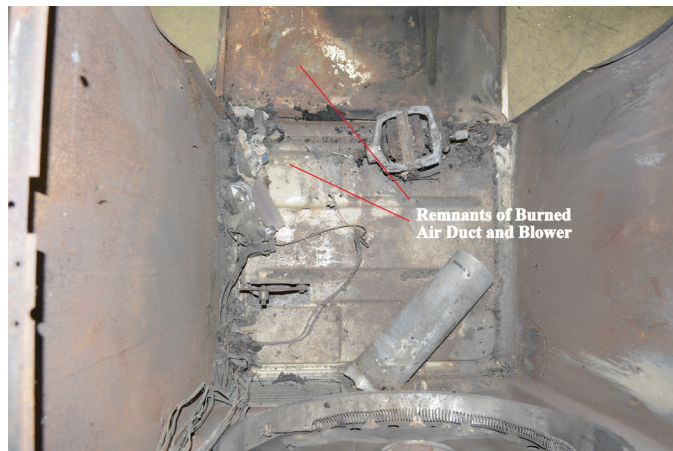
Load with minimal fire damage.

Figure 35
Consumed plastic components.

event and dispersal of molten metal into the dryer ignited lint within the dryer. The load had minimal fire damage (**Figure 34**). Most of the combustible plastic components burned (**Figure 35**).

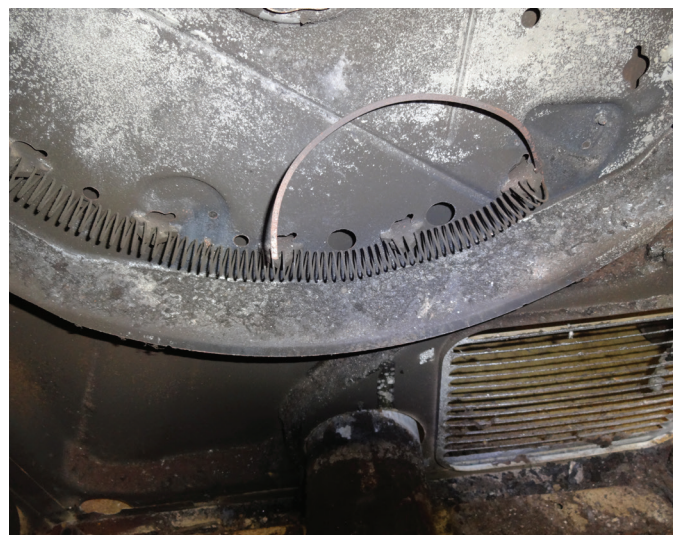
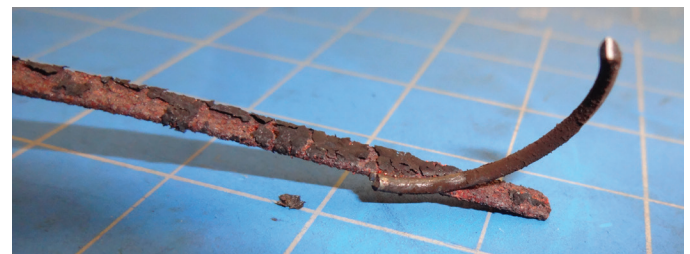
Figure 36
Bra underwire welded to heating element.

Figure 37
Bra underwire welded to heating element.

directly behind the drum. The underwire was welded to the element, and a large portion of the element was damaged (**Figures 36 and 37**). The resulting arcing event and dispersal of molten metal into the dryer ignited lint within the dryer. Most of the combustible plastic components burned. The dryer exhaust vent complied with the installation instructions.

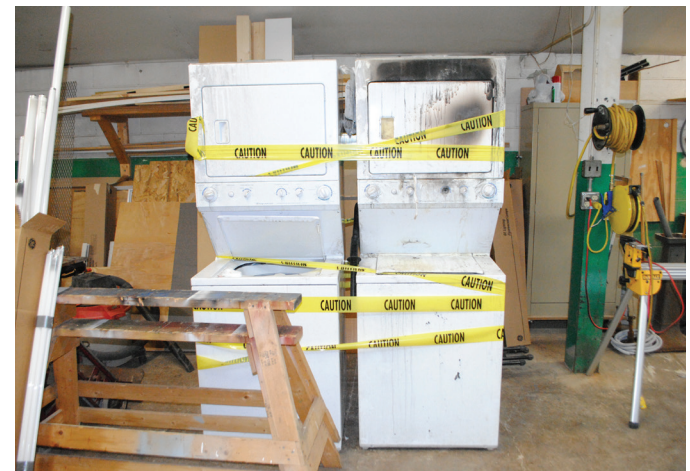
Figure 38
Two identical model laundry centers.

Figure 39
Fire-damaged dryer.

Figure 40
Undamaged dryer and load.

Two identical laundry centers (washer/dryer combination machines) were in use in a high school home economics department (**Figure 38**). Both machines were less than one-year-old at the time of the fire. The laundry centers were used to wash and dry kitchen towels from cooking classes. This activity likely contaminated the towels with vegetable oils. Multiple brands and varieties of vegetable oils were found in the kitchen areas. On the day of the fire, both dryers were started with loads of kitchen towels after the last class of the day. A fire was discovered in one of the dryers several hours later, when the fire sprinkler system activated. Fire damage was limited to the one dryer. The other dryer was not fire damaged (**Figures 39 and 40**). Both dryers were examined in detail. In the fire damaged dryer, the damage was mostly limited to the drum. Minimal lint

was found in both dryers. No testable remnants of the load remained in the fire damaged dryer. However, the towels in both dryers had been used in the same manner with the same kitchen products. A sample of the towels of the unburned dryer was sent out for chemical analysis. The presence of unsaturated vegetable-type oils was detected in the sample. It was concluded that the fire was likely caused by self-heating of the vegetable oil-contaminated towels.

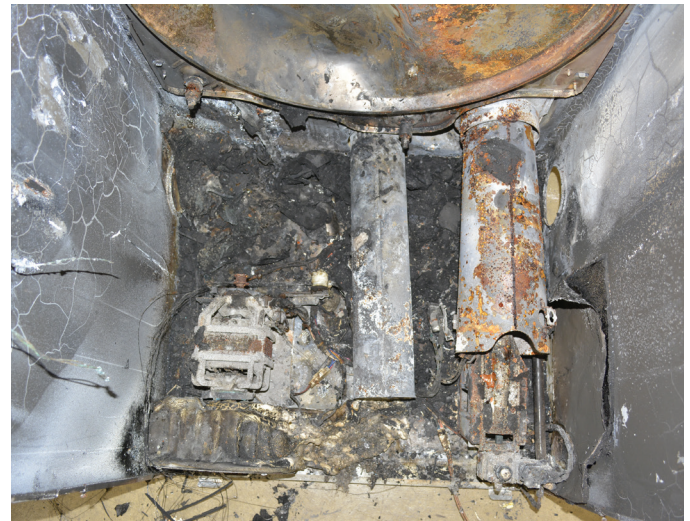
Figure 41
Front of dryer.

Figure 42
Dryer base.

A user discovered a fire in an operating gas clothes dryer (**Figure 41**). When the fire was discovered, the load was not burning. A detailed lab exam of the dryer found a large amount of charred clothing items in the base of the dryer (**Figure 42**). A large section of the dryer drum at the
