Vol. 35 No. 2 December 2018

# Forensic Engineering Analysis of an Explosion Allegedly Caused by an Overfilled Propane Cylinder

By Jerry R. Tindal, PE (NAFE 642S)

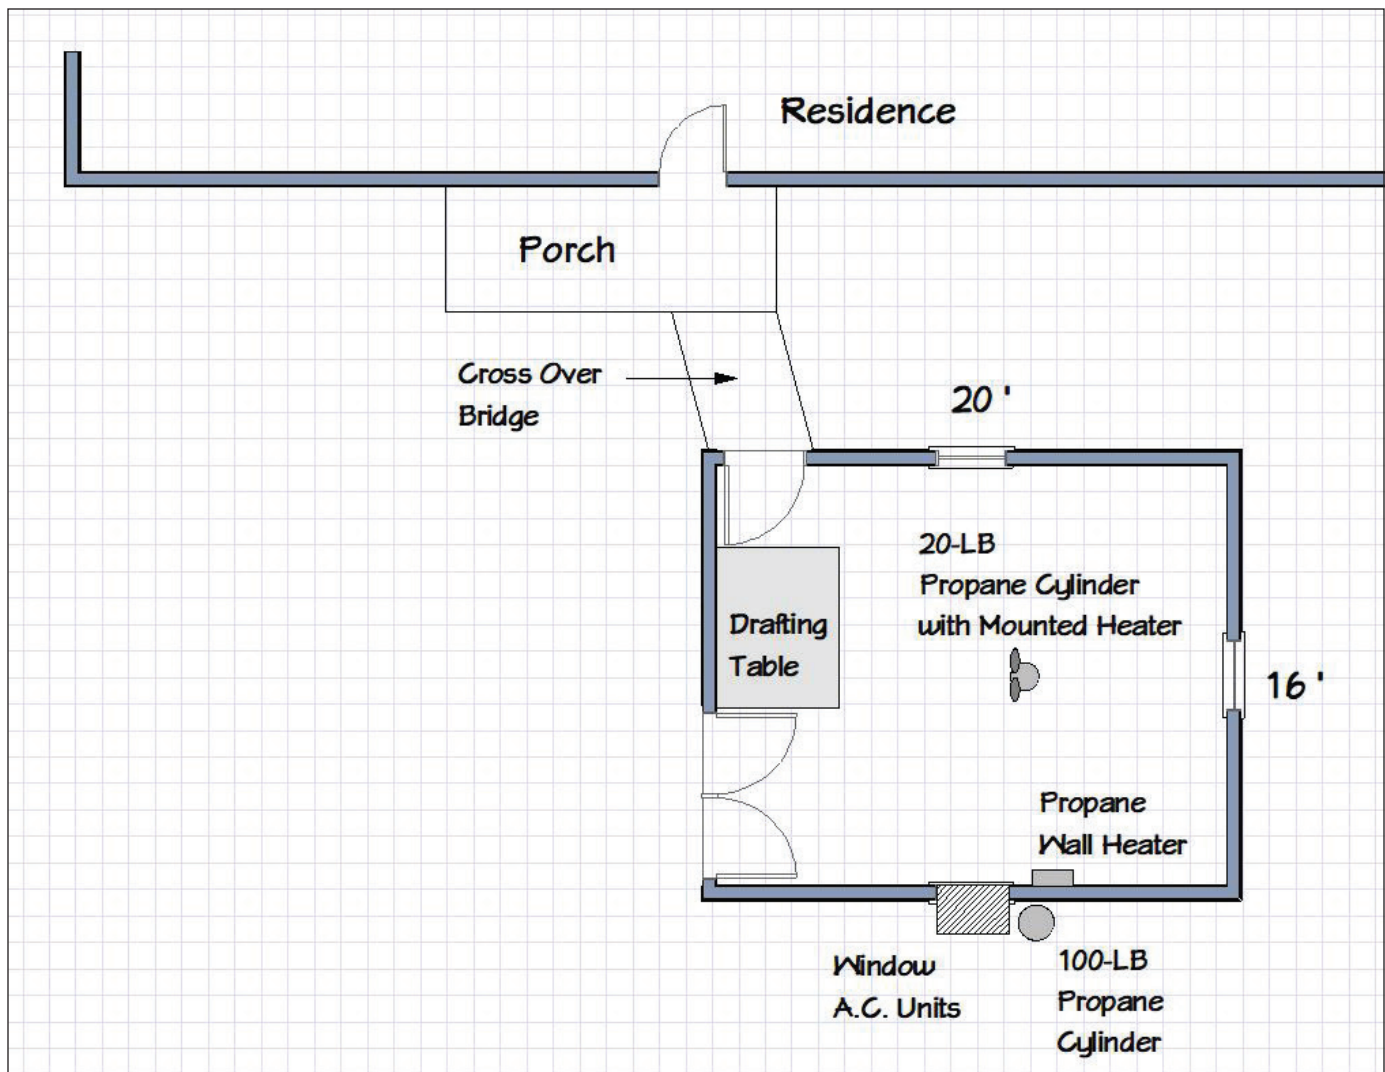
Figure 1

**Figure 1** depicts a general plan view layout of the detached office building, which was derived from the remains of the foundation, flooring, fragments remaining at the scene, and a verbal description provided by the owner.

Office plan view layout with the approximate location of a 20-lb propane cylinder with top-mounted heater.

**Figure 1** depicts the plan view of the office with the location of a 20-lb propane cylinder with top-mounted heater as observed by both the assistant fire chief and the first-in firefighter. **Figure 3** is annotated to indicate the general location of where the 20-lb cylinder with top-mounted heater was located. **Figure 6** depicts an "exemplar" 20-lb propane cylinder with top-mounted heater of a similar configuration

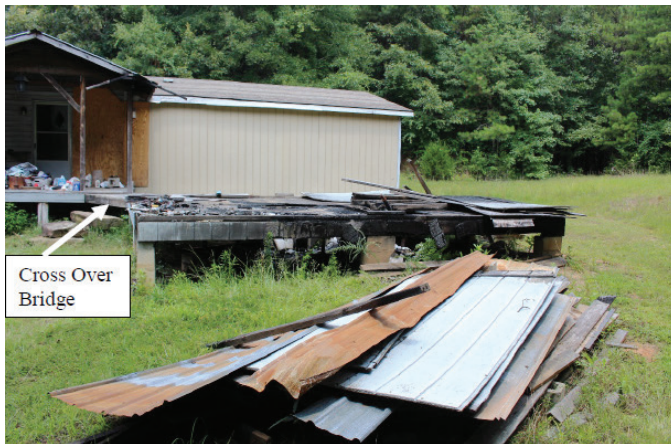
**Figure 2**  
View from the south side of the office adjacent to the residence looking north.

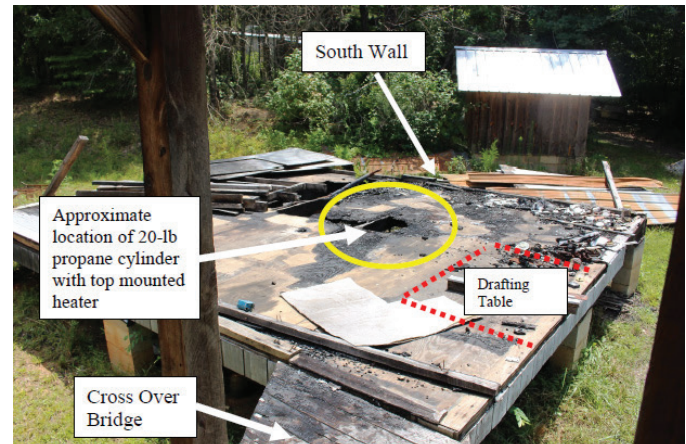
**Figure 3**  
View from the northwest corner of the office looking from the residence porch, southeast over the elevated cross-over bridge.

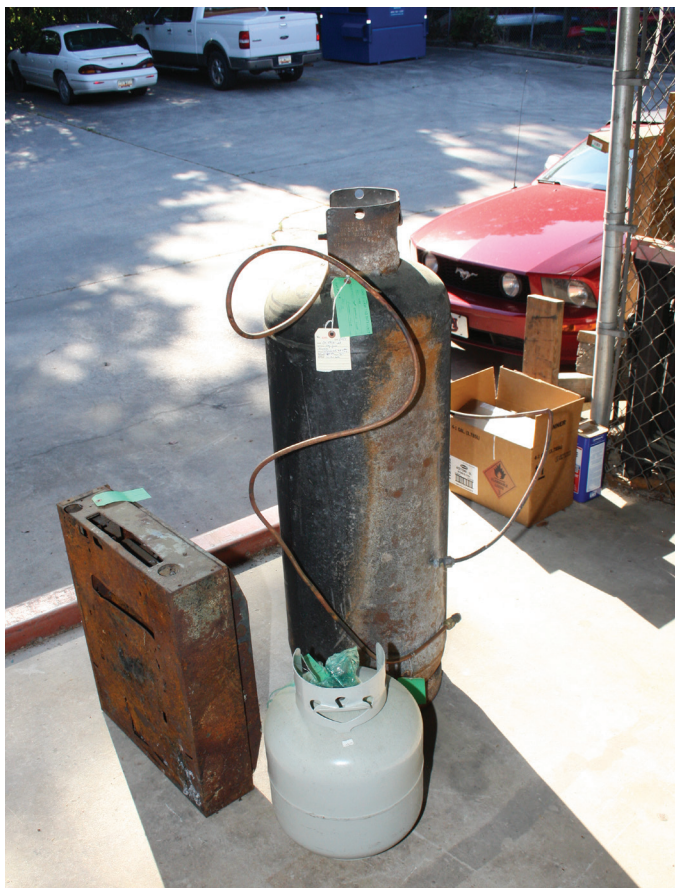
**Figure 4**  
View of the artifacts collected by the owner.

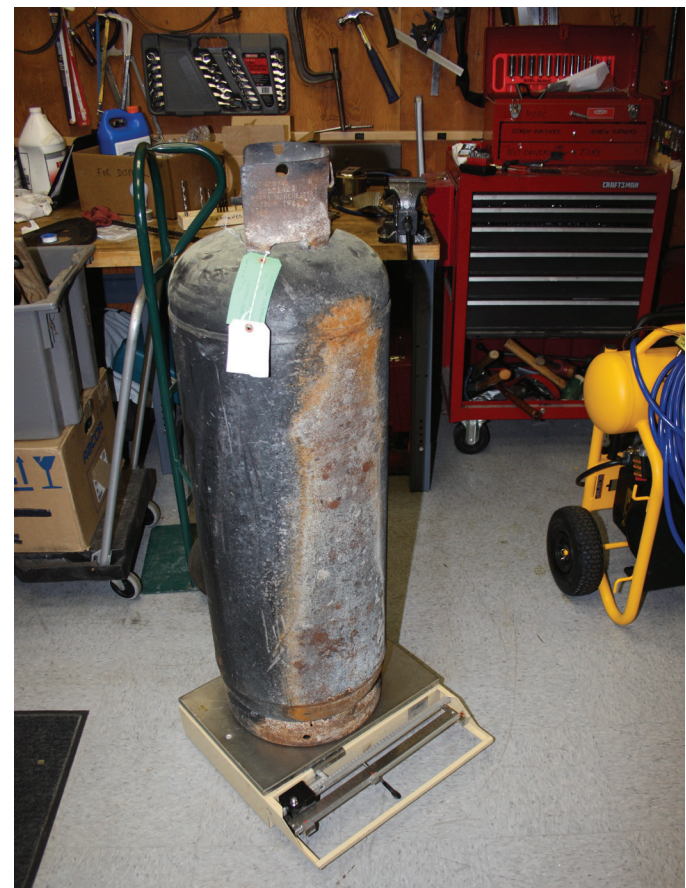
**Figure 5**  
View of the 100-lb propane cylinder collected by the owner.

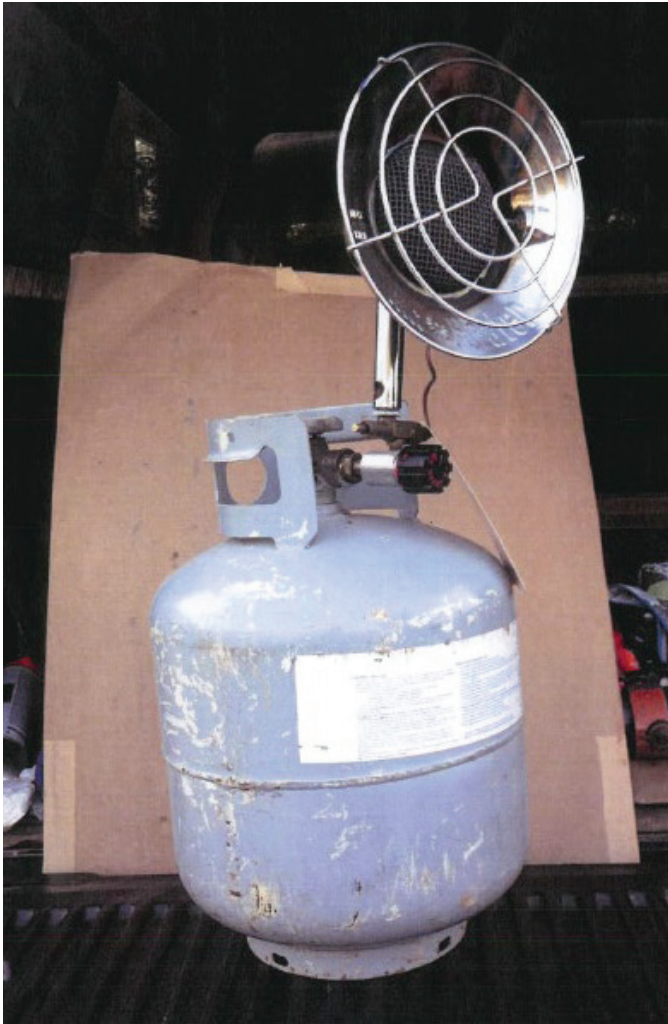
**Figure 6**

“Exemplar” 20-lb propane cylinder with top-mounted heater of the general type observed by the assistant fire chief and first-in firefighter.

as observed by the assistant fire chief and first-in firefighter. Since neither the cylinder nor the top mounted heater were recovered, the manufacturers are unknown — yet the configuration and style were similar, according to the witnesses.

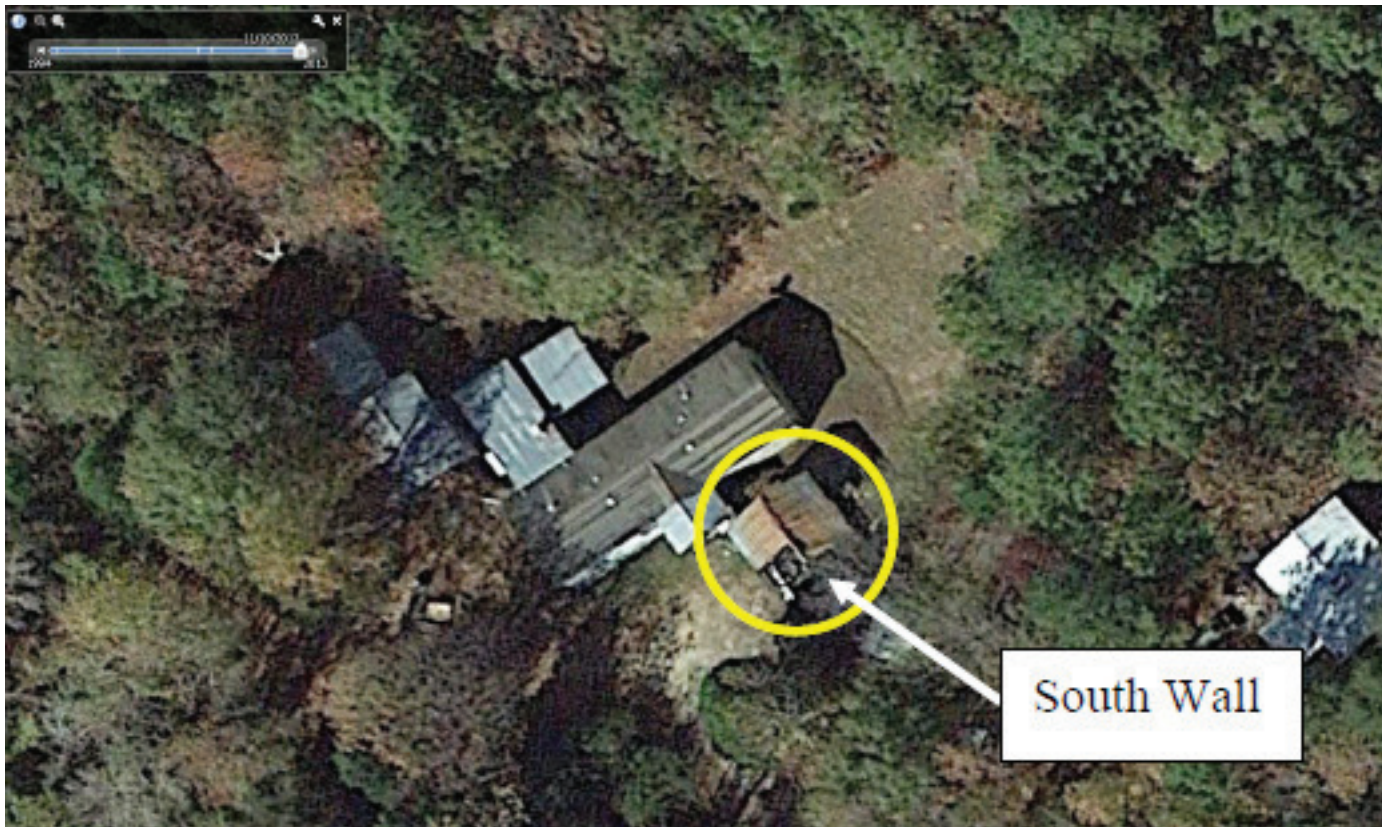
Google Earth image of incident site approximately eight months after the event.

The Google Earth image depicted in previously referenced **Figure 7** indicates that the south wall, including the 100-lb propane cylinder, is well shaded in the afternoon due to the nearby stand of trees. The propane tank at the refilling store where the cylinder was allegedly filled was not significantly shaded, but substantially exposed to direct sunlight most of the day. **Figure 10** depicts the refilling station. The cylinder was allegedly filled near the end of the day.

However, based on reported information, the 100-lb cylinder was located somewhere near the window units, which would likely provide some degree of shading effect for a period of time on the cylinder surface and reduce any potential overall solar heating effects. In addition to the air-conditioning units, the wall and roof overhang of the building also provide a shading effect from the sun for periods of time. Furthermore, there are considerable trees surrounding the area, which would also impact and substantially reduce any potential solar heating effects for periods of time (see **Figure 7**, depicting the trees and the corresponding shading of the building's south exterior wall where the cylinder was located).

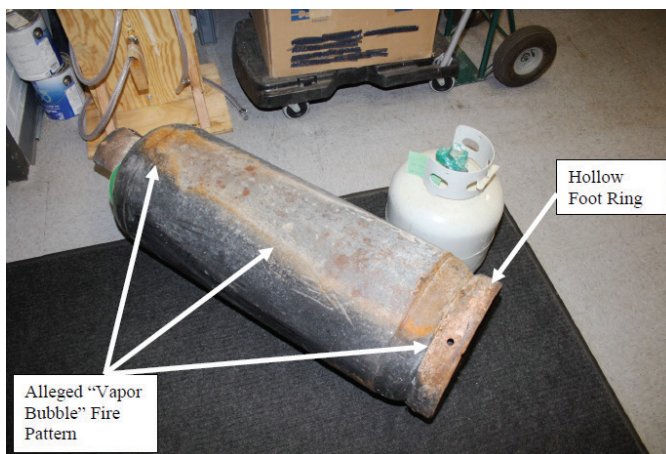
**Figure 9**

A view of the 100-lb propane cylinder and the alleged “vapor bubble” fire pattern. Note that the alleged fire pattern extends beyond the cylinder wall in contact with propane across and to the end of the hollow foot ring. Allegedly, the cylinder was lying on its side with the foot higher than the top, still connected to the regulator and line, 96% full, and the liquid/vapor bubble interface created the depicted pattern during radiant heat exposure from the burning building.

The plaintiff's expert determined the cause of the fire based on his interpretation of a single, isolated, alleged "vapor bubble" fire pattern on the surface of the 100-lb propane cylinder. The "vapor bubble" fire pattern is depicted in **Figure 9**. He opined that the fire pattern conclusively indicated the cylinder was overfilled. According to the plaintiff's expert, the propane cylinder at some point during the event was knocked over by one of the cylinder

There was no reliable scientific basis for opining that the isolated alleged fire pattern on the 100-lb cylinder was conclusively caused by differential heat processes primarily involving the liquids and vapors inside the cylinder and heat exposure. Aside from the absence of the history of the cylinder post-incident as previously described — and the unknown nature of other fuel packages, locations, quantities, positions, and the fire patterns associated with them — the observations in the following paragraphs are also relevant.

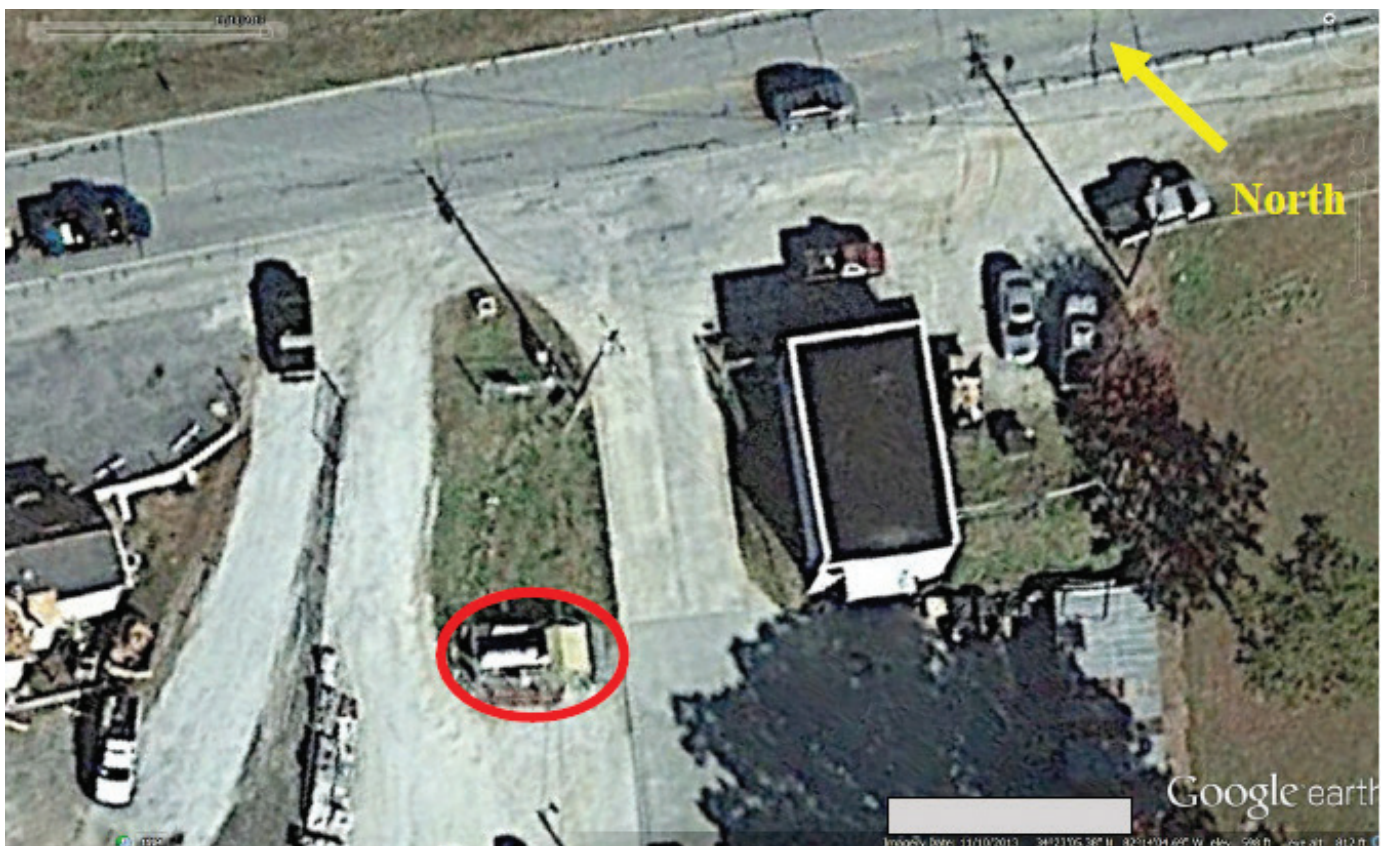
**Figure 10**  
Refilling station and supply tank. The refilling tank and pump station is circled in red.  
The pump station had a rain canopy. The vast majority of the tank is exposed.

In addition to ignoring any solar heating on the filling supply tank at the refill station, the plaintiff's expert assumed that the temperature of the liquid propane in the 100-lb cylinder was essentially the instantaneous outdoor temperature plus 18°F for solar radiation heating at any given time. For example, as the outdoor thermometer ticked to 71°F, the propane inside the cylinder at that instant was 71°F + 18°F = 89°F. He reasoned that this was true because of the high thermal conductivity of the steel cylinder, which would, in his view, more or less instantly heat the liquid propane inside to the same temperature.
