Journal of the  
**National**  
**Academy** OF  
**Forensic**  
**Engineers**<sup>®</sup>

# Forensic Engineering Evaluation of an Automated Warehouse Accident

By Michael D. Leshner, P.E. (NAFE 559F)

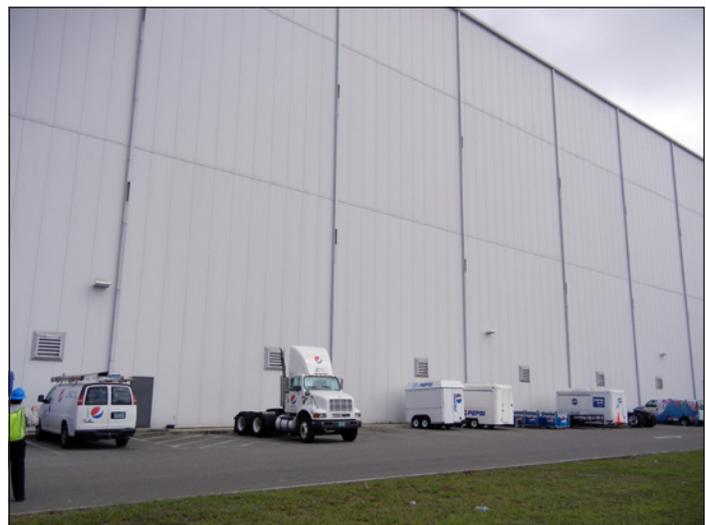
**Figure 1**  
Warehouse exterior.

The warehouse (**Figure 1**) is built around an automated storage and retrieval system (ASRS) designed and installed by the automation developer. The warehouse automatically stores and retrieves pallets loaded with cases of soft drinks, and can hold up to 250,000 pallets. The ASRS and building exterior are illustrated in **Figure 2**.

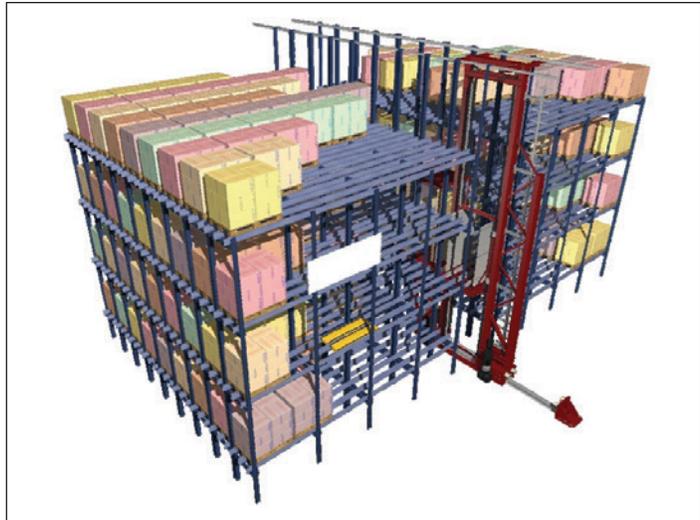
**Figure 2**

The apparatus within the ASRS consists of two storage and retrieval machines (SRMs). These operate and perform combined functions of a forklift and crane. The system also

includes a central rail system on which the SRMs move back and forth. The center aisle of the ASRS has two SRM cranes, each extending 13 levels high. The cranes automatically deliver and retrieve two loaded pallets at a time, using rolling platforms called “satellites” that travel down long aisles called lanes. The lanes each have a pair of horizontal rack rails to guide the satellites and support the loaded pallets. The lanes, satellites, pallets, and SRMs are all within a central protected zone where automated equipment may start or stop without warning.

Automated storage and retrieval system (ASRS).

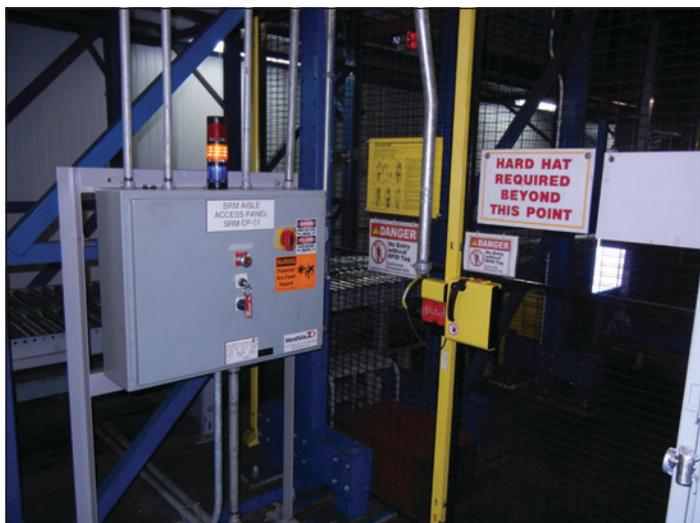
**Figure 3**

The warehouse is equipped with multiple safety systems designed to prevent entry into the ASRS during operation. A system of interlocked entry doors and dedicated keys assures that the automation equipment within the ASRS must be shut down before the entry doors into the central protected zone can be opened. The key switch controlling ASRS operation must be switched off and the key withdrawn before the same key can be used to unlock the ASRS entry door (see **Figure 3**).

The ASRS must be switched off before the entry door can be unlocked.

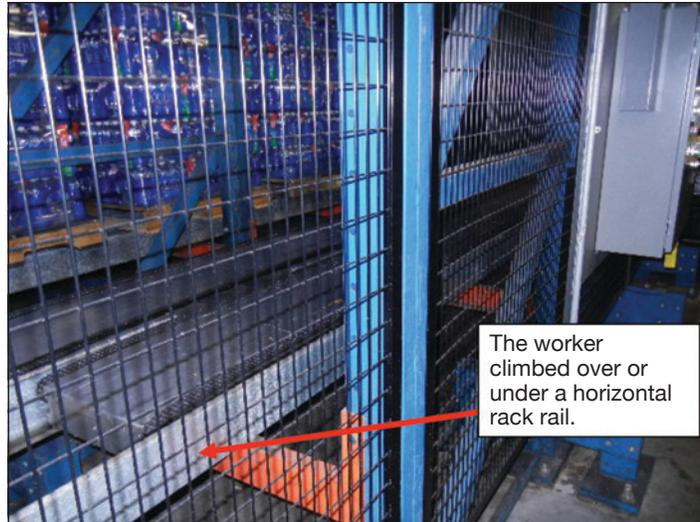
**Figure 6**

The worker bypassed controlled ASRS access doors by climbing over or under a horizontal rack rail from a maintenance lane to the adjacent ASRS lane while the equipment was operating (see **Figure 6**). He bypassed the electromechanical interlocks on the ASRS entry doors by entering through the rack system. He also propped open an emergency exit door from the maintenance area so that he could bring a shop vacuum from outside the building through that door to clean the floor under the rack system. Entering the ASRS by climbing through

1. Without the mesh barriers shown in **Figure 6**, the only barrier between the maintenance aisle and adjacent ASRS lane was the waist-high horizontal rail used to support loaded pallets and guide the satellite. This horizontal rack rail was an inadequate barrier and was not marked with any warning.
2. In addition, it was suggested that the automation equipment should have been equipped with additional safety sensors to detect the presence of a worker during automated operation.

The black mesh barriers were added after the accident.

Regarding adequacy of the physical barrier between maintenance aisle and automation zones, there was a difference of opinion. More robust steel grate barriers were installed after the incident, shown in **Figure 6**.

This author was of the opinion that the horizontal rack rails used to support pallets provided an adequate barrier. The rails were waist-high, requiring a person to intentionally climb over or under the rails to enter the automation area. Following the installation of the steel mesh barriers, it is still possible for a person to climb over or slip under the barriers. It was argued that such egress is needed to comply with fire safety considerations. However, a more appropriate solution would be floor-to-ceiling barriers with interlocked emergency exit doors between the central and peripheral-controlled areas.
