Vol. 43 No. 1 June 2026

# Beyond the Building Code — Compliance and Forensic Failure Analysis of Retaining Walls

By Brian C. Eubanks, PE, DFE (NAFE #962S), Noel Janacek, PE, DFE (NAFE #1375M),  
Garrett Ryan, PE, DFE (NAFE #1125M), and Joseph Roberts, PE, DFE (NAFE #1354A)

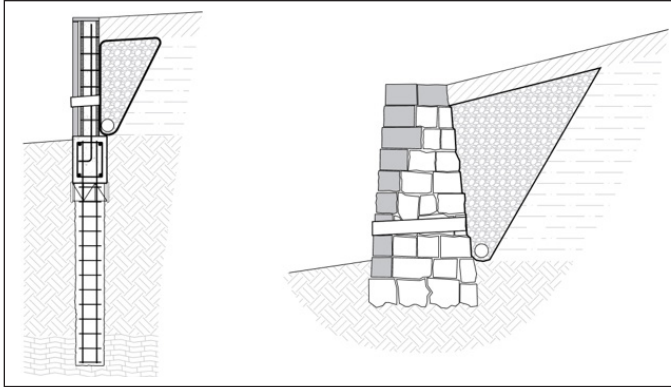
**Figure 1**

Exemplary cantilevered retaining wall (concrete masonry unit, CMU, stem on cast-in-place concrete beam on cast-in-place concrete piers, left) and gravity retaining wall (mortared stone, right).

structure to be capable of transmitting the external loads to the foundation soils for resistance. Examples of a cantilevered retaining wall system and a gravity retaining wall system are provided in **Figure 1**.

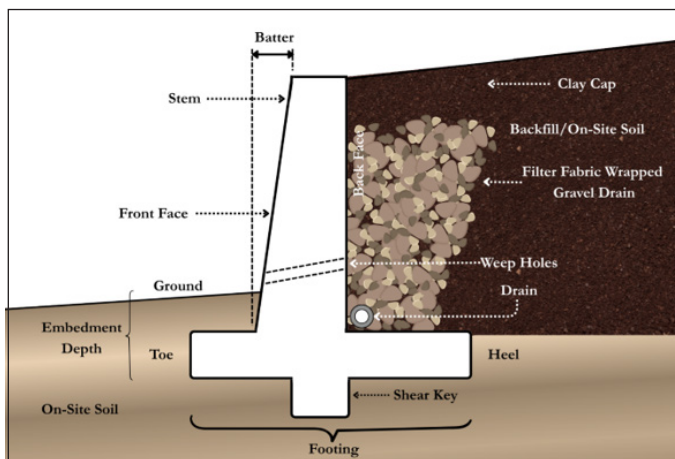
**Figure 2**

Basic retaining wall terminology for a typical battered cast-in-place cantilevered concrete gravity retaining wall.

Basic retaining wall terminology for a cantilevered cast-in-place concrete gravity retaining wall is graphically illustrated in **Figure 2**. This type of wall is often referred to throughout the industry as a cantilevered retaining wall due to the fact that it incorporates a cast-in-place concrete

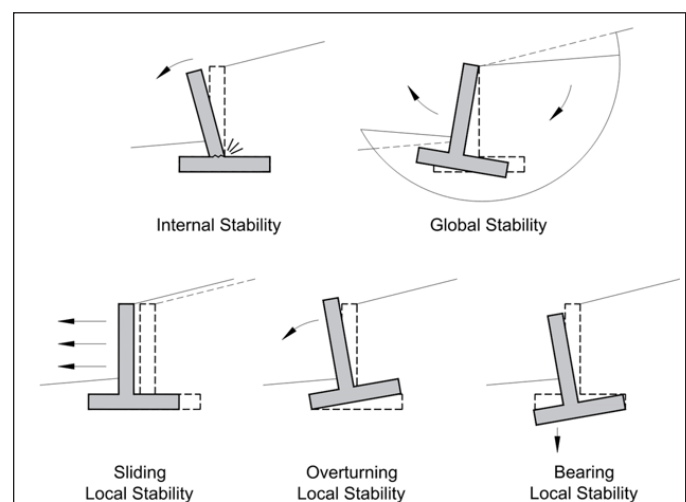
**Figure 4**  
Different types of stability of a typical retaining wall.

retaining wall system, including the retained soil mass, soil slopes, and surrounding site conditions. A global stability analysis evaluates potential slip planes that extend behind and/or below the retaining wall that may undermine the stability of the site. Refer to **Figure 4** for illustrations of different types of stability for a typical retaining wall.

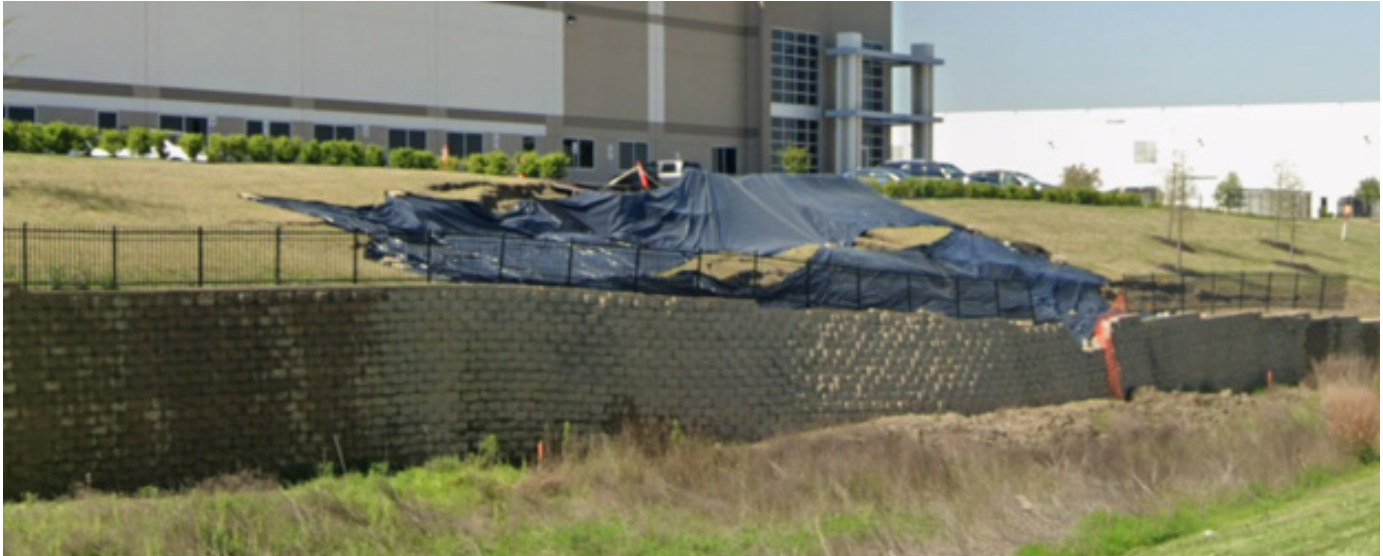
**Figure 5**

At the time of the initial site visit following the wall failure, scarps were observed behind the subject retaining wall (high side of wall), and portions of the subject retaining wall were observed to exhibit rotation, with the top of the wall leaning inward toward the backfill. In addition, weep mechanisms through the retaining wall were observed to be exposed by temporary excavations where they were previously blocked/occluded by soil prior to/during the failure of the retaining wall. The retaining wall exhibited the presence of bulging, with cracks in some of the blocks, and it also exhibited signs of sliding outward at the base.

Google Street View image of MSE retaining wall post-failure from April 2019 [8].

the subject retaining wall included a complete rebuild of the portions of the wall that failed and the addition of tie-backs to the non-failed portions of the wall.

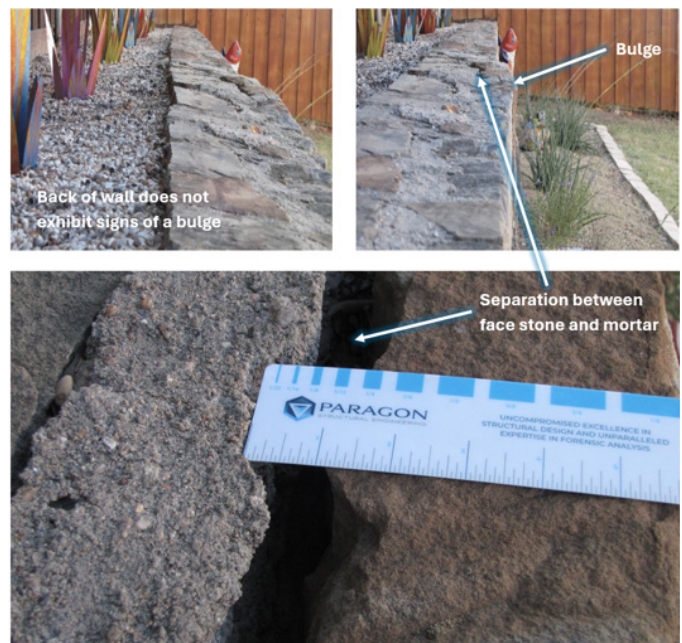
Figure 6

exhibited signs of bulging that appeared to be related to delaminated face stone, as shown in **Figure 6**. The aforementioned condition is considered to be cosmetic in nature; however, it can also pose a safety hazard due to the fact that a stone can fall off the face of the retaining wall. As a result, it was recommended that such conditions be remediated by the removal and reinstallation of the face stone at such locations.

Photographs of mortared-stone retaining wall with bulge related to delaminated face stone.

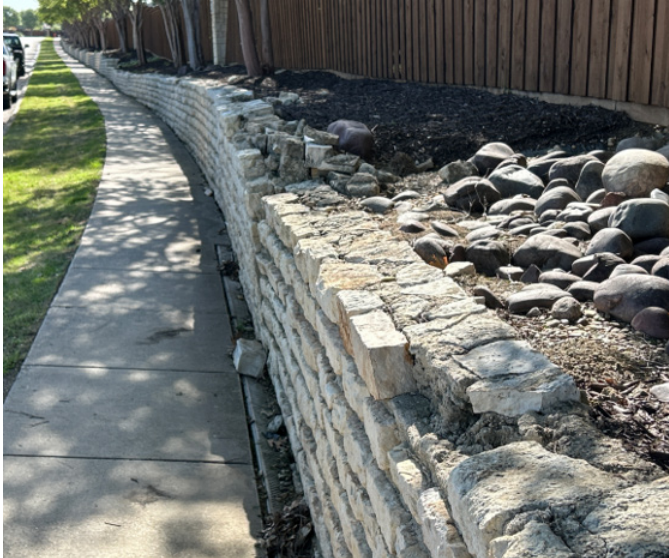
**Figure 7**

Some engineering judgment may be required to determine acceptable limits/thresholds at which mortared-stone retaining walls should be remediated versus monitoring. There was only one wall that exhibited a lean/rotation of a degree, such that it exhibited a reverse batter with the top of the wall away from the soil that it was retaining (**Figure 7**). The aforementioned retaining wall varied in

View of mortared-stone retaining wall that exhibited a reverse batter (lean/rotation with the top away from the retained soil).

Due to the fact that mortared-stone retaining walls utilize their mass and geometry to resist applied forces, additional mortared stone can typically be added to an existing mortared-stone retaining wall to increase the mass and/or change the geometry as necessary to achieve an acceptable design. Based upon an analysis of the subject retaining wall, additional mortared stone would be necessary to increase the mass of the wall. In addition, it was necessary to replace the existing clay soil backfill with free-draining gravel backfill in order to reduce the lateral pressure on the wall and achieve an acceptable design. In order to implement the aforementioned remediation, the soil (and trees) behind the existing retaining wall would need to be excavated such that additional mortared stone could be added to increase the cross-sectional geometry, and the excavated backfill would need to be replaced with a wedge of gravel behind the retaining wall.
