Vol. 38 No. 1 June 2021

The Applications of Matchmoving for Forensic Video Analysis of a Fatal Sprint Car Accident: Part II

By Richard M. Ziernicki, PhD, PE (NAFE 308F), Martin E. Gordon, PE (NAFE 699F), Steve Knapp, PE (NAFE 819S), and Angelos G. Leiloglou, M. Arch. (NAFE 956C)

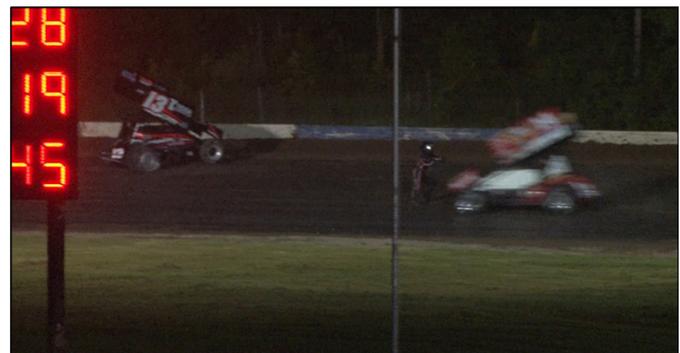
Figure 1

Still frame from track video moments before the fatal impact.

The second in a two-part series, this paper presents the application of matchmoving to a 13.8-second video clip of a racetrack video (**Figure 1**) to reconstruct the accident and determine the path, heading, speed, and acceleration of seven race cars and the movement of the pedestrian who was struck and killed.

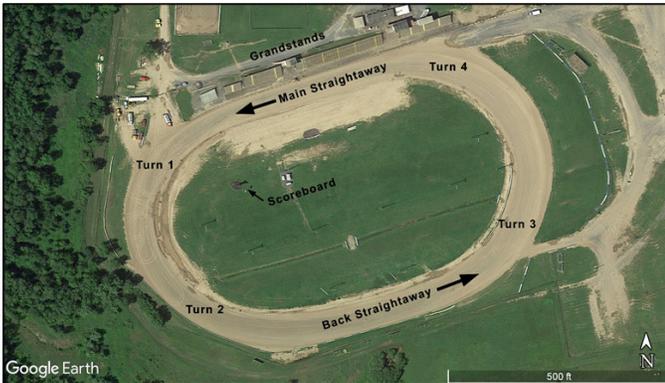
Figure 2

Google aerial imagery of the motorsports park with annotations added by authors.

low-banked dirt oval track with the straights running southwest and northeast and the grandstands positioned on the north side of the track. The track corners were divided into quadrants (1 to 4) with the cars racing counter-clockwise. Turn 1 was the first turn after passing the grandstands on the main straightaway as shown in **Figure 2**.

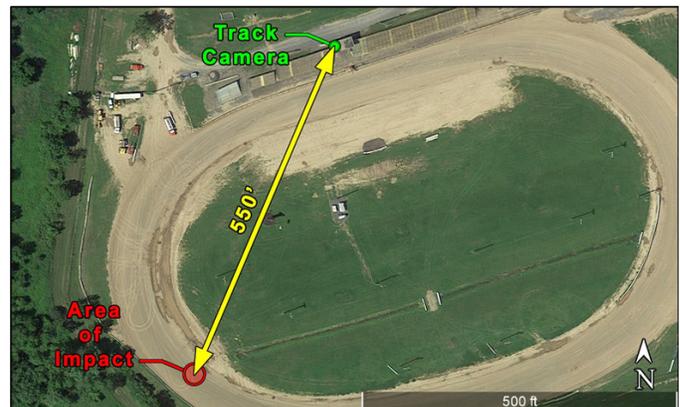
Figure 4

Aerial view of racetrack, depicting the distance between the track camera and the area of impact.

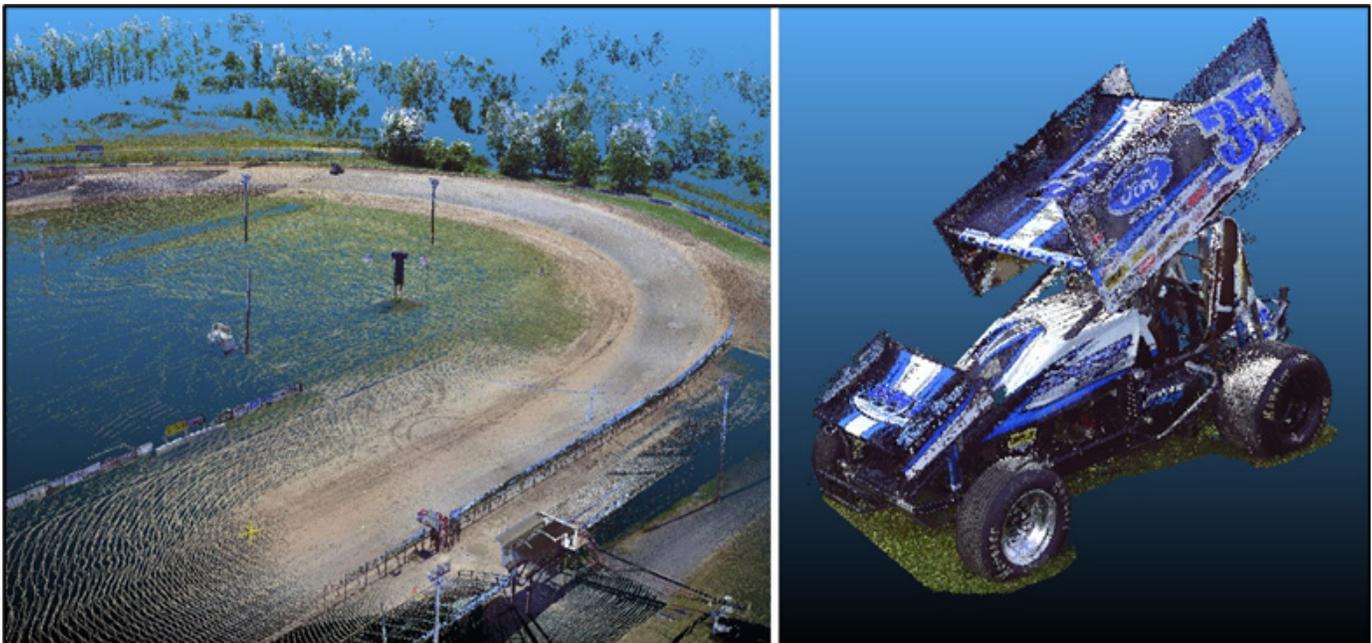
Figure 5

Point cloud model of the racetrack (left) and the exemplar Sprint Car vehicle model (right.)

The point clouds were captured using a Faro Focus 3D X330 Laser Scanner and consisted of approximately 860 million data points for the racetrack and approximately 390 million data points for the exemplar Sprint Car (**Figure 5**). Each data point in the point clouds is defined by its three-dimensional coordinates (x, y, z) and is accurate to within a few millimeters. The point cloud models of the racetrack and the exemplar Sprint Car were used by the authors to perform videogrammetry analysis on the provided racetrack video footage.

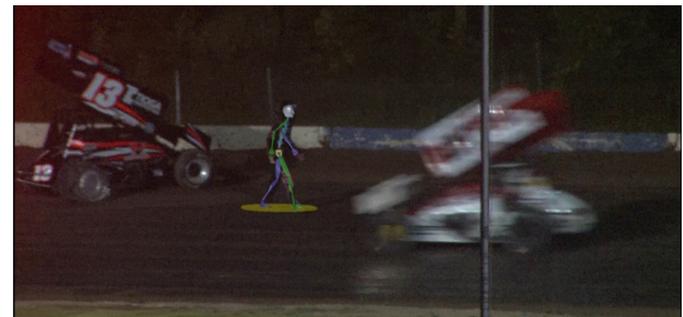
Figure 17

Virtual surrogate bi-ped model used to match the motion of the driver of SC#13.

The position of SC#13 at rest position was also matched to the video. Additionally, the authors matched the SC#13 driver's walking motion by using a virtual biped surrogate model to match (track) the driver's body parts (legs, arms, head, etc.) relative to the racetrack

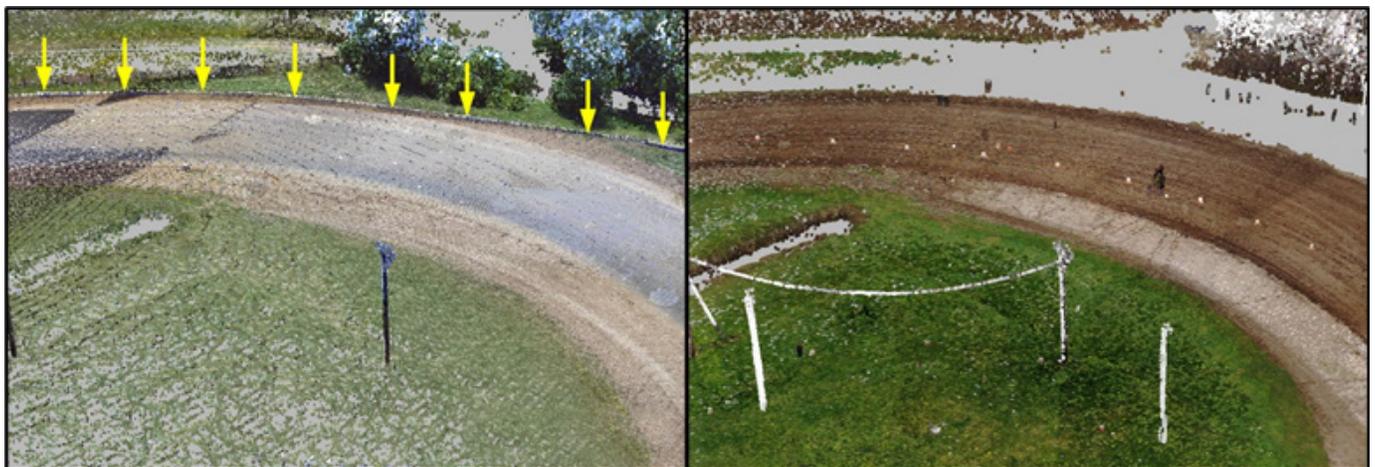
Figure 23
Left: Point cloud of the portion of the track where incident occurred (barrier wall highlighted in yellow);
Right: Barrier wall had been removed/moved when the opposing expert scanned the racetrack.

For example, in the previously discussed motorsports park fatal incident, the concrete barriers that were around the outer perimeter of the track at the time of the incident are vital 3D features that were tracked in order to calibrate the virtual track video camera. Those barriers had not been moved between the incident and the time the authors scanned the racetrack. However, when the opposing expert scanned the racetrack, the barriers around the area of the incident had already been removed (**Figure 23**).
