Vol. 38 No. 2 December 2021

# Forensic Engineering Analysis of a Crash Caused by Swingout of an Articulated Booster on a Semi-Trailer

By Shawn Ray, PE (NAFE 970S), Donald J. Fournier, Jr., PE (NAFE 626S), Reza Vaghar, PhD, PE (NAFE 979S), and Steven Mitchell, PhD, PE

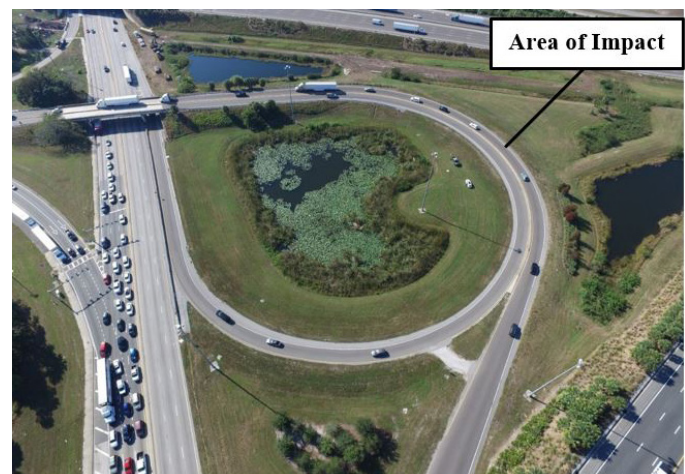
**Figure 1**  
Accident site location and roadway configuration.

an aerial photograph of the accident site. For orientation purposes, north is to the bottom of the figure; the turnpike is the north-south highway on the left of the figure.

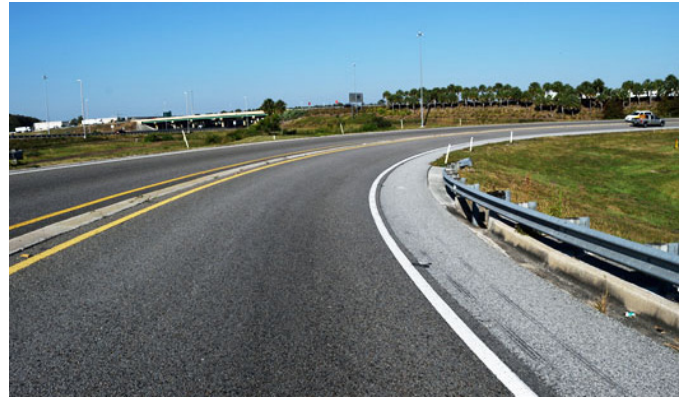
**Figure 2**

Truck driver view approaching the area of the crash event.

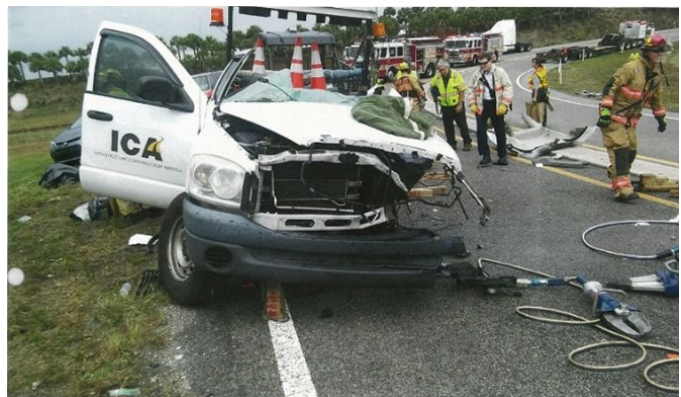
Traffic was described as moderate-to-heavy, and witnesses each reported traveling at or slightly below the advisory speed of 35 mph. **Figure 3** shows the post-impact locations and condition of the pickup.

Collision scene photo taken by investigating officer.

The pickup was in the outside lane on an uphill grade. The truck was heading downhill in the inside lane.

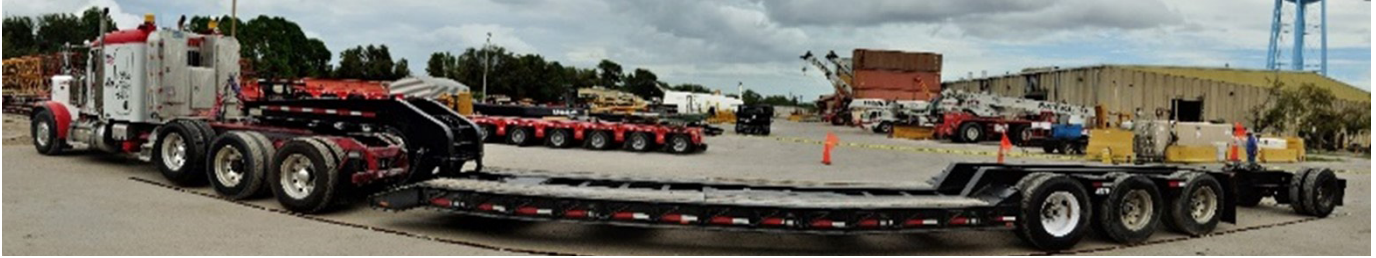
The first vehicle was a 2007 Class 8 conventional cab 6x4 tractor chassis. The engine's event data recorder was set with the "Quick Stop" record "off" consistent with the factory default position and did not record sudden deceleration data. The tractor was pulling a lowboy trailer with a booster axle. **Figure 4** shows photographs of the combination. **Figure 5** and **Figure 6** show the articulated booster axle. The large and heavy loads transported by this tractor-trailer combination often require an articulated rear booster axle. The booster axle is attached to the trailer with

**Figure 4**  
Truck-tractor and semi-trailer with booster axle.

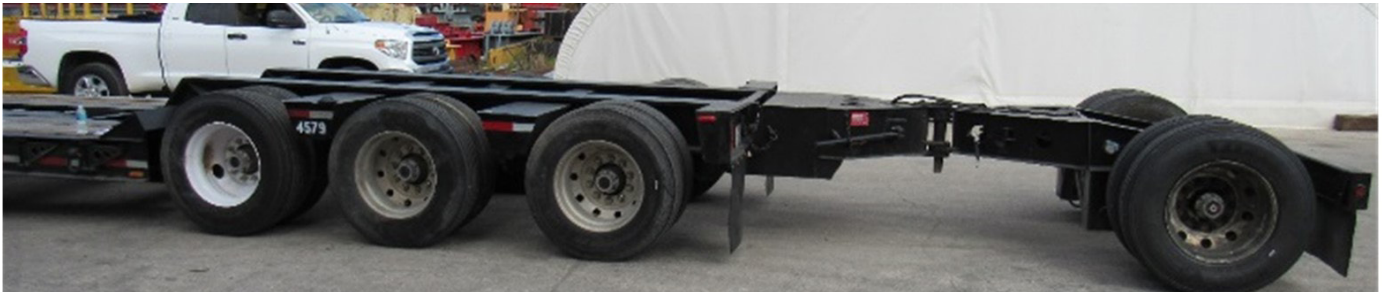
**Figure 5**  
Trailer with booster axle.

a pin and can articulate as necessary to navigate turns.

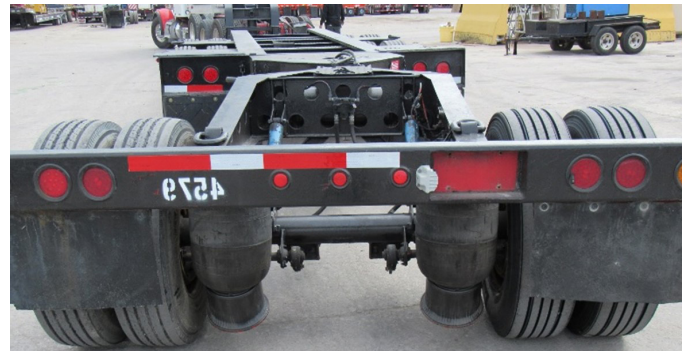
**Figure 6**  
Trailer with booster axle.

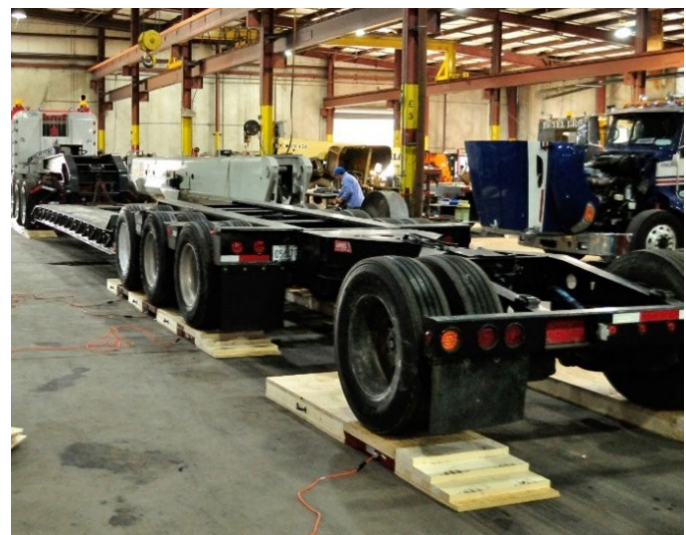
In order to quantify the wheel loading and weight transfer from axle to axle for the truck, trailer, and booster axle, the weights of each wheel load were measured on level ground and under a series of progressively increasing differential tractor/booster heights.

Scale platforms were placed under each pair of trailer and booster axle wheels on one side. Wheels on the other side and tractor wheels were supported by wood shims such that all the wheels were at the same level. The tractor and the booster wheels were lifted in ½-inch increments from an initial height of 1 inch up to a maximum of 4 inches. At each level, the loads on the trailer and booster wheels were measured with the scales and all data recorded. **Figure 7** shows the setup for the wheel load measurements.

**Figure 7**  
Wheel load measurement.

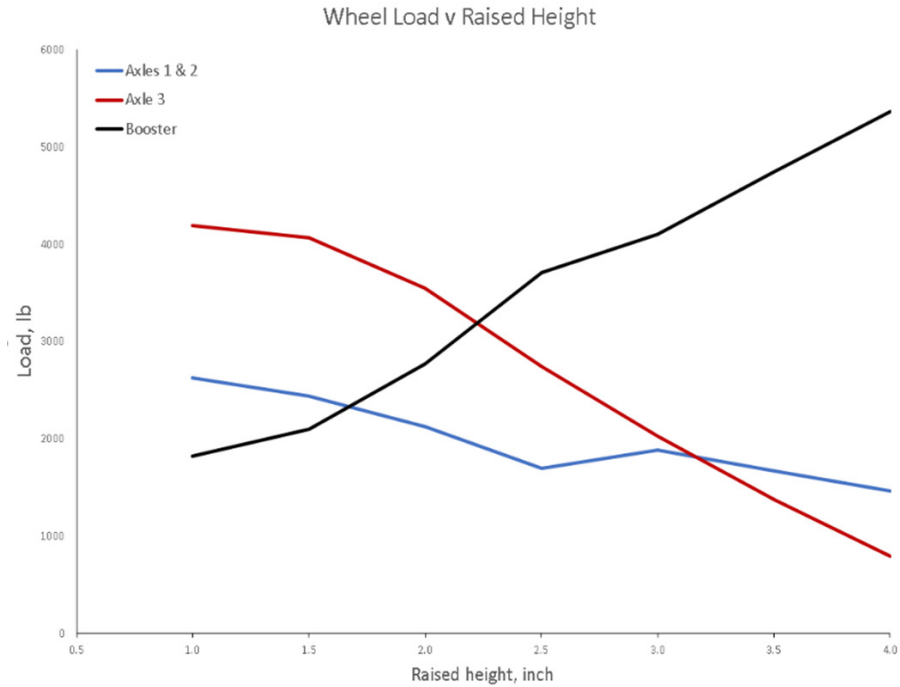
The results showed that as the trailer gap increased, the loads on the trailer axles generally decreased —

and the load on the booster axle increased. **Figure 8** shows the wheel load of the trailer and booster axles as a function of raised height of the tractor-booster axle datum. Data

**Figure 8**  
Wheel load as a function of raised height of tractor-booster axle datum.

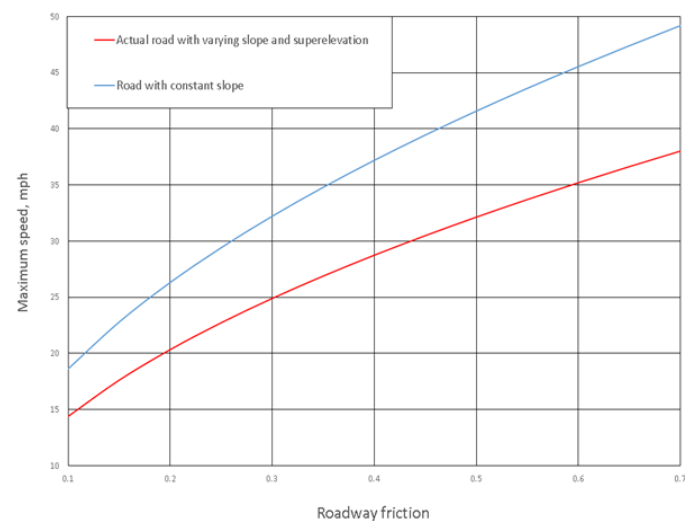
The maximum critical speed for the tractor-trailer at the onset of trailer slide-out as a function of roadway friction is shown in **Figure 15**. Two geometric scenarios are shown: the actual road geometry with varying slope

**Figure 15**  
Maximum speed without trailer slide-out.

and superelevation, and a road with constant slope.

4. At the location where the trailer tires had less friction force available because of the dip and curve in the road, the curvature of the roadway created centrifugal force on the trailer. Typically, centrifugal force is resisted by the lateral traction of the tires. However, in this case, the moment about the kingpin created by the centrifugal force exceeded the lateral traction at the trailer tires at a speed of 27 mph, whereas the advisory speed was 35 mph.

6. At the measured tire friction of 0.35 for the wet road, the geometry of the road surface and the geometry of this particular trailer reduced the safe travel speed for this tractor trailer from 35 to 27 mph.
