Journal of the
National
Academy OF
Forensic
Engineers[®]

Vol. 38 No. 1 June 2021

State of the Arc (Mapping)

By David J. Icove, PhD, PE, DFE (NAFE 899F), Elizabeth C. Buc, PhD, PE, Mark E. Goodson, PE, and Thomas R. May, JD, Esq.

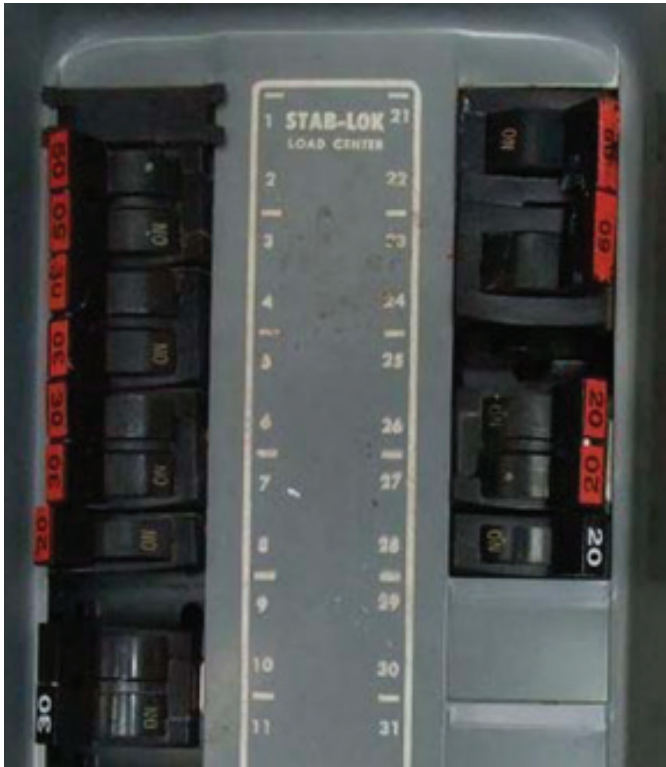
Figure 5
Federal Pacific Electric (FPE) panel.

transition in the copper from the melt to non-melt regions. When a breaker is slow to trip, this can result in multiple arc sites being present or in the wiring having the appearance of the melt. A typical FPE breaker panel is shown in **Figure 5**.
