Vol. 38 No. 1 June 2021

# Forensic Identification and Root Causes of Hot Socket Problems Found in Electrical Meters

By David J. Icove, PhD, PE, DFE (NAFE 899F) and Thomas A. Lawton, BSME

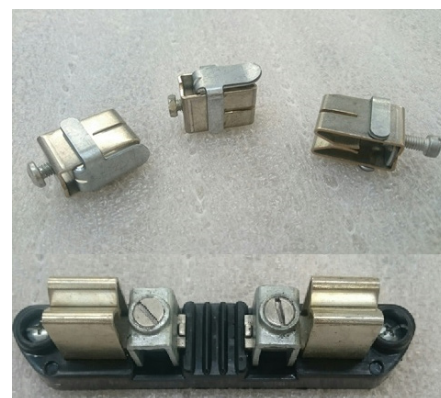
**Figure 1**  
Typical meter socket base, meter socket, and jaws (left to right). Source: TESCO – The Eastern Specialty Company, Bristol, Pa; reprinted with permission.

socket, the blades on the rear of the meter are inserted directly into the gripping jaws of the socket (**Figure 1**). The unit is locked in place by a retaining ring or by the meter socket cover, neither of which can be secured unless the blades are inserted into the jaws completely<sup>8</sup>.
