Vol. 39 No. 2 December 2022

Forensic Engineering Analysis of an Apartment Freezing Sequence Using Heat Flow Equations

By Daniel P. Couture, PEng (NAFE 951S)

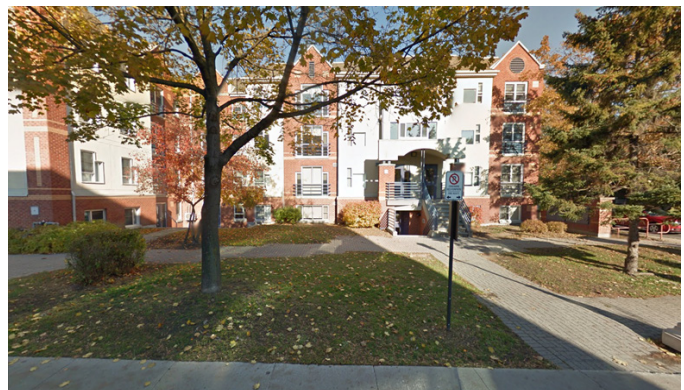
Figure 1

South elevation of University residence apartment block.

A water supply pipe burst in the kitchen of an upper-floor apartment suite of a student residence (**Figure 1**) of a university in southeastern Ontario on or about December 30, 2009, resulting in subsequent significant water damage.

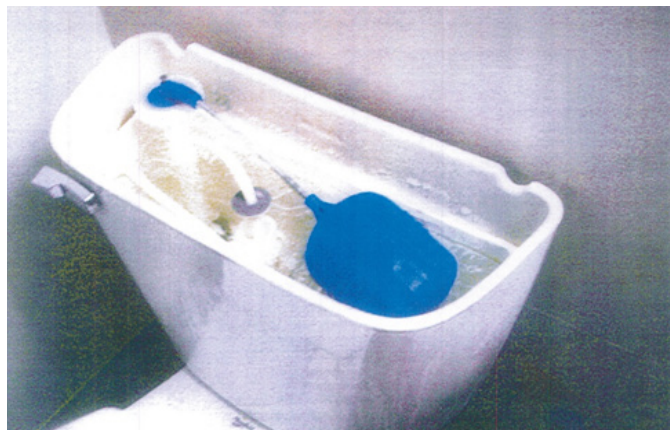
Figure 4

The water in the toilet tank and the bowl of both bathrooms had frozen with one tank shown in **Figure 4**. The float was immobilized in ice and the overflow pipe displaced. The interior wall of this tank was insulated with white closed-cell polystyrene with a smooth skin surface.

One of two toilet tanks with ice formation.
