Journal of the
National
Academy OF
Forensic
Engineers[®]

Vol. 37 No. 1 December 2020

Machine Safeguarding: Theory, Practice, and Case Studies

By Nicholas A. Petrucci, PE, CSP (NAFE 650M)

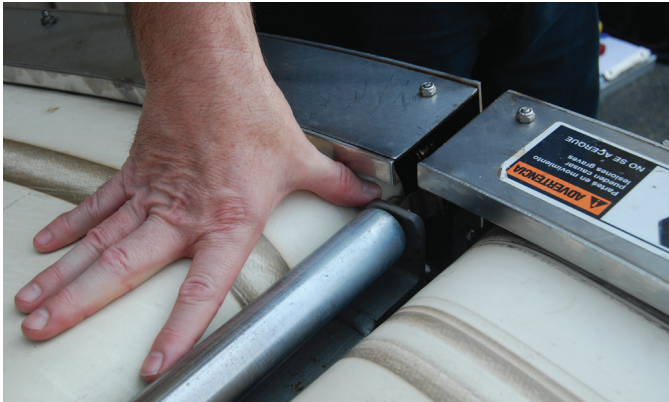
Figure 4

Incident pinch point showing how a worker severed her right thumb. Product moves from right to left.

Bags of frozen cookie nuggets were being transported by a conveyor system. One of the bags ripped open, which resulted in frozen cookie nuggets spilling onto the conveyor. As a worker was gathering the cookie nuggets by hand near the interface of two 90° conveyor sections (Figure 3), she unknowingly placed her right thumb into a gap between the moving conveyor belt and the conveyor frame (Figure 4). This resulted in her thumb being severed from her hand.

The conveyor manufacturer claimed that it sold the unit with “filler plates” that covered the gaps between the conveyor belt and the frame, thereby guarding the incident pinch point. Why these guards were not in place at the time of the incident is unknown. Having an interlock fitted to the four guards at each conveyor interface may have been impractical. However, a conspicuous “Danger — Install Guard Before Operating Conveyor” label that would be exposed when a guard was removed would not have been unduly burdensome.

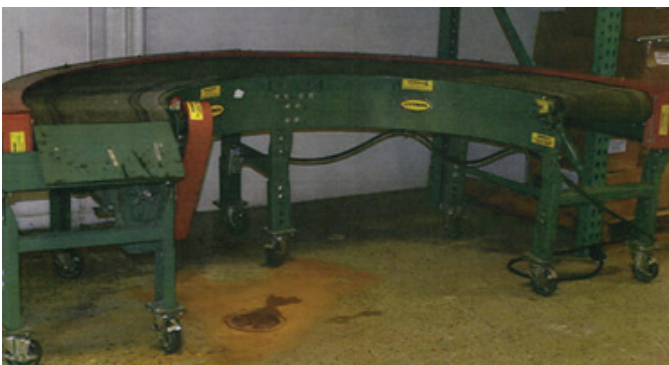
Figure 5

180° conveyor section.

There are inherent dangers at the interface of two conveyor sections. The incident pinch point would have been eliminated by using a single 180° conveyor section instead of two abutting 90° sections (compare Figures 3 and 5). However, similar hazards would still have existed at the interfaces between other abutting conveyor sections.

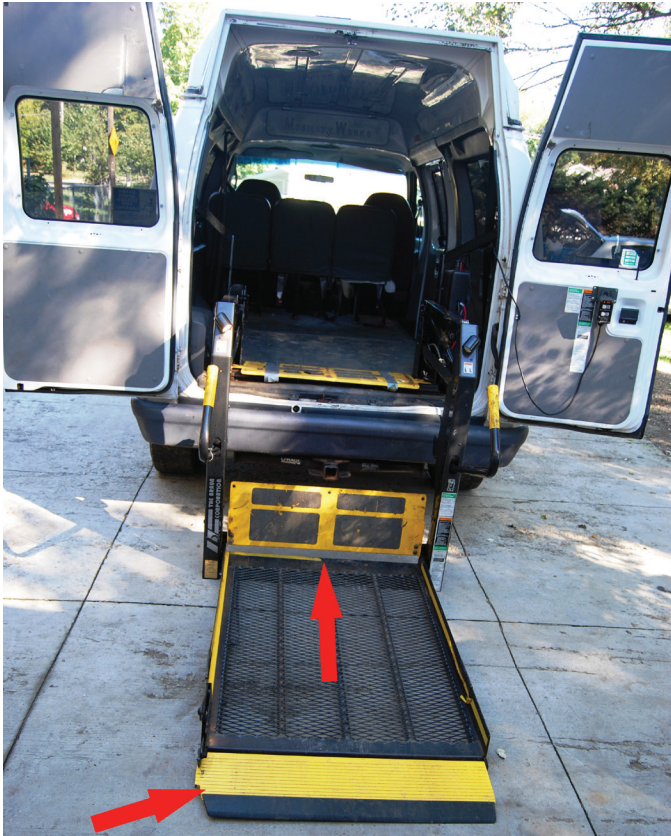
Figure 7

Wheelchair lift in the lowered position. Upper arrow shows the inboard roll stop in the vertical position. Lower arrow shows the outboard roll stop in the horizontal position.

An individual in a wheelchair was being lifted from the ground to the floor level of a transport vehicle (**Figure 7**). There were vertically oriented inboard and outboard roll stops that prevented the wheelchair from rolling off of the ends of the lift platform. When the lift platform was at the ground level, the outboard roll stop was oriented horizontally to allow for loading and unloading of the wheelchair passenger. Similarly, when the lift platform was at the transport vehicle floor level, the inboard roll stop was oriented horizontally (**Figure 8**). During the initial portion of the lift, the wheelchair occupant's right foot entered the approximate 1.5-in. gap between the inboard edge of the platform and the inboard roll stop (**Figure 9**). When the lift was near its raised position, the inboard roll stop transitioned to the horizontal position, the gap between the inboard roll stop and the platform closed, and the occupant's right foot was crushed (**Figures 10 and 11**).

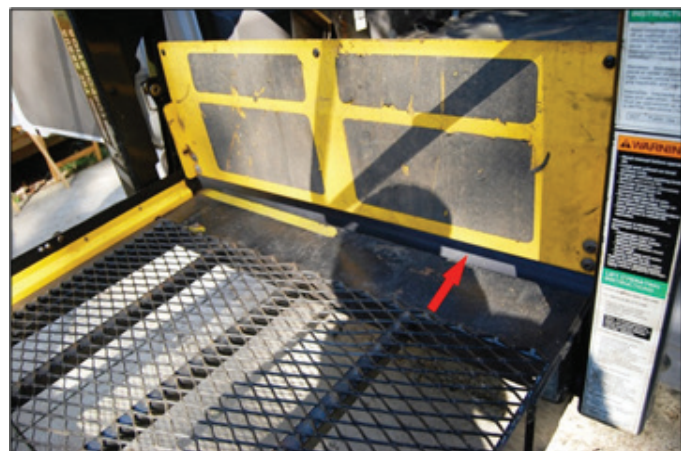
Figure 9

Inboard roll stop in the vertical position. Arrow shows an approximate 1.5-in. gap between the inboard roll stop and the platform.

The incident pinch point between the inboard roll stop and the platform should not have existed. An example of

an alternative design without the pinch point is an inboard roll stop that rotates about a hinge that is always coplanar with the platform (i.e., there would never be a gap between the roll stop and the platform).

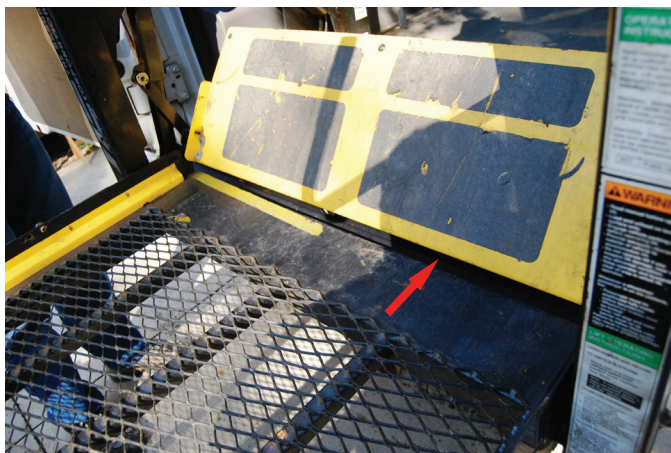
Figure 10

Inboard roll stop about halfway between its vertical and horizontal positions. Arrow shows the reduced gap between the inboard roll stop and the platform.

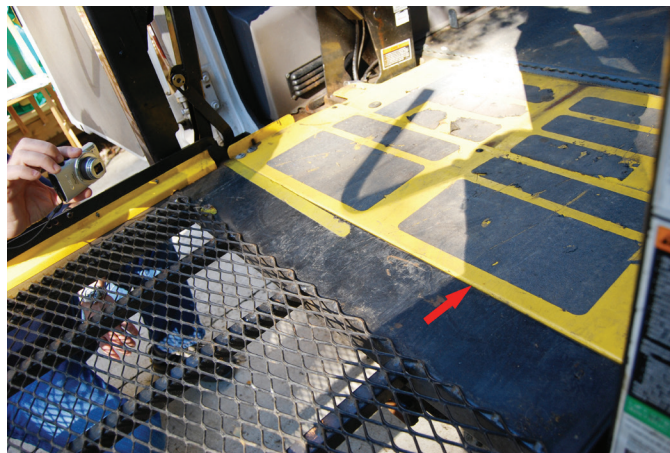
Figure 11

Inboard roll stop in the horizontal position. Arrow shows essentially no gap between the inboard roll stop and the platform.

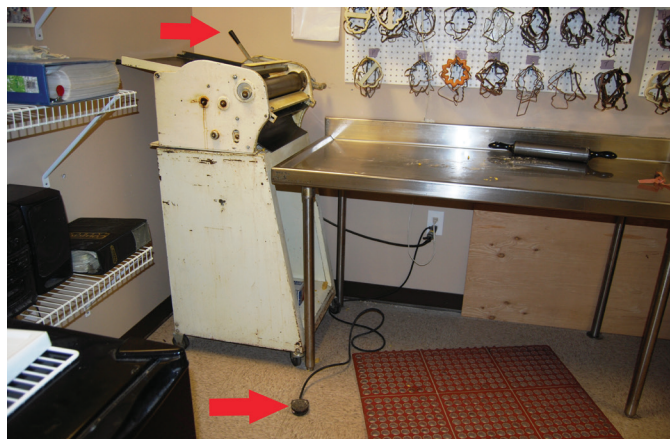
Figure 12

Dough rolling machine. Upper arrow shows its handle control. Lower arrow shows its foot pedal control.

As a worker was cleaning the rolls of a dough rolling machine, she inadvertently stepped on the foot pedal that controlled the operation of the rollers. This resulted in her hand being injured as it was pulled through the ½-in. gap between the rollers (**Figures 12 and 13**).

3. Nonetheless, the electrical plug of the dough roller was inserted into the plug connected to a foot pedal that was in turn inserted into a 120V wall outlet. This configuration allowed the operation of the rollers to be controlled by the foot pedal, which likely required a modification of the dough roller controls as noted in Item 2 above.

Based on the information above, and other factors, the author concluded that the foot pedal was not supplied by the dough roller manufacturer and was added sometime after the machine was put into service. Whether using a foot pedal to control the operation of the rollers was acceptable is a reasonable question. However, the incident foot pedal was unguarded; therefore, it was not suitable to control the operation of a machine such as a dough roller. There was a label affixed to the side of the foot pedal containing the text: "WARNING TO AVOID PERSONAL INJURY, DO NOT USE THIS CONTROL ON MACHINERY WITH AN UNGUARDED POINT OF OPERATION." This warning is consistent with OSHA's foot pedal guarding requirement noted in the following section.

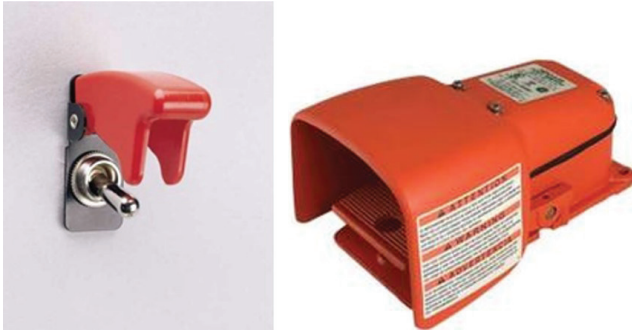
Figure 14

Toggle switch guard (left). Foot pedal guard (right).

The dough roller could have been fitted with a point of operation guard, such as a hopper, that would have prevented contact with the rollers during its normal operation. However, the incident occurred during a cleaning operation, and any such guard would likely have been removed to clean the rollers. In addition to preventing personnel from putting a body part into a hazardous area of a machine, physical guards can also prevent the inadvertent energization or activation of a machine. In these cases, hinged or limited access guards are placed over machine switches (see **Figure 14**).

The (foot) pedal mechanism shall be protected to prevent unintended operation from falling or moving objects or by accidental stepping onto the pedal.

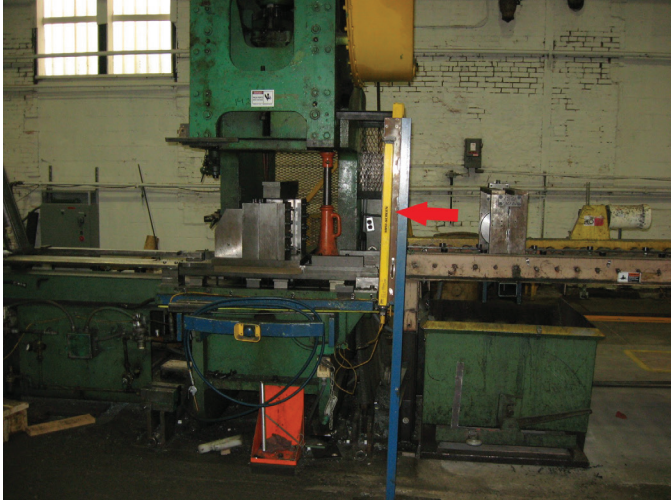
Sheet metal press safeguarded by a light curtain (see arrow).

Figure 15 shows a sheet metal power press with a presence-sensing light curtain. A stopping time of 0.360 seconds was measured from when the light curtain was tripped until the downward stroke of the press ram was stopped. This time coupled with OSHA's stipulated 63 in./second hand speed yielded a minimum safety distance of 22.68 in.⁴. The actual shortest distance from the light curtain to the press was approximately 25 in., which was acceptable (**Figure 16**). It should be noted that if the presence-sensing device is too far from the hazard, other safeguards may be necessary between these two items.

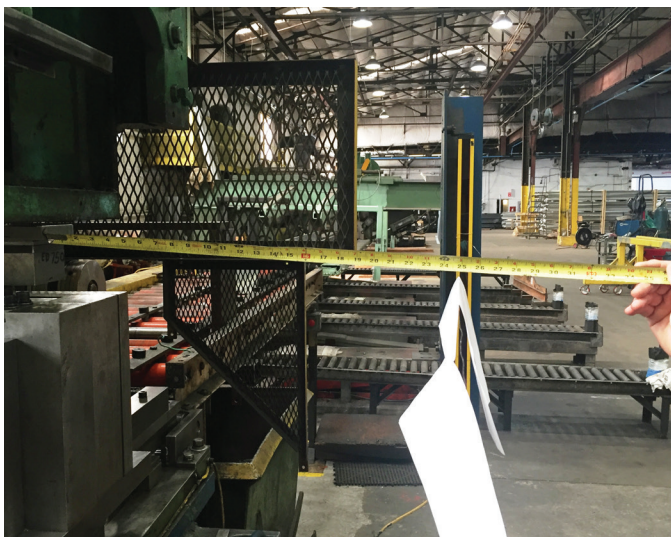
Figure 16

Distance of approximately 25 in. from the light curtain to the closest hazard of the press.

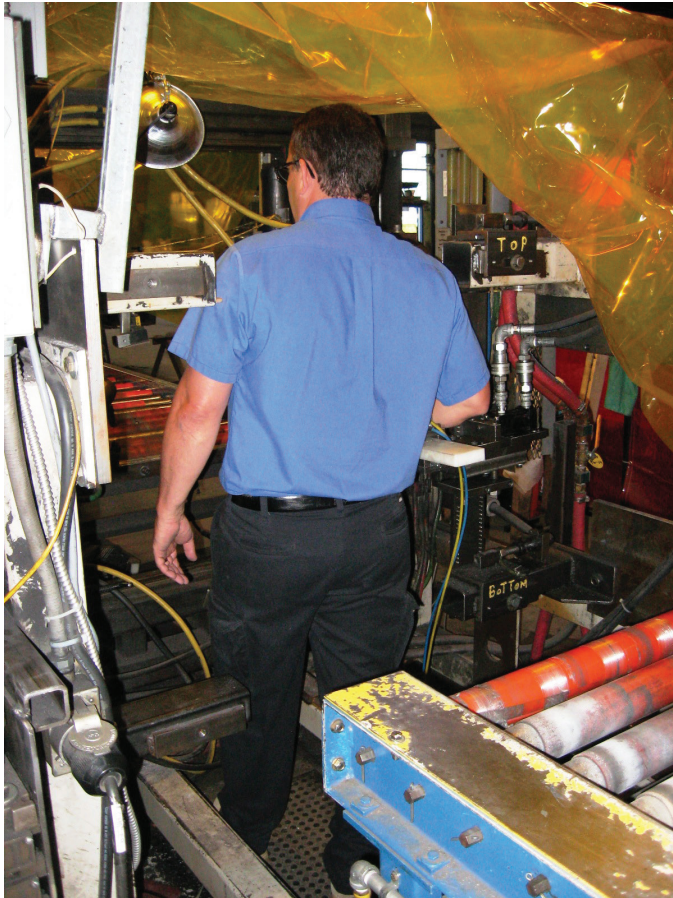
Worker cleaning weld tips on a resistance welder while standing on a safety mat that secures power to the machine.

Figure 17 shows a worker cleaning tips of a resistance welding machine, which meets all of the above criteria. The alternative safeguard in this case is the safety mat that prevents the welder from being energized while the worker is standing on the safety mat.
