Vol. 38 No. 2 December 2021

# Forensic Issues that Arise from Recirculating Hot Water Systems

By Stephen R. Jenkins, CPEng (NAFE 11)

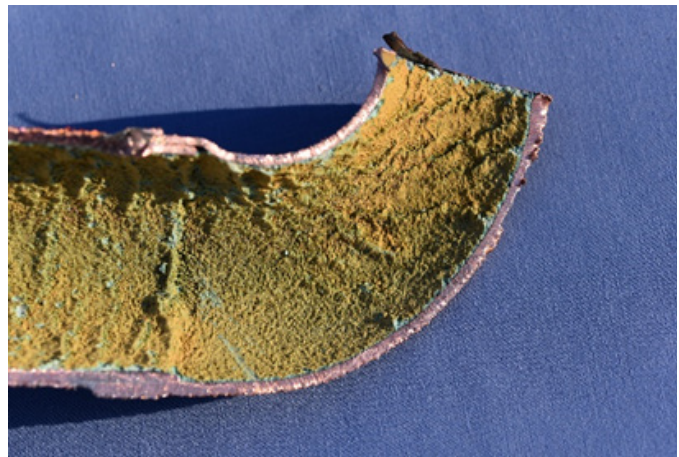
**Figure 1**

Copper is a soft and reasonably reactive material. When used in water reticulation systems, it typically develops a protective coating either through the formation of copper oxide or copper carbonate films or a layer of minerals precipitated from the water being carried by the pipe. In essence, the copper becomes the mechanical support for a contact surface that is not metallic copper (**Figure 1**).

Copper pipe after 30 years of service with an internal coating.

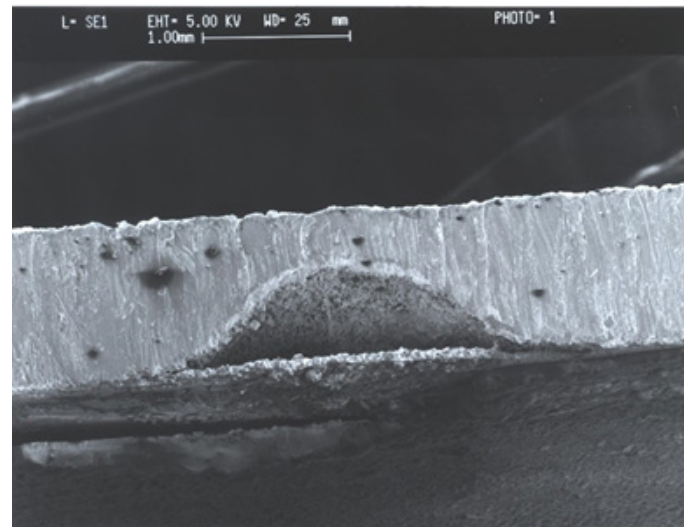
Type I pitting is rarely (if ever) seen in current installations. This is because the root cause was identified as being a thin carbon film left on the inside of the pipe during the manufacturing process as a result of oxidation of drawing lubricants<sup>12,13</sup> (**Figure 2**). This film was generally imperfect, and accelerated electrochemical pitting took place at breaks in the film. This happened in cold water,

**Figure 2**  
Scanning electron micrograph of a Type I pit.

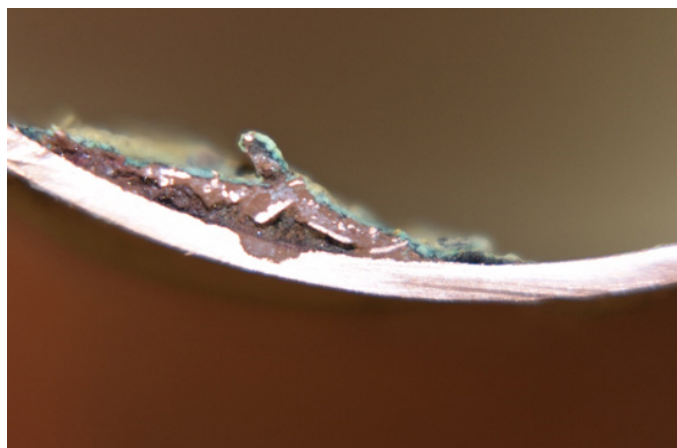
**Figure 4**

Pits caused by debris on the bottom of the pipe can be easily identified by the inclusion of large debris in the corrosion cap (**Figure 4**). It should be noted that a Type II corrosion cap can contain finely divided copper released by the corrosion process. This type of corrosion, which involves differential access to oxygen caused by the presence of the debris, is not limited to copper pipe.

Pit caused by an accumulation of debris at the bottom of the pipe.

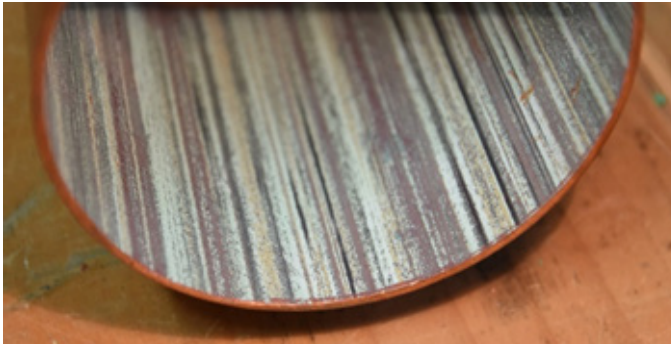
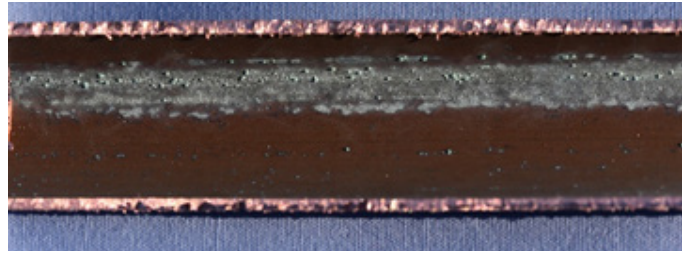
**Figure 5**

When copper pipes are recovered and opened after periods of service, they often exhibit characteristic linear blue-green deposits (**Figure 5**), which, to an observer, suggest a logical connection between linear surface defects arising from the extrusion or drawing process and pin-hole leaks or corrosion. However, no research has found a definite correlation, although there is still some unproven suspicion that there is a connection between them.

Normal linear markings inside copper pipes removed from service at around 10 years.

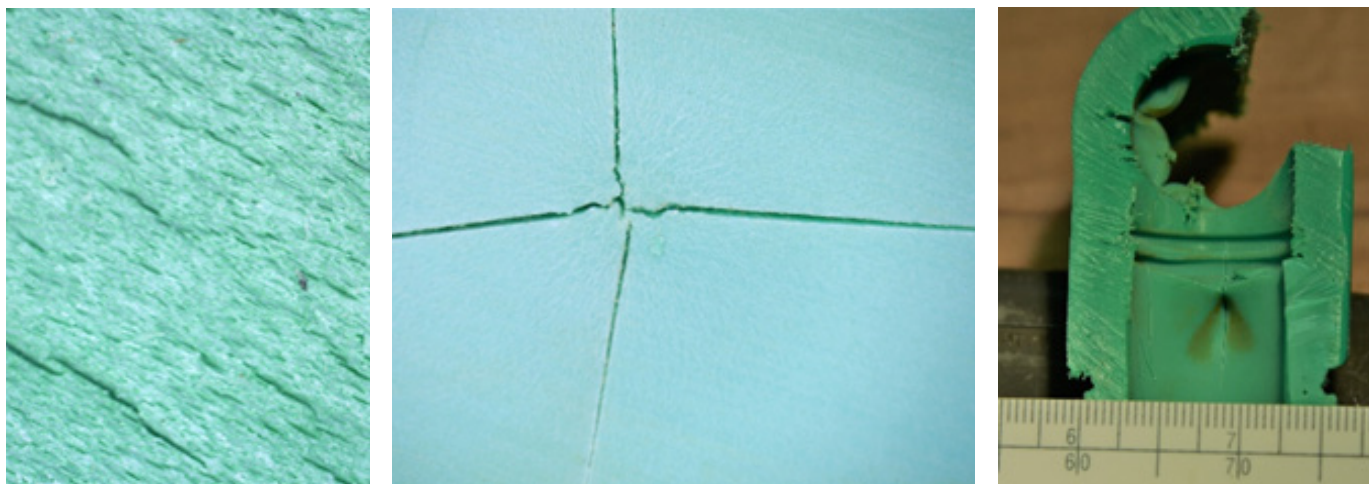
**Figure 6**

One common factor in both these types of failure is a water temperature above 65°C, but the nature of the failure obviously is different in different materials. Some failures as observed in polypropylene random copolymer are related to stress or joints that appear to have been moved during fabrication while the joint is still hot and occur in both hot and cold services (**Figure 6**, on page 58).

In terms of the failures investigated by the author in polypropylene random copolymer systems, the problem appears to be a combination of temperature and pressure, particularly in high-rise buildings as the failures tend to occur at a level where the static pressure is high, and the recirculating water has not lost much temperature.

Typical failures in PPR piping in hot and cold systems. Left: internal surfacing cracking; center: cracking from point stress; right: cracking from poorly formed joints.

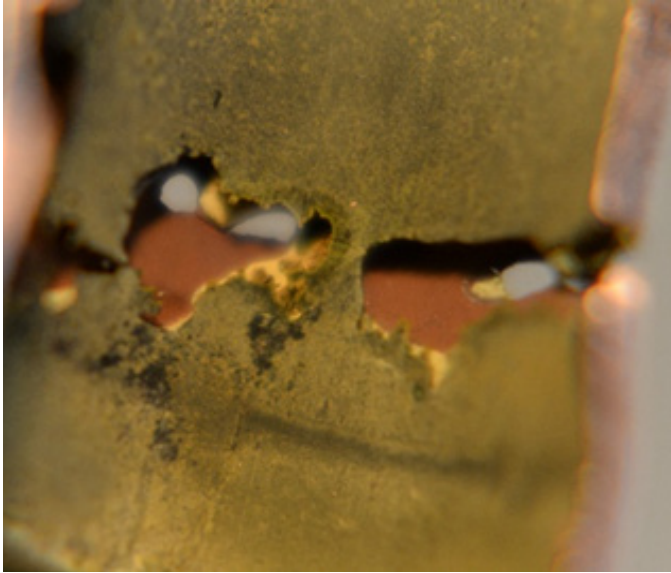
**Figure 7**  
Erosion penetrations at poorly formed joints.

In cold water systems (Type 1 corrosion), the external appearance of the pin-hole will be the same (although with less mineral and adhered materials). But internally the corrosion site will more likely appear flat or slightly depressed with raised corrosion material around the edge. Type 1 corrosion does not occur in hot pipes and is unlikely to be observed in current cold systems. Erosion leaks tend to be irregular in shape woprihen examined from the outside of the pipe and will often appear in groups or in a circumferential pattern around an artifact, such as a brazed joint (**Figure 7**).

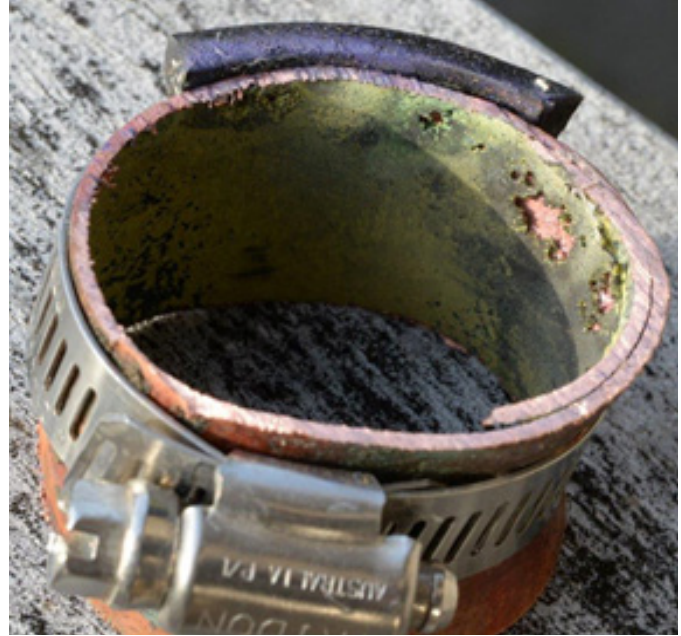
Left-hand end general material removal from surface with gross erosion extending from a burr measured at 0.1 mm high at the joint coupled with a poorly formed joint. Flow left to right. (Bend in joint at bottom was caused when the section was cut.)

Hot water above 65°C is an aggressive material with a high capacity to damage copper through erosion, particularly as a result of cavitation, which can be originated by poor joints (**Figure 7**) or partially closed valves used for flow control (**Figure 8**). It can also erode apparently smooth surfaces most likely starting at a small surface imperfection<sup>3</sup> (**Figure 9**, on page 60).

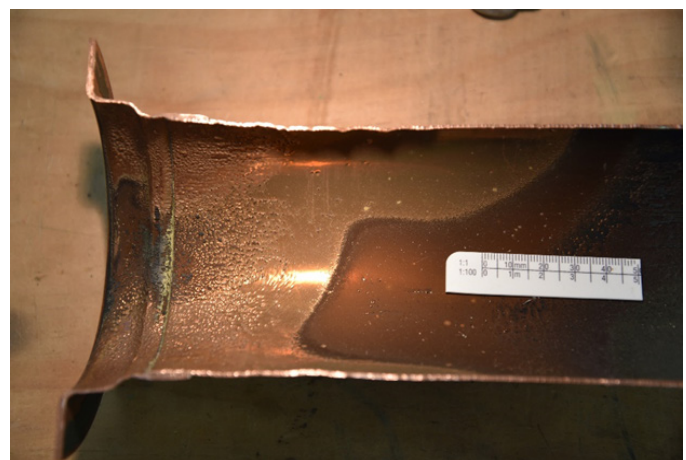
**Figure 8**  
Copper pipe removed from service showing erosion and surface polishing where a butterfly valve was used to throttle flow rates. Flow left to right.

Rough internal surfaces (**Figures 8 and 9**) or highly polished areas are both indications of surface material loss as a result of local cavitation or high-velocity flow fields.

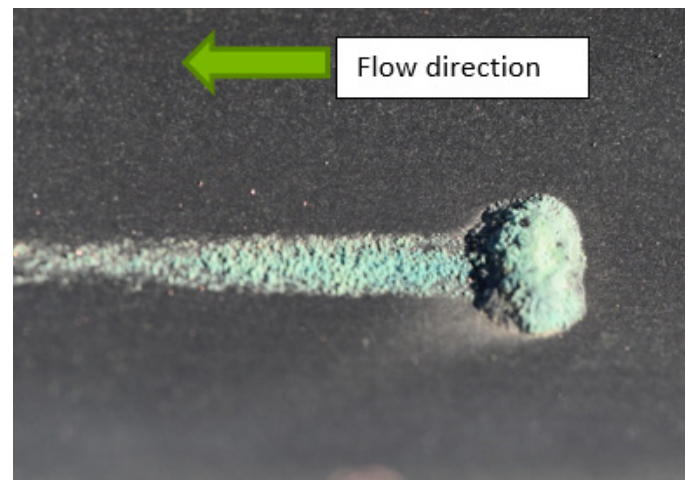
**Figure 10**

mass of corrosion, adhered insulation material, and mineral deposits on the outer pipe surface. Examined internally, it will have a mound of corrosion product often with a comet tail extending downstream of the deposit (**Figure 10**).

Typical active pin-hole leak and internal corrosion tubercule.

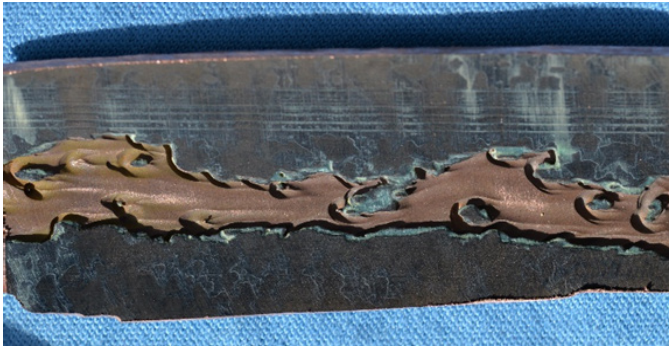
**Figure 11**

Gross material erosion. Flow from left to right cut from a section of pipe about 3 meters (10 feet) long.

horseshoe shape (**Figure 11**). The direction of flow can be identified using the mnemonic that horses walk upstream. It may be difficult to find an origination for this kind of erosion, which can extend for significant distances along the inside surface of the pipe.
