Vol. 39 No. 1 June 2022

FE Investigation and Analysis of Poor Electrical Connections and Related Fire Investigation Case Studies

By Timothy C. Korinek, PE (NAFE 1023M)

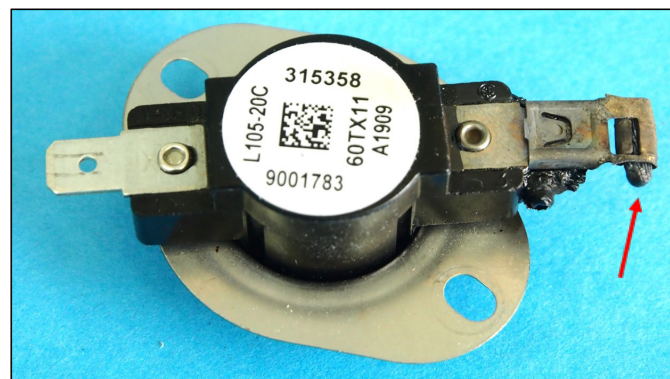
Figure 12

This case involves a thermal cut out (TCO) switch from a commercial cooking range. The subject TCO, as shown in **Figure 12**, was presented to this author’s laboratory by the range appliance manufacturer for a failure analysis. The subject TCO was part of a range that was being field tested under the control of the manufacturer. The range had been in service for approximately 10 months prior to the failure of the TCO crimp terminal connection. The current through the subject TCO is 20 amps during normal operation when both range heating elements are

Subject TCO with overheated terminal crimp on the right-hand side. The TCO manufacturer markings have been blurred out.

on. There is some melting and thermal decomposition of the plastic insulation materials close to the terminal, but no other surrounding materials ignited before the subject OPC melted open at the region indicated by the red arrow.

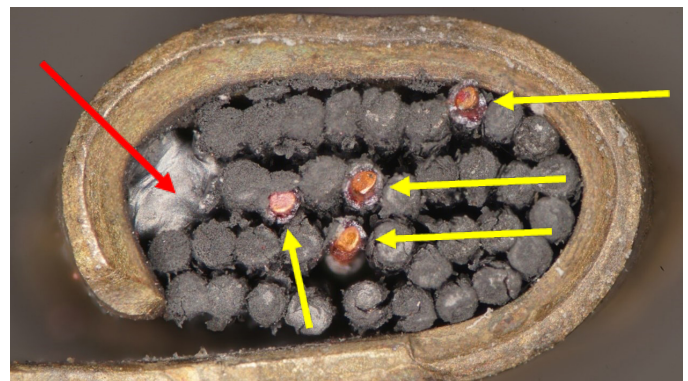
Figure 15 shows the subject crimp at the end opposite the melted-open region. The subject crimp was improperly made because it failed to properly compress the copper strands, which can easily be seen by the large gaps between the strands. The copper strands themselves have undergone a significant amount of secondary high-temperature oxidation from the OPC. The red arrow points to a formerly liquid oxide mass, which, at some point, was undoubtedly part of the molten worm. The rippled appearance, shiny gray exterior, and engulfed strands are a dead giveaway. Surface analysis of this worm region also shows micro-sized oxide spatter droplets. The blue

This shows a positive identification of an OPC worm between a brass crimp body and a stranded copper wire. This component had been installed in a real-world application, and the failure resulted in an open circuit. The red arrow points to a globular region, which was a worm at some point in time. The yellow arrows point to fractured high-temperature oxidation scale on the individual copper strands, which is a secondary effect of the heating caused by the worm. All of the wire strands not consumed by the worm globule display this secondary scale.

arrows point to the layer of high-temperature oxidation scale surrounding the copper strands.

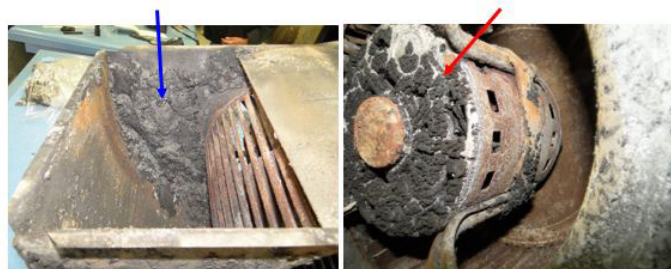
Figure 19 shows four images from the subsequent examination of the furnace. (A) shows the furnace fan discharge with a thick layer of burnt flour deposits, as indicated by the blue arrow. (B) shows more burnt flour deposits on the end-bell of the motor for the furnace air handling fan, as indicated by the red arrow. (C) shows an image after the fan motor end-bell was removed, and (D) shows an enlarged view of the thermal protector switch, which exhibited a formerly molten bead consistent with an OPC and a solidified oxide that melted open. The stranded wire, which was previously crimped into the steel thermal protector body, also displayed localized melting consistent with an OPC.

(A) shows caked-on flour deposits inside the blower volute, as indicated by the blue arrow. The witness who first spotted flames identified a location close to this component. (B) shows the motor end bell, which is caked with flour deposits. This is where the cooling fan within the motor housing draws in air to cool the motor. (C) is the thermal protector with the overheated connection, and (D) is a close-up of the melted open connection.
