Forensic Engineering Analysis of a Mobile Refuse Collection Vehicle Accident

By Drew Peake, P.E., DEE, DFE, CIH, CSP (NAFE 460F)

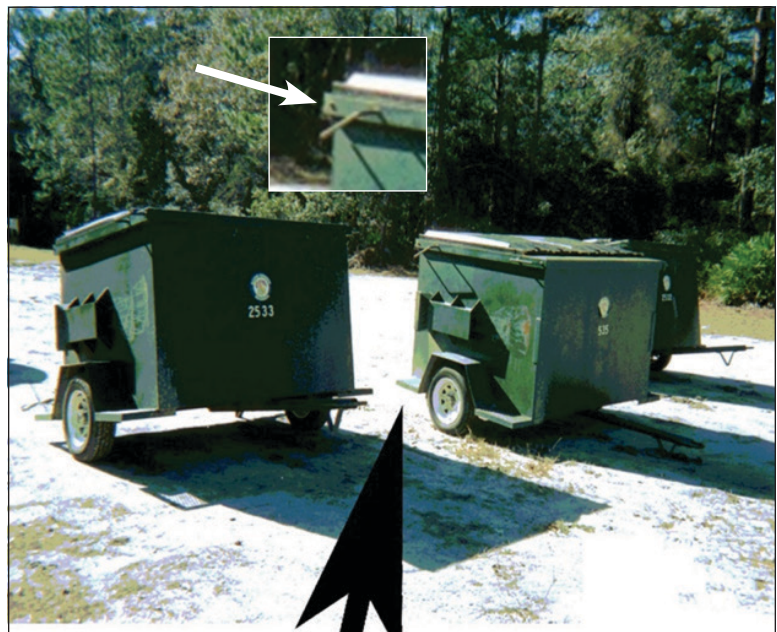
Figure 1

Trash tram showing close-up of broken handle (in inset photo).

was not made aware that there were gloves in the cap of the truck available for his use (gloves may have mitigated the impact enough to allow him to hold onto the rim). The hinge of the cover was in front. When the wind caught the lid, it closed. Because the handhold was broken (see inset of **Figure 1**), the plaintiff was holding onto the top of the container. When the lid slammed onto his hand, he fell off, suffering a left front temporal acute subdural hematoma with impending cerebral herniation.

Broken handholds were a common and perennial issue. A park employee testified that the waste hauler damaged the handles with the forks of the container lifting devices — and that she had notified the waste hauler “years ago” about the problem. Another park employee testified that the handle on the side where the plaintiff was riding had broken off. Notifying the waste hauler once was insufficient management control.

- Supervisors were aware of damaged handles and did not repair them or take action to prevent recurring damage.
- Supervisors were aware community service workers were not wearing the gloves, and did not take action to advise the workers.
