Vol. XX No. 1 June 2003

Forensic Engineering Investigations of Gas-Fueled Appliance Fires and Explosions

by Joseph G. Leane, P.E., C.S.P. (NAFE 524M)

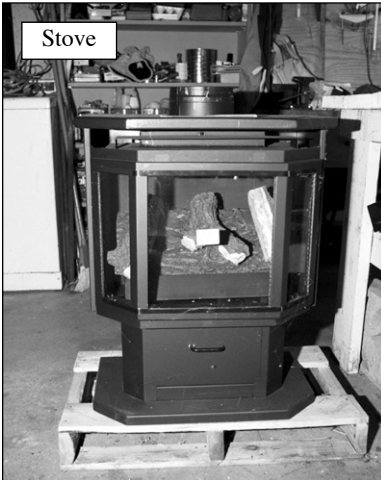
An employee of a local gas utility was installing an LP-Gas fueled decorative stove in a house. After he completed the installation, he opened a shutoff valve on the LP-Gas storage tank on the property, which pressurized the gas lines including the line he had installed. He then checked the line he installed for gas leakage, by applying a leak detector soap solution to the joints of the gas line. Once he assured himself of no leakage, he fired up the stove. With the stove operating, he then re-lit the pilot burners on the other gas appliances in the house. Those burners had been extinguished when he had closed the shutoff valve on the LP-Gas tank. After relighting the pilots, he shut off the stove, which had been operating for approximately 10 to 20 minutes. He then told the mother that was home with her young child, to come into the room and he would show her how to operate the stove. After she entered the room, he asked her if she smelled gas (she testified to that point, but he denied it). He then pushed an igniter pushbutton several times while demonstrating how to light the pilot burner of the stove. Several seconds later, a momentary flash fire occurred within the room. The child, who was seated directly in front of the stove, was burned.

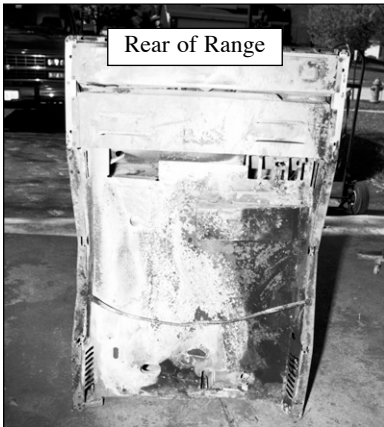
Rear of Range

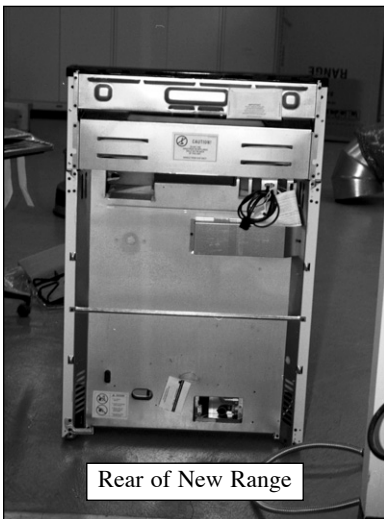
Rear of New Range

Next, we purchased a brand new identical range, set up the range in our laboratory and test operated it. There was an opening in the rear of the appliance where the gas line entered, which was right where the suspected gas leak was located. We conducted smoke tests to determine airflow patterns in that area during various modes of operation. When only the range burners were firing, the air flowed upward between the rear of the range and the wall. However, when the oven was operating for several minutes and became heated, the airflow changed and began to be drawn through the opening in the rear of the appliance and into the oven compartment.

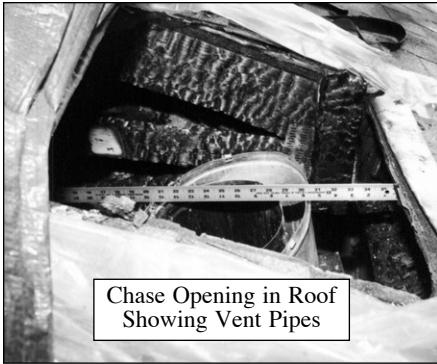
Chase Opening in Roof Showing Vent Pipes

The author conducted a site inspection, at which time we removed the factory-built fireplace unit and its vent (chimney). No rain (termination) cap was found for the top of the vent. The fireplace unit had sustained virtually no damage since the fire had been contained to the house attic. However, discoloration of the vent

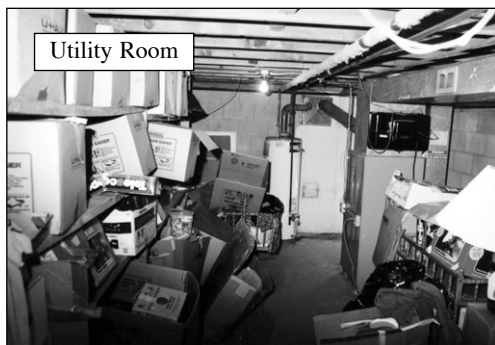
Our investigation revealed that the utility room, where a natural gas fueled furnace and water heater were located, was a confined space that did not have provisions to supply adequate air for the proper operation of the appliances. Further, the furnace blower compartment did not have a bottom panel. So, when the blower operated, it pulled air from the room and distributed it throughout the residence. Finally, there was ample visible evidence that water was condensing in the vent system and that the furnace was spilling its combustion products into the room.

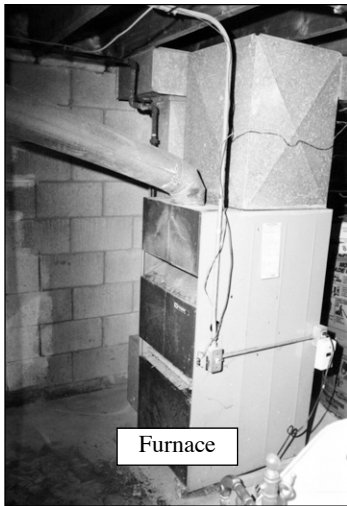
Furnace

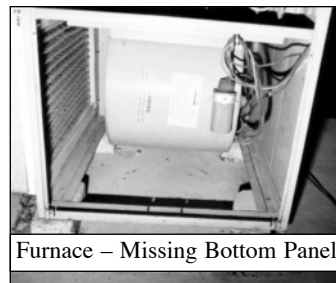
Furnace – Missing Bottom Panel

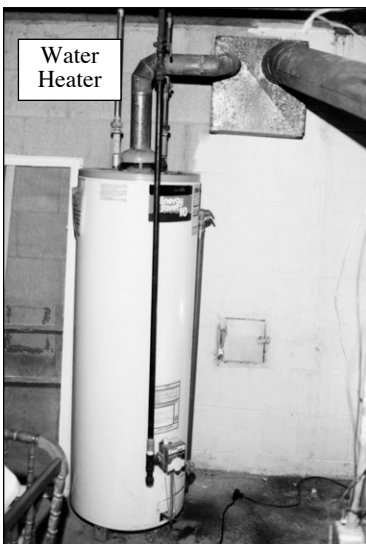
Water Heater

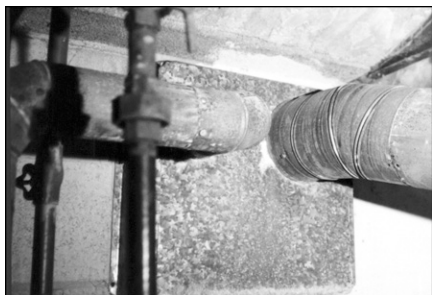
Appliance Vent Pipes Showing Corrosion from Condensation

residence was cold when the appliances were started. The outside air temperature had been in the forties during the several days preceding the incident. Once started, the water heater and furnace would have operated continuously until they brought the water and comfort air up to the set temperatures of the thermostats. Finally, numerous indicators were present that should have alerted the technician that the appliances were unsafe to use. Those indicators were the confined space, corrosion on the furnace from long term spillage of combustion products, corrosion at various joints of the vent system from

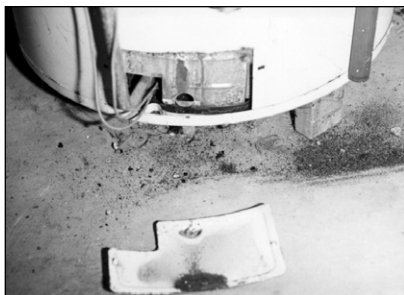
Damage from Flue Spillage and Condensation
