Vol. 39 No. 1 June 2022

Forensic Engineering Investigation of a High-Voltage Transmission Line Anchor Shackle Failure

By Daniel P. Couture, PEng, DFE (NAFE 951S)

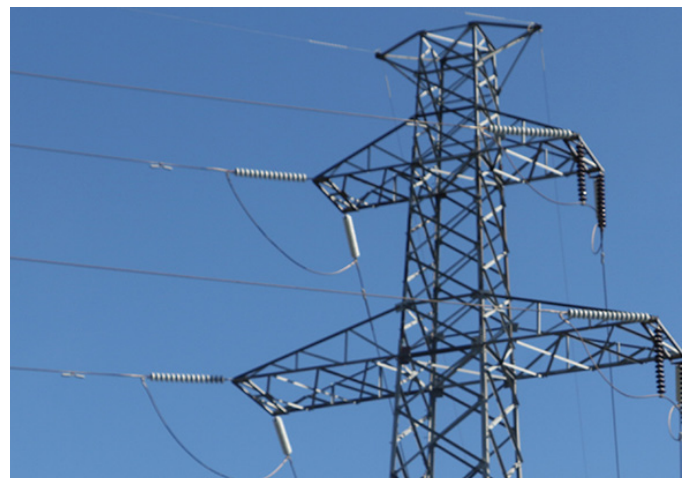
Figure 2
High-voltage transmission tower.

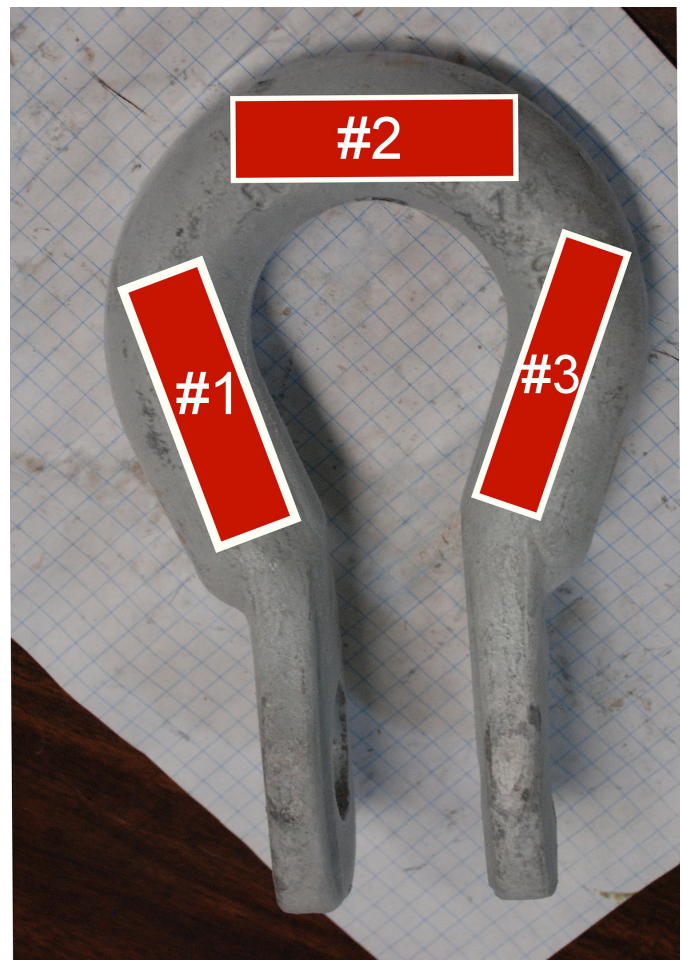
Figure 13

The variation appeared to be related to the location of the samples, taken from one of three places in the body of the shackle shown in **Figure 13**, with those in #2 central position testing significantly lower and not meeting the acceptance criteria. These are not the area where the shackle failed adjacent to the clevis pin hole, shown in

Locations of typical Charpy tests for Company C.

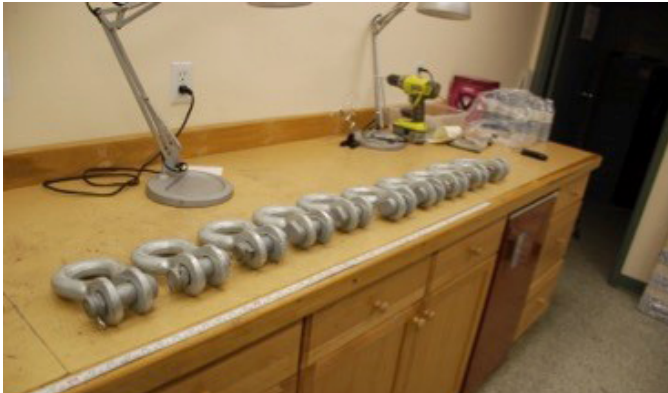
Figure 16
Samples as-received from Batch 2525 stock.

Twenty shackles were obtained from the utility's warehouse, and randomly assigned (**Figure 16**) reference identification numbers. The testing run sequence order was set from first to last, according to the size of a random number generated on a calculator, for each run of the factorial design. These shackles were placed into simulated cold temperature field service conditions, with similar parameters to the Company A room temperature tensile test assessments.

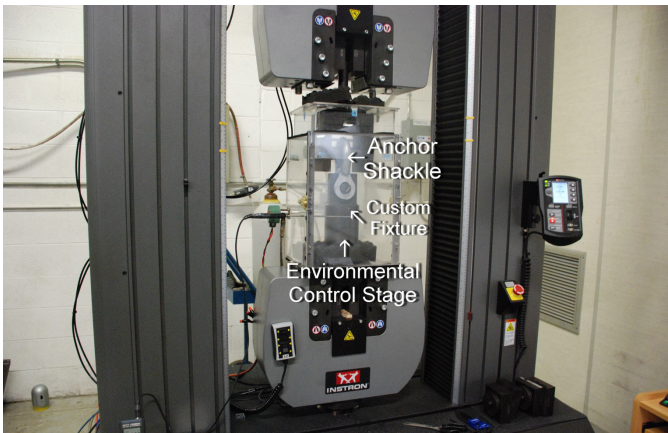
Tensile tests were performed by Company D in the special environmentally controlled chamber on an Instron universal test machine for the nominal rated load, and then on a SATEC universal test machine for the maximum load levels. Universal testing machines include electromechanical and hydraulic systems to perform static testing, including tensile, compression, bend, peel, tear, and other mechanical tests. The utility calculated that the maximum load on the shackles would be 127 kN, not including wind oscillation and other cyclic loads. The configurations are shown in **Figures 17 and 18**.

Figure 17
Environmental control stage on the Instron tensile test machine for rated load tests.

The first stage of mechanical testing consisted of temperature conditioning followed by a low-level load test. Specimens were cooled to the specified test temperature and held long enough to reach thermal equilibrium. Then, they were inserted into the Instron machine, and a pre-load of 0.7 kN was applied. The cross-head was then extended at a rate of 40 mm/minute up to a load of 374 kN (the reusability load) where it was held for 5 minutes before the load was released. The reusability load level is defined on page 319 of the CSA Standard — 374 kN compared to the 440 kN rating of a Number 9 Anchor Shackle.
