# Forensic Engineering Analysis of Pedestrian Trauma Using BioMedical and Accident Reconstruction Engineering Methods

by *Laura Liptai, Ph.D. (NAFE C339)*

*Rowland Lamb, P.E. (NAFE 690S)*

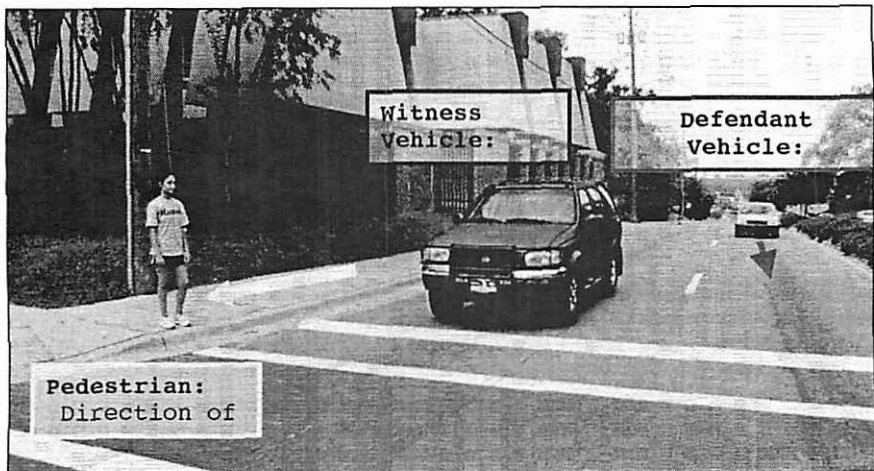
Figure 1A

Vehicle and Pedestrian Initial Juxtaposition:  
Pedestrian Crossing in Front of Stopped SUV and Defendant Vehicle On-Coming

- An older model compact sedan was traveling in the center lane adjacent to the SUV. See Figures 1A and 1B.
- The speed limit was thirty (30) miles per hour.

To determine the line of sight as well as illustrate how the pedestrian's trauma mapped onto the vehicle, a kinematic study proved invaluable as seen in Figures 1A, 5, 7, 8 and 9. The road was closed so that the vehicles could be safely placed and photographed to determine if there were any vehicular or pedestrian blind spots. Procedurally, all the vehicles were put in place on the actual roadway and a model of like height and weight was utilized to represent the pedestrian. This test was conducted during the same calendar week of the actual incident. It was determined that the sun/lighting and foliage effects were non-contributory. The kinematic study revealed that:

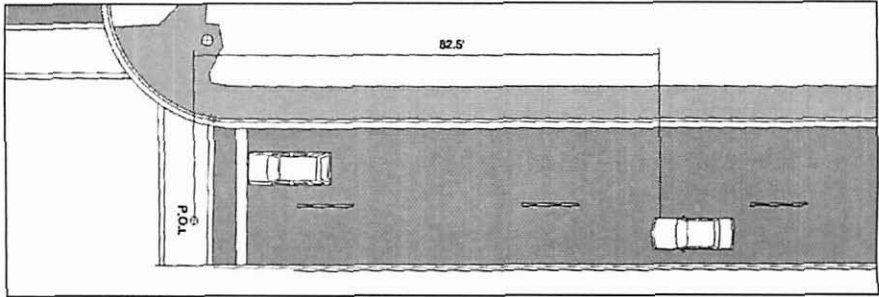
**Figure 1B**  
Locations of the Two Vehicles and the Pedestrian at the  
“Point of No Return” for the Defendant

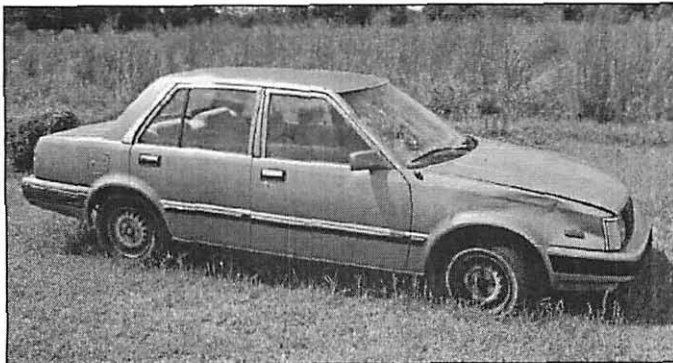
**Figure 2**

Defendant Vehicle Damage –

Note passenger side front quarter panel damage

The BioMedical Engineering analysis began with a review of the vehicle photos, scene photos, medical records, autopsy photographs, and the pedestrian's clothing. From this, every trauma on the pedestrian's body was documented in description as well as photographically. Even the evidence on the pedestrian's watch provided insight into the trajectory. The physical evidence on the defendant's vehicle is pictured as Figure 2. The decedent's primary trauma map diagram is shown as Figure 3.

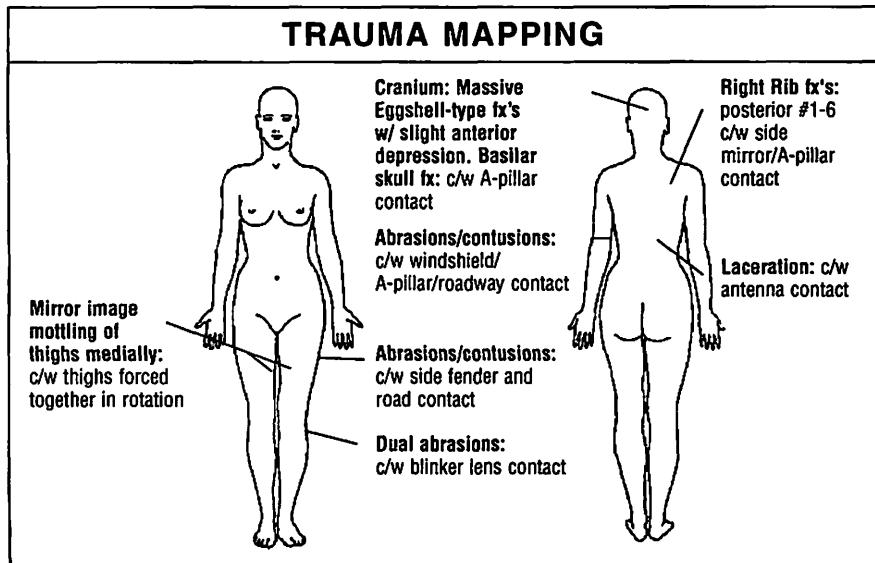
**Figure 3**

**Trauma Map of the Primary Injuries Sustained by the Pedestrian**

- the displaced headlight was from a previous unrelated incident;
- the absence of hood damage was not consistent with a classic frontal pedestrian impact;
- the pedestrian sustained no bumper related trauma;
- the "mirror image type contusion-like mottling of the opposing surfaces on the right and left thighs medially" traced to the medial thighs being rubbed against each other forcefully in shear, when the pedestrian laterally impacted the passenger side quarter panel; and
- the pedestrian was not visible to the approaching vehicle at one point five (1.5) seconds before impact.

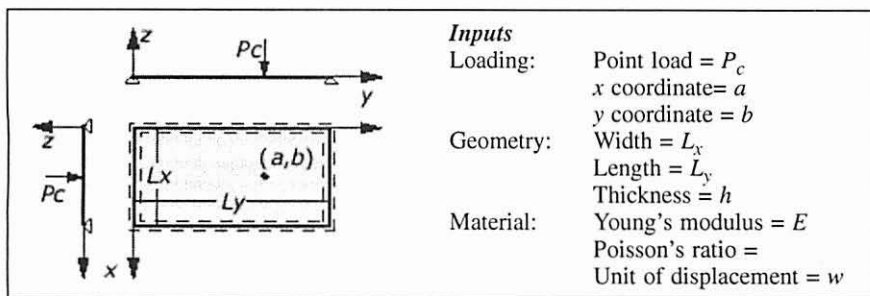
The Model of a Simply Supported Rectangular Plate under a Point Load and Inputs to the Model

To analyze whether the pedestrian's body could have deformed the right front quarter panel, the area of impact was modeled as a simply supported rectangular plate. All variables are defined in Figure 4 except "D" which equals the bending rigidity of the plate as a function of the Young's modulus (E), the poisson's ratio ( $\mu$ ) and the thickness of the plate (t).  $D = (E \cdot t^3) / [12(1 - \mu^2)]$  This was appropriate as there were three (3) inches of structural clearance under the indented fender.

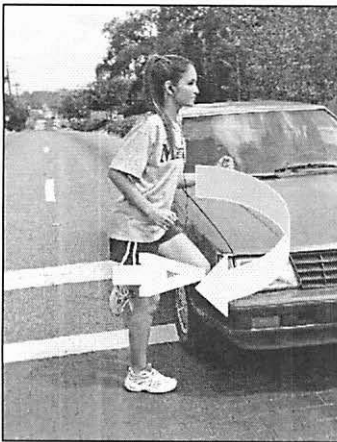
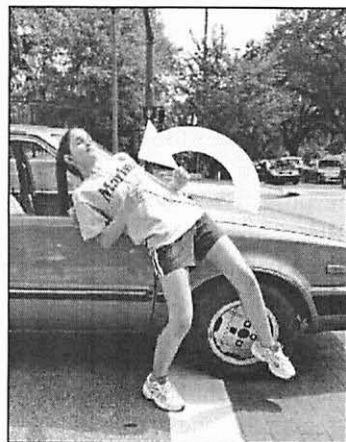
**Figure 7**

Causes of the Trauma Illustrated with the Model: Back Contacts Antenna, Head Contacts A-Pillar and Elbow/Walkman Contacts Windshield

The analysis and trauma mapping revealed that the pedestrian most likely ran into the side of the sedan at which time the pedestrian's body rotated and fell in a backward fashion with her posterior cranium (back of the head) impacting the right front passenger side A-Pillar of the vehicle (Figure 7). The physical evidence of skull and brain trauma was consistent with A-Pillar impact. The trauma mapping and the physical evidence on the defendant's vehicle are consistent with the pedestrian running into the side of the vehicle.

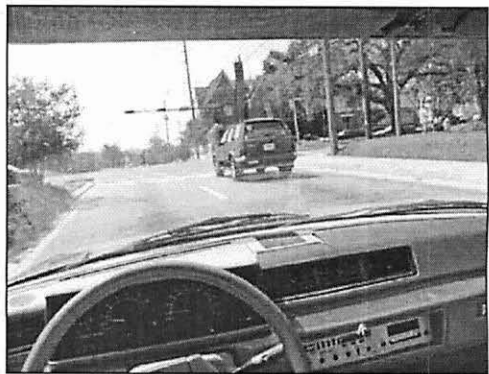
**Figure 8**  
Pedestrian in Defendant's Blind Spot

- the pedestrian's trauma was consistent with the pedestrian running into the side of the defendant's vehicle and causing the dent in the right front quarter panel;
- the pedestrian traveled for two (2) seconds from the curb to point of impact and the defendant required more than two (2) seconds to swerve or come to a complete stop. Therefore, once the pedestrian left the curb, the defendant could not react in time; and
- the pedestrian was not visible to the defendant at one point five (1.5) seconds (because she was hidden behind the stopped SUV, as shown in Figure 8). Also the vehicle was not visible to the pedestrian during the one point five (1.5) seconds prior to impact because she was on the other side of the SUV, as shown in Figure 9. This was consistent with the defendant not knowing what had hit him and the pedestrian running into the side of the defendant's vehicle.

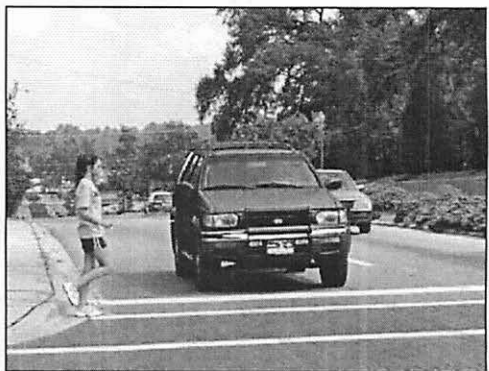
**Figure 9**  
Defendant Vehicle in Pedestrian's Blind Spot

- 1. Blind Spot for both the vehicle and pedestrian occurred at one point five (1.5) seconds prior to impact.** The vehicle and the pedestrian were not visible to each other at the last chance to perceive and react;
