# Forensic Engineering Analysis of a Car vs. Car vs. Pedestrian Accident

by Jeffrey D. Armstrong, P.E. (644S)

## Abstract

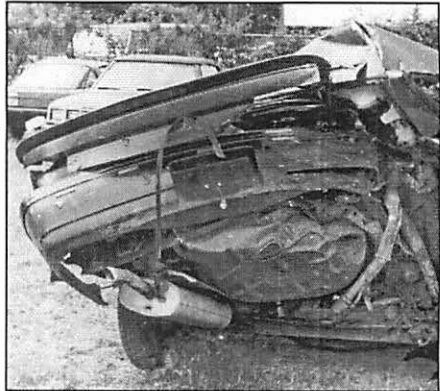
Figure 3  
Chevrolet Beretta.

The victim's vehicle was a 1994 Chevrolet Beretta two-door coupe. It received severe contact damage to the right rear portion of the car as shown in Figure 3. It also received damage to the left-front corner from the impact with the New Jersey barrier as shown in Figure 4. This Figure supports the belief that the hood was up at the time of the collision. The lower portion of the windshield has a long rainbow-shaped crack that matches the shape of the back of the hood as shown in Figure 5 and Figure 6, which suggests that the hood struck the windshield with some force during the collision.
