Vol. 38 No. 1 June 2021

# Forensic Engineering Analysis of a Commercial Dry Storage Marina Reinforced Concrete Runway Slab

By David W. Stewart, PE (NAFE 301S)

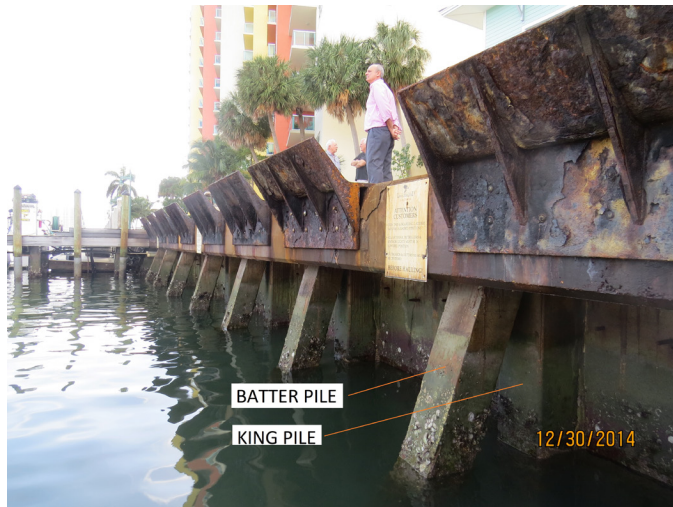
**Figure 3**

The north perimeter of the runway is adjacent to the marina bulkhead, which was designed and built shortly before the runway but as part of the same development project. The bulkhead consists of a precast concrete “king pile-and-slab” system (**Figure 3**). The vertical concrete king piles, spaced approximately 14 ft apart, support precast concrete wall panels or slabs. There is an inclined batter pile in front of the king pile to increase the lateral load capacity of the bulkhead. The precast piles and panels are locked together with a cast-in-place reinforced concrete cap. This type of construction is also known as a “soldier-beam” retaining wall<sup>2</sup>.

Marina bulkhead king pile and slab system.

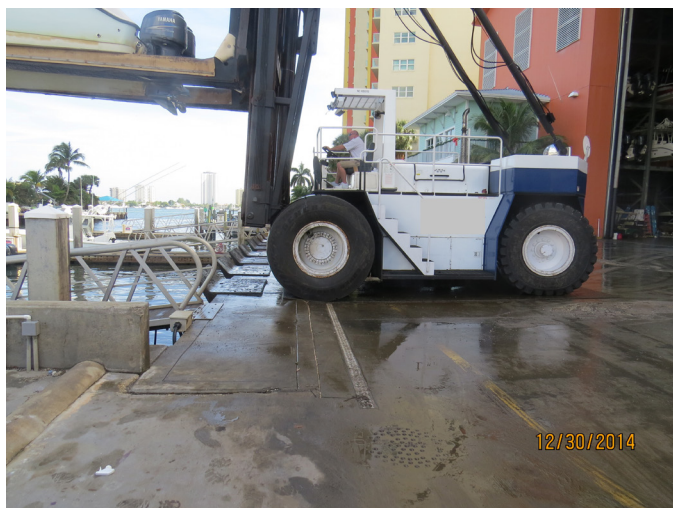
Marina forklift approaching the bulkhead.

As part of the investigation, the wheelbase and tire dimensions of one of the marina forklifts were measured and compared against the manufacturer's published data<sup>3</sup>. **Figure 4** shows a side view of the forklift equipment working on this site.

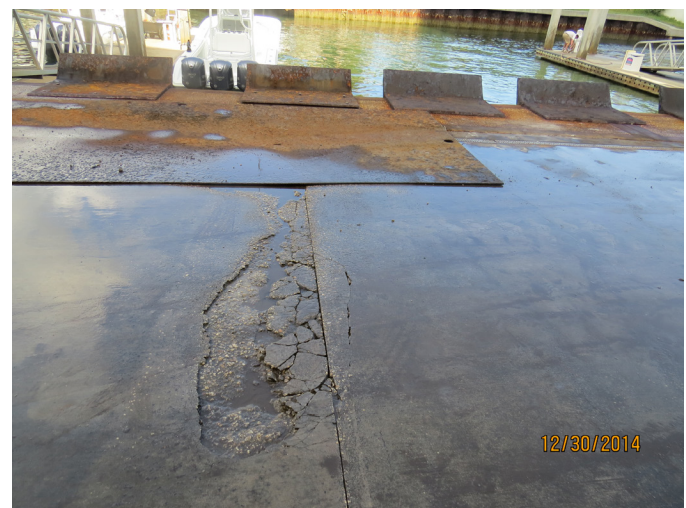
**Figure 6**

Runway surface spalls and cracks.

photograph of some of the surface deficiencies. Some areas of the runway had been repaired prior to the author's first site visit. Throughout the investigation, the marina remained open, and the runway was in use.

locations to ramp from the runway to the cap (**Figure 6**).

The runway slab appears to generally conform to the plans and specifications. The concrete compressive strength, quantity, and placement of the reinforcing steel (and overall slab thickness) were inspected and accepted during construction. Examination of concrete cores did not find aggregate segregation, cold joints, or critical deviations in the placement of the reinforcing steel. The observed surface damage, consisting of shallow spalls, chips and raveled joint lines (**Figure 6**), are not deep enough to affect the strength of the slab.

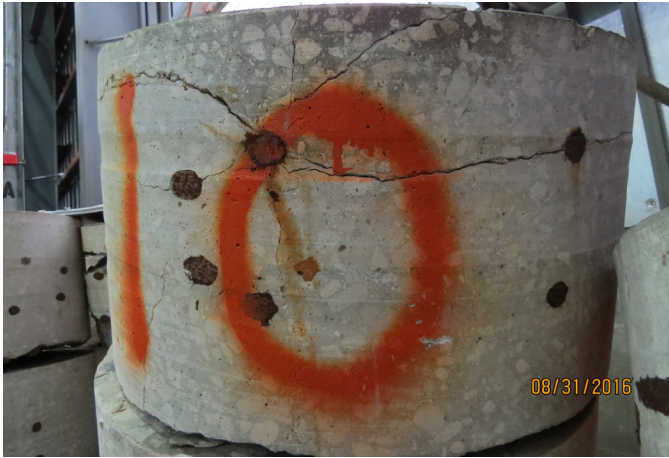
**Figure 9**  
Concrete core with horizontal cracking.

Three of the cores (#8, #10 and #26) examined had horizontal cracks at the elevation of the top reinforcing steel (**Figure 9**). This caused a delamination (spall) of the concrete cover above the top steel that indicates the concrete section failed in compression.

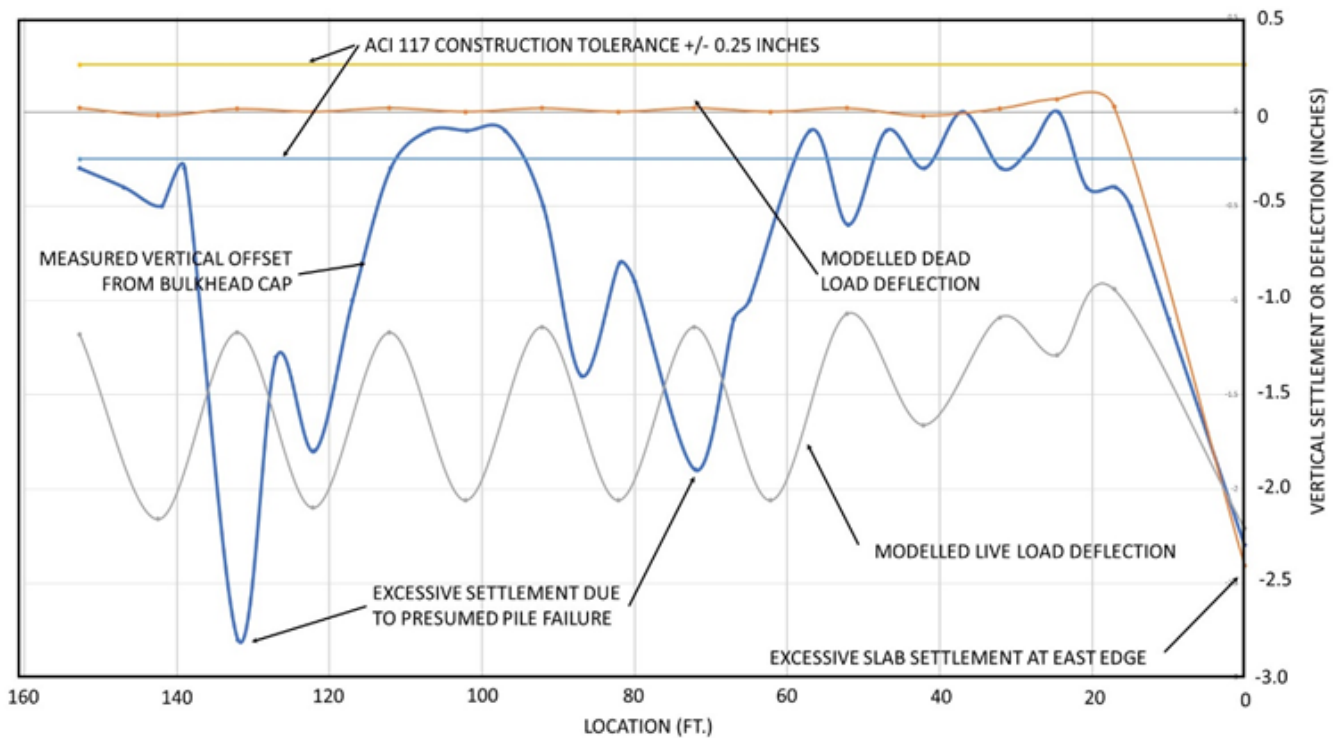
**Figure 10**  
Measured and predicted deflections along the runway north edge.

the north edge of the runway slab and the south edge of the bulkhead cap were measured using a straight edge and steel rule. Measurement locations were referenced to the northeast corner of the runway slab. The north edge should have been constructed flush with the top of the cap within the tolerances of the Specifications for Tolerances for Concrete Construction and Materials and Commentary (ACI 117)<sup>5</sup>. The measured offset is compared with the ACI 117 tolerance of 0.25 +/- inches in **Figure 10**.

Approximately 27 percent of the north edge is within 0.25 inches of the top of cap. Another 25 percent is between 0.25 and 0.5 inches. Approximately 15 percent is between 0.5 and 1.0 inches. The remaining 33 percent has deformations (settlement plus dead load deflection) between 1.0 and 2.8 inches.

**Figure 10** shows the live load deflections of the slab edge predicted by the FEM Model A. They generally oscillate between about 1.1 inches at the pile centerline and about 2.1 inches midspan between the piles.

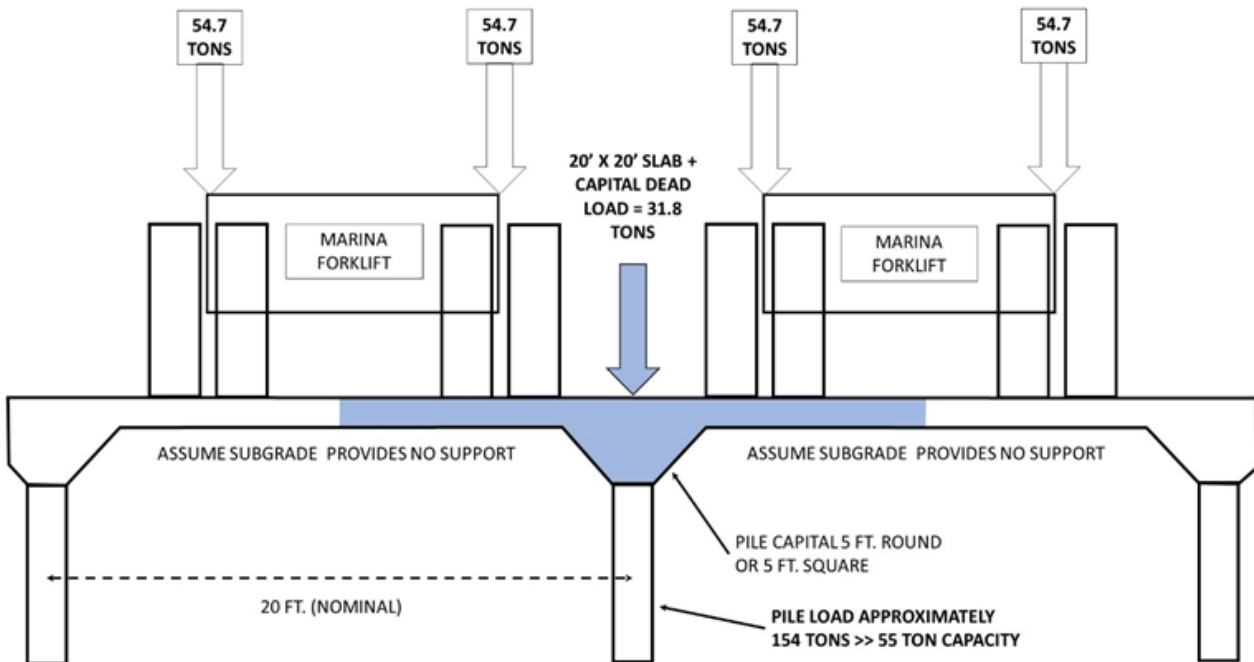
Figure 12  
Maximum load on interior pile.

In the worst case, with no subgrade support and a runway with adequate flexural strength, a runway area of

about 20 ft square would be tributary to the pile (**Figure 12**). This maximum dead load is about 31.8 tons. This leaves only 23.2 tons to support the forklift wheel loads.

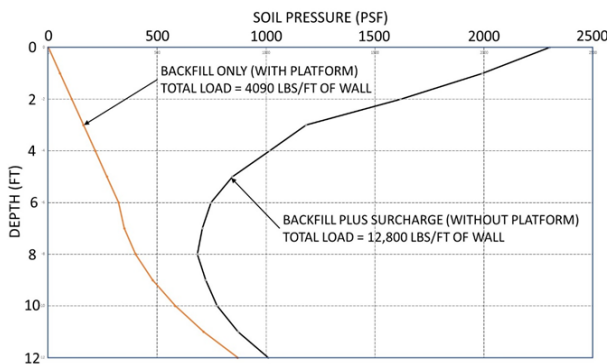
**Figure 13**  
Effect of runway acting as a relieving platform to reduce bulkhead design load.

**Figure 13** illustrates the effect a relieving platform has on reducing the design loads on the bulkhead. In this example calculation, the backfill load is based on a dry unit weight of 122 lb per cu ft, an angle of internal friction of 34 degrees, and a depth to water table of 6 ft. The equipment loads on top of the backfill or “surcharge” is based on a single pair of forklift drive wheels. The normal stress was estimated from Giroud 1970 using Tables 3.14

to 3.18 as presented by Poulos and David 1974<sup>7</sup>. Because the bulkhead is rigidly supported by batter piles, the at-rest coefficient of earth pressure of 0.44 was used to calculate lateral pressures<sup>8</sup>.

In this example calculation, for a condition with backfill only, the maximum lateral soil pressure is approximately 869 psf. For the backfill plus surcharge condition, the maximum lateral soil pressure is approximately 2,300 psf. Integrating over the height of the wall results in total design loads of 4,090 lb per ft of wall and 12,800 lb per ft of wall for backfill only and backfill plus surcharge, respectively. This represents an increase of more than 300% in design pressure.
