Vol. XXV No. 1 June 2008

Forensic Engineering Analysis of Propeller Contact Injury

by *Laura L. Liptai, Ph.D. (NAFE C339)*

Paul Kamen, N.A. (NAFE C396)

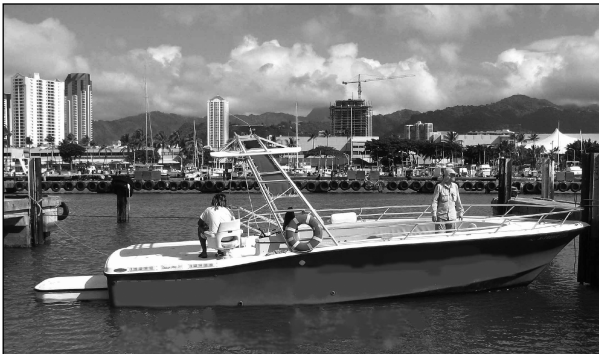
Figure 1

Lateral view of a parasail winchboat

Applications requiring high thrust at a relatively low speed, such as water skiing, wakeboarding and parasailing, result in unusual demands on both the propulsion system and on the maneuvering capabilities of the vessel (see Figure 1). As a result, there are additional hazards associated with propeller contact that may not be anticipated by even experienced small craft operators.

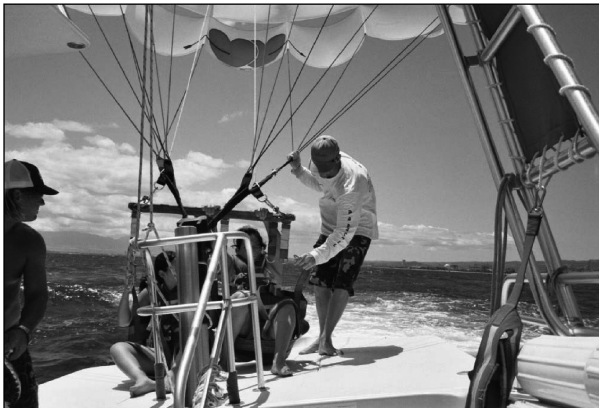
Figure 2

Launching parasailers from the “flight deck”
at the aft end of the winchboat

Immediately prior to the accident, two first-time parasailers were on the flight deck preparing to hook up to the parachute towline as shown in Figure 2, with the assistance of a crewmember on the flight deck. The wind was reported to be approximately 15 knots from ahead, the boat speed was 1.5 knots or less, and the engine speed was approximately 1000 RPM.

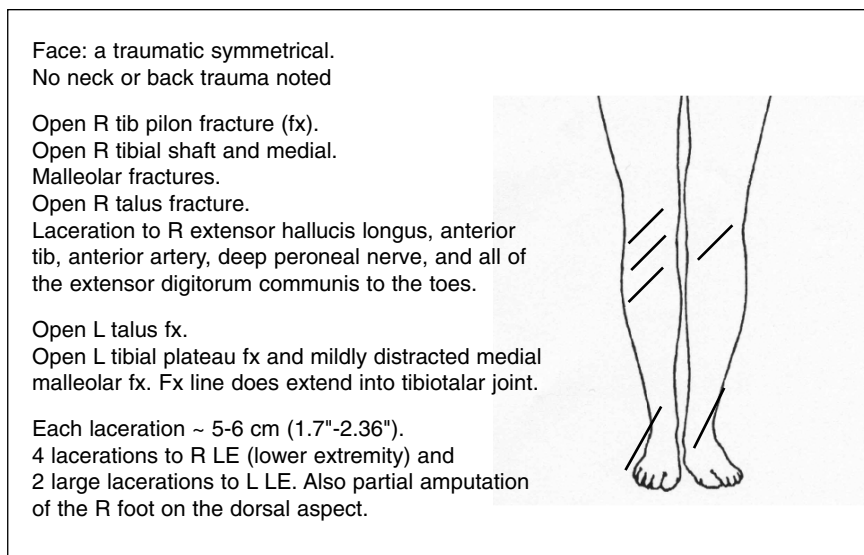
Figure 3
Trauma Map

- Right and left ankle lacerations are at similar angles consistent with lower extremity positional and time proximal events bilaterally.
- Right distal leg laceration is more perpendicularly oriented to the long axis of the tibia at the time of contact, as consistent with laceration evidence.
- Right mid leg laceration is also more perpendicular, relative to the more parallel oriented ankle lacerations.
- Right proximal leg laceration occurs more parallel to the long axis, which is consistent with horizontal alignment of the lower extremity and more parallel orientation to the propeller blades.

The trauma diagnosed and documented by the health care providers in the incident is outlined in Figure 3. Forensic kinematic analysis of the physical evidence including medical records, injury photographs, topographical vessel and overboard kinematic (movement) data follows:

Based on kinematic tests, the plaintiff most likely fell into the water laterally with torso flexion or posteriorly (supine/face up) with torso flexion and sustained laceration trauma within seconds. The kinematic study determined juxtapositions of the body proximal to the propeller and mechanics of the lacerations. An outline of the analysis and findings follows.

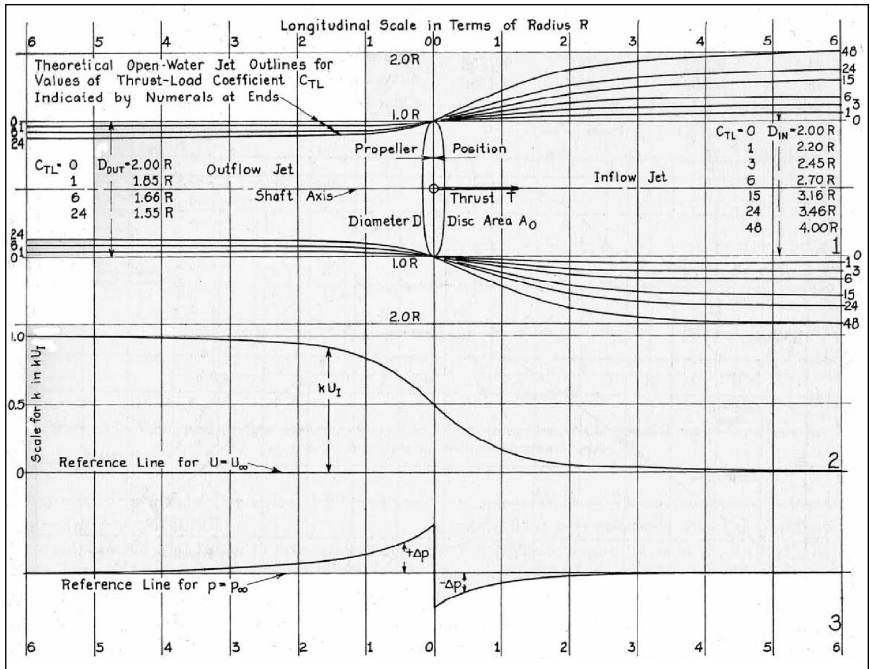
Figure 4

Propeller inflow and outflow as a function of C_t : Theoretical Jet Outlines, Axial-Velocity Distribution, and Axial-Pressure Distribution for an Ideal Screw Propeller

This leads to the characteristic “wine bottle” flow pattern into and out of a propeller (Figure 4). Continuity and Bernoulli both require that the flow field some distance upstream is wider than the propeller disk, and that the flow field necks down as it accelerates and the pressure drops. As the water passes through the actuator disk, the pressure is increased from below ambient to above ambient. The flow continues to accelerate and contract until it reaches ambient pressure again in a narrow slipstream jet.

Captain Saunders, in his classic work *Hydrodynamics in Ship Design*, (ref.1) presents a diagram illustrating the dependence of inflow field shape on C_t .

In the case of ski towboats and parasail winchboats, relatively low speeds and high thrust values are common. The resulting high C_t values result in a field of wider inflow than would be experienced at high speed or at low thrust.

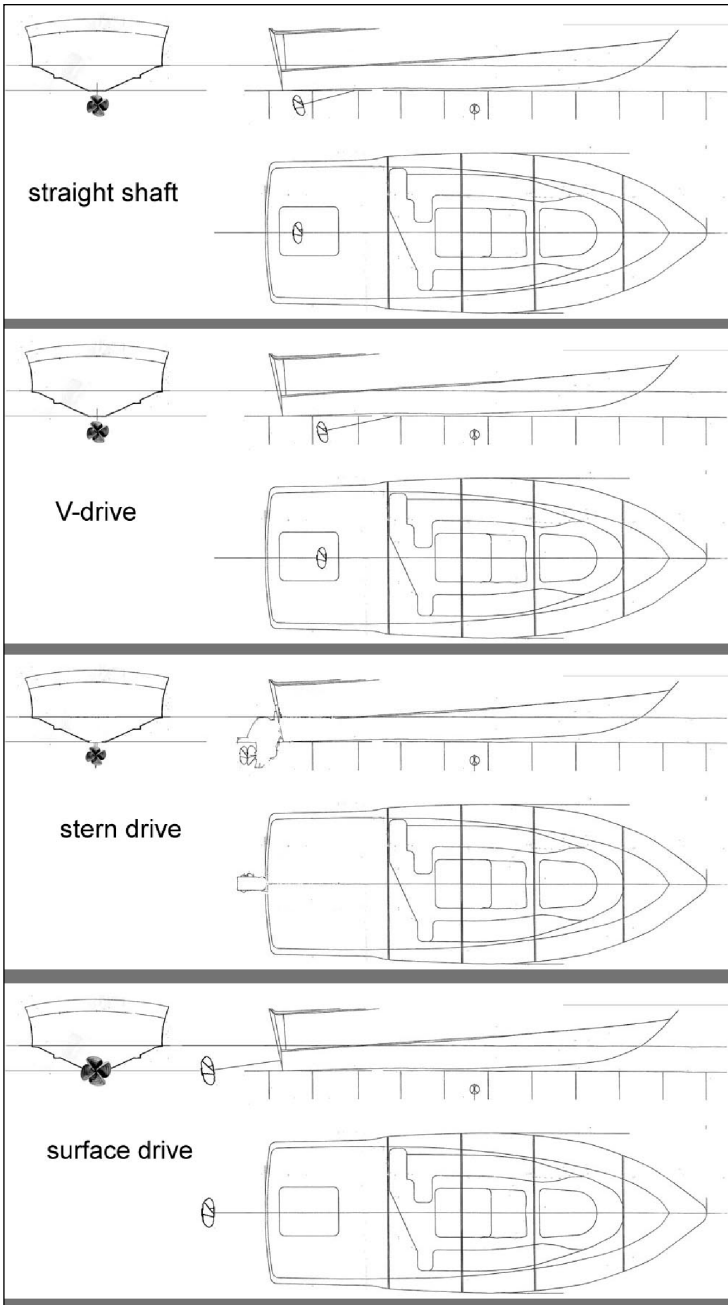
Figure 6

Composite 4-frame comparison of various drive configurations

Similar boats with conventional drives are reported to pull straight back when aft-pulling parachute forces exceed forward-pushing propeller thrust. However, the surface drive configuration places a number of additional drag elements, particularly a large rudder, much further aft than conventional propulsion systems, as shown in Figure 6.

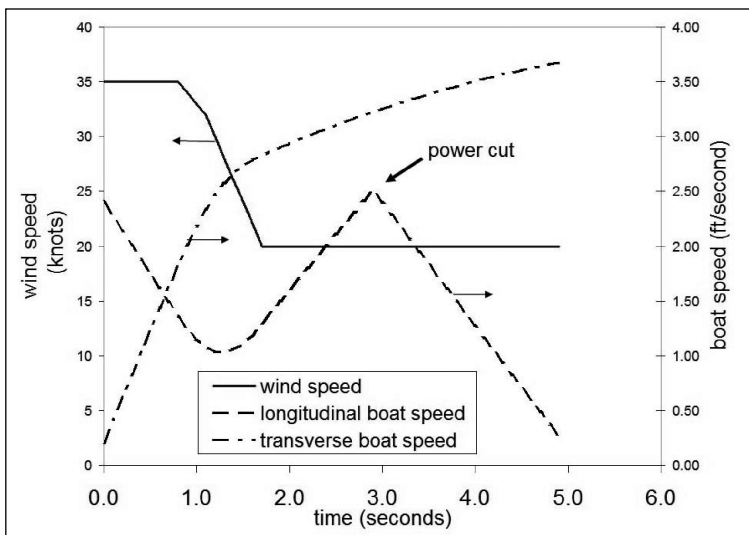
Figure 7

Vessel response to wind gust and power change

The response of the vessel to the wind gust and subsequent changes in the towline loads are calculated using a basic time-domain force and motion analysis, implemented on an excel spreadsheet for time steps of 0.1 second (Figure 7). For each time step, calculated aerodynamic and hydrodynamic forces are applied to the mass of the vessel and entrained water to compute the new velocity and position for the next time step.

During the four seconds following the initiation of the gust, the analysis shows that the average transverse speed of the vessel was approximately 1.5 knots and increasing, and the average forward speed was approximately 1.0 knots. Forward speed first decreases in response to the high towline force when

the gust hits, then increases as the gust subsides, but begins to drop again after the gearbox is shifted to neutral, three seconds after the initial gust onset.

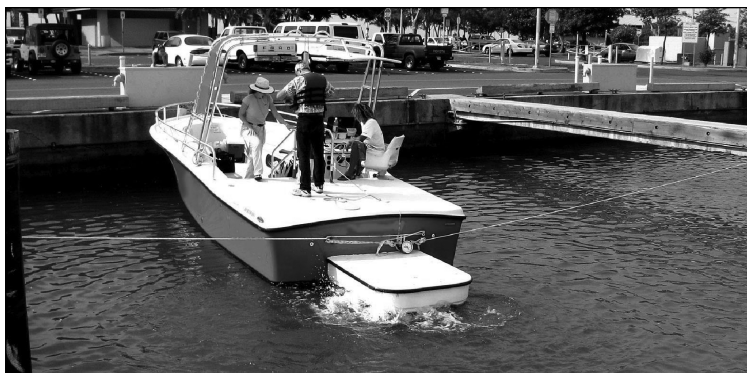
Figure A-1
Winchboat in test basin for steering thrust measurement

In order to determine thrust and steering forces relative to a vessel's response to parachute wind load, static thrust and steering yaw torque were measured directly using the subject vessel.

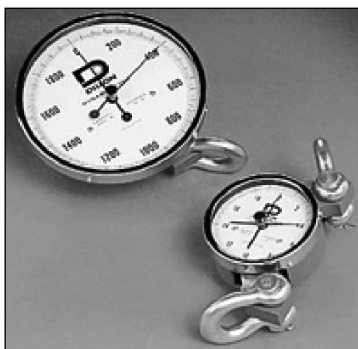
Figure A-2
Dynamometer

Static thrust at various engine and propeller speeds was measured directly using a calibrated spring dynamometer.

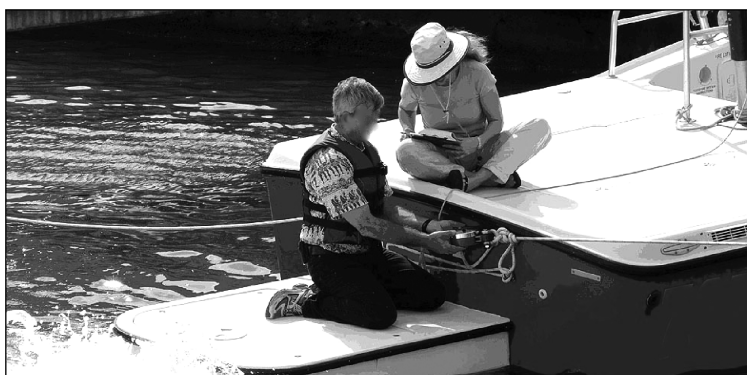
Figure A-3
Recording steering thrust

Static steering force was measured by restraining the vessel at the bow and measuring tension in restraining cables at right angles to the vessel's centerline.

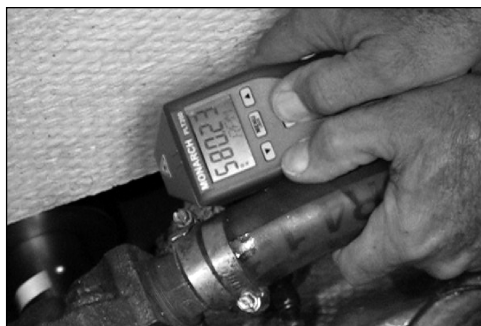
Figure A-4
RPM measuring device

The handheld laser RPM meter, aimed at a marker on the propeller shaft produced a time history of the propeller RPM before and after the gearbox was shifted to neutral.

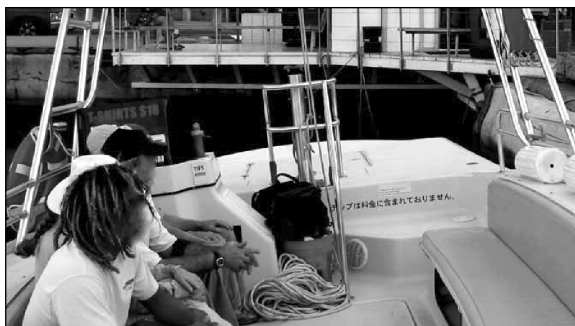
Figure A-5
Inclining test

Static roll stability was determined by means of an inclining test. These tests normally require a detailed description of the vessel's hull form in order to assess center of gravity and other mass properties for the purpose of determining compliance with regulatory requirements. However, for this application it was succinctly necessary to establish the relationship between heeling torque and heel angle, so both mass properties and hull form characteristics would drop from the calculation. The test was performed by moving a known weight, measured with acceptable precision by means of a domestic scale, across a known distance from one side of the vessel to the other. Total weight on board was approximately the same weight as at the time of the accident, and heel angle in response to the weight movement was measured photometrically (See Figure A-5).

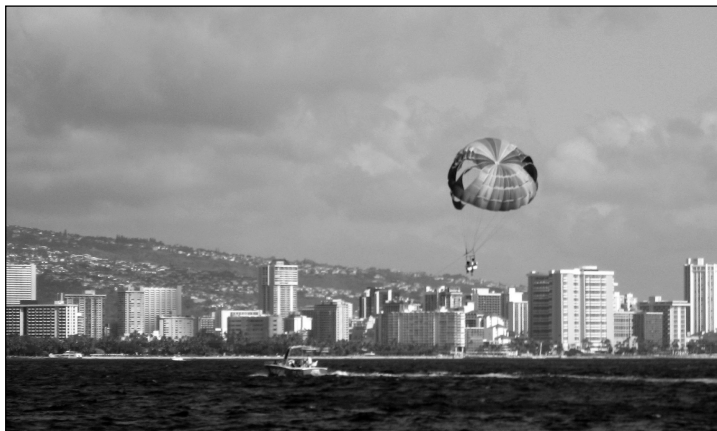
Figure A-6
Overall view of parasailing operation

The parachute used for parasailing is circular with vents. In operation, it is towed horizontally but assumes an angle to the direction of motion, producing drag and lift (See Figures A-6 and A-7).

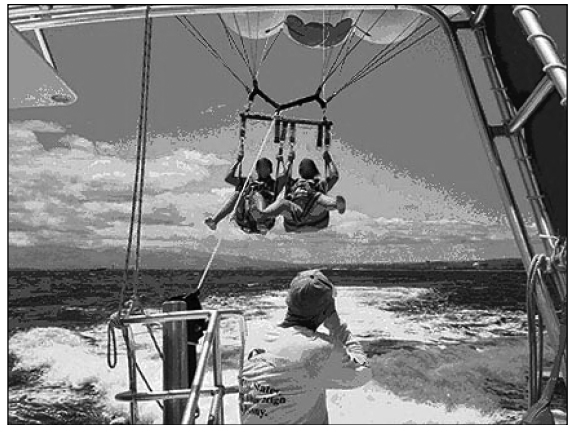
Figure A-7
Parasail towing geometry

By rotating the coordinate system of the gliding parachute 45 degrees, a reasonable approximation to the configuration of a parasail parachute under tow could be obtained. The lift and drag coefficients from Hoerner resolve to a towline force

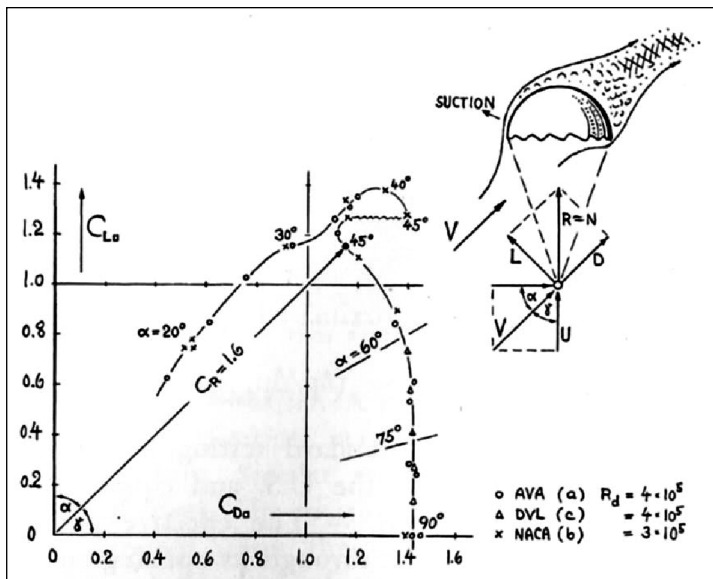
Figure A-8

Diagram of gliding parachute forces: aerodynamic characteristics of hemispherical shells, rigidly suspended in wind tunnels²

Data for for a “gliding” circular parachute is found in *Fluid-Dynamic Drag*, by Hoerner¹ (see figure A-8).
