**Vol. XXV No. 1 June 2008**

# Forensic Engineering Assessment of Safety for Stand Up Forklifts

by *Richard M. Ziernicki, Ph.D., P.E. (NAFE 308F)*

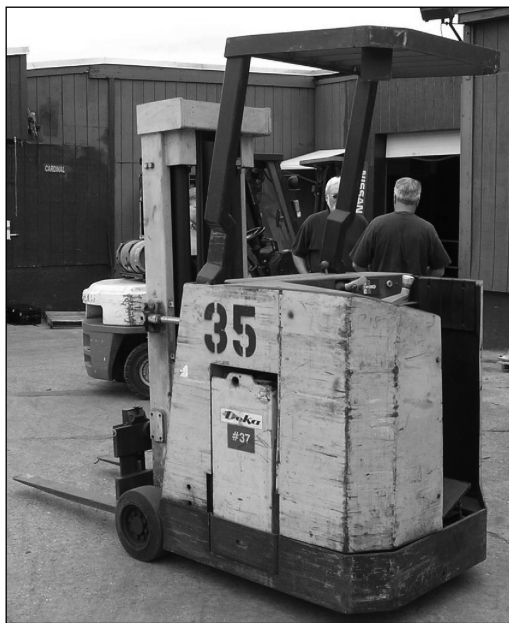
**Figure 1**

Crown RC30TT – Stand Up, End Control, Counterbalance Lift Truck

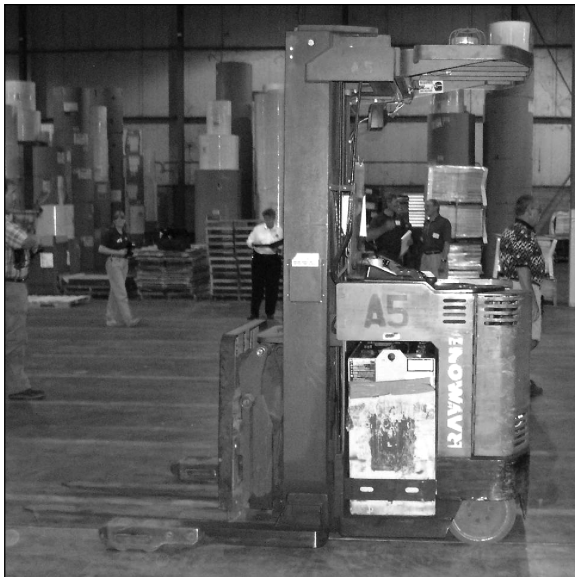
**Figure 2**

Raymond 31i-DR30TT – Stand Up, End Control,  
Deep Reach Truck

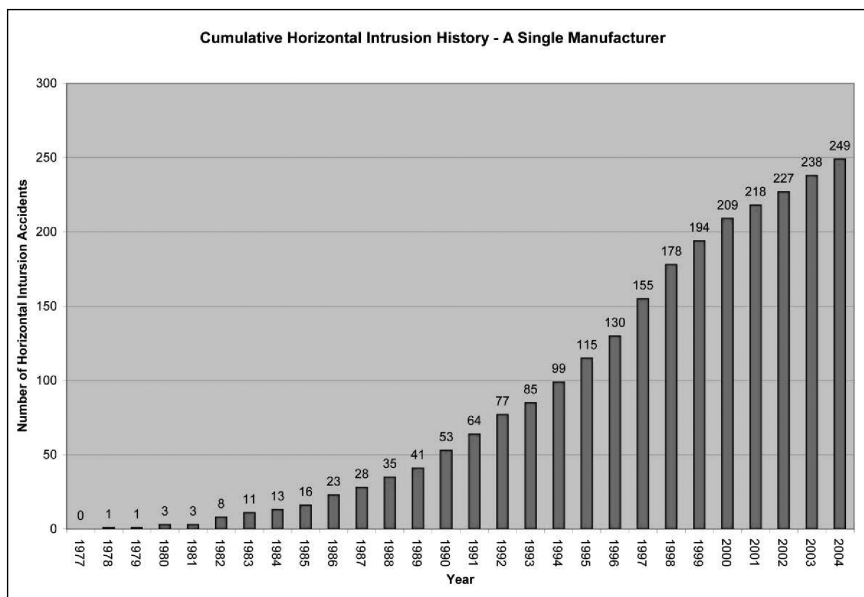
**Figure 3**

Cumulative Number of Horizontal Intrusion Incidents

Statistics regarding the frequency and severity of horizontal intrusion incidents are not readily available. Some manufacturers of stand up lift trucks keep relatively detailed databases regarding incidents, while others do not retain records of incidents. OSHA records regarding incidents of horizontal intrusion are available however, the employee must have been injured and the employer must notify OSHA before a report can be generated. Review of one manufacturer's records indicates that over 250 incidents of horizontal intrusion have occurred on the manufacturer's stand up narrow aisle and counterbalanced lift trucks. The incidents include 12 fatalities and over 100 serious injuries over the past 30 years. Given the similarity between the stand up lift trucks manufactured by various manufacturers, it is likely that many more fatalities and significant injuries have occurred due to horizontal intrusion. Figure 3 details the cumulative horizontal intrusion incident record of one stand up lift truck manufacturer, and Figure 4 details the horizontal intrusion incident record of the manufacturer on an annual basis. The manufacturer detailed in Figure 3 and 4 began production of stand up lift trucks in the mid 1970's and did not begin tracking incidents until 1977.

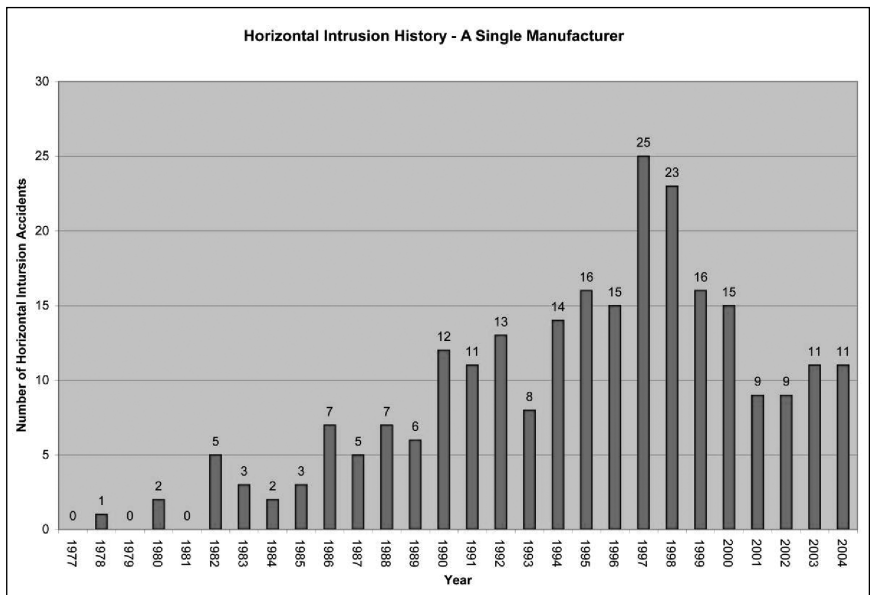
**Figure 4**  
Annual Horizontal Intrusion Incident History

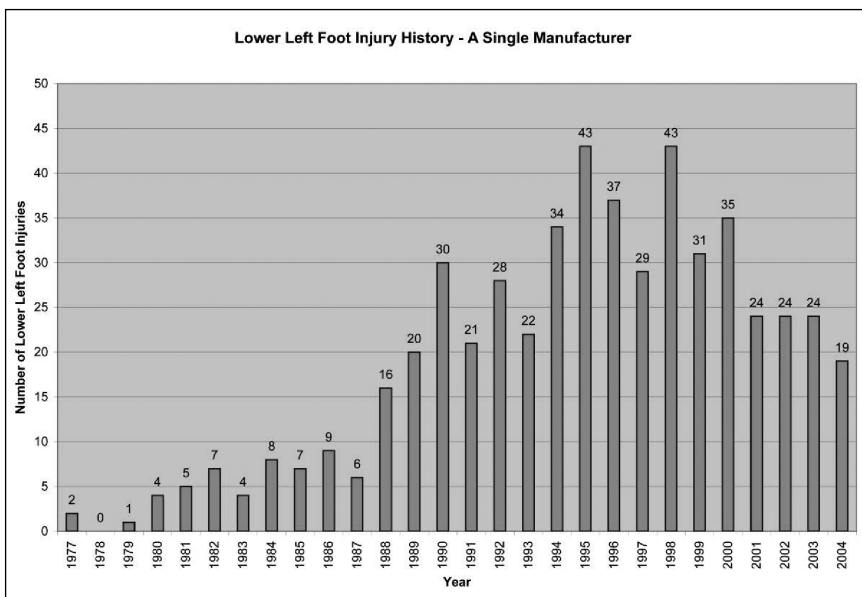
**Figure 5**  
Annual Lower Limb Injury/Incident History

Statistics regarding lower limb injury and foot crush have been compiled in several ways. As with horizontal intrusion some manufacturers keep detailed databases, while others do not. Because of the number of serious lower limb injuries a significant track record has become established in the legal system and attorneys involved in this litigation have established a significant database of lawsuits filed on this issue. OSHA records are also available to establish the frequency of injury. Figure 5 and Figure 6 detail the number of injuries and

incidence on a single manufacturer's stand up lift trucks. As with the charts detailing horizontal intrusion history, the manufacturer detailed in Figure 5 and 6 began production of stand up lift trucks in the mid 1970's and did not begin tracking incidents until 1977. The manufacturer's records indicate that over the last 30 years, over 500 accidents or incidents involving lower limb injury have occurred.

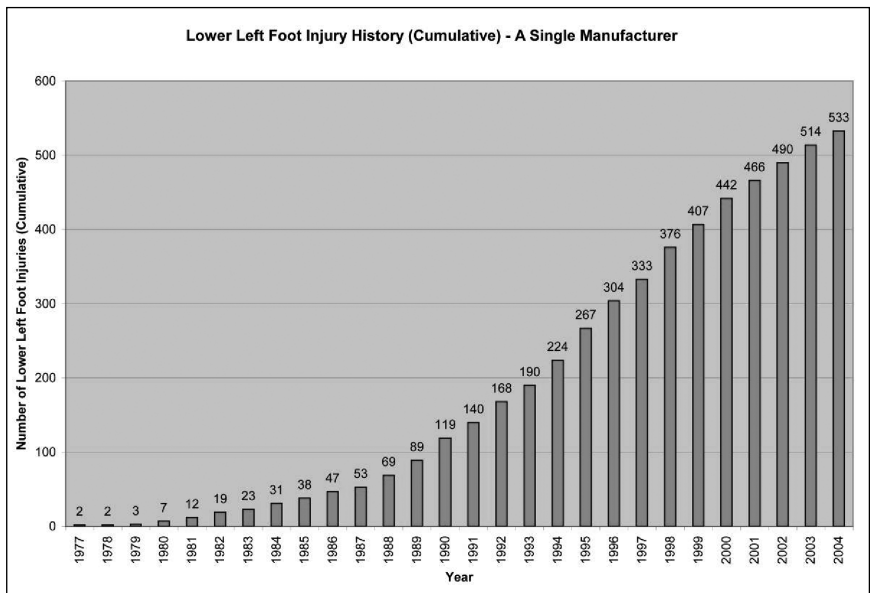
**Figure 6**  
Cumulative Lower Limb Injury History

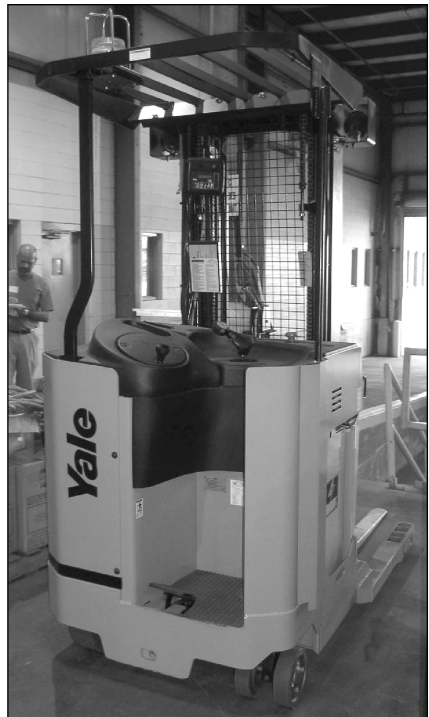
**Figure 6**  
Yale Stand Up Narrow Aisle Reach Truck

In contrast to the manufacturer who has suggested that all warehouses should be redesigned, other safety engineers have addressed the design of the stand up lift truck. An engineering design solution to eliminate the hazard and protect the operator from horizontal intrusion has not currently been identified. However, several styles of guards have been produced to protect the operator from horizontal intrusion. Vertical posts extending from the rear of the operator compartment to the overhead guard form an effective guard against rack beams entering the occupant compartment. Posts have been used for several decades by some manufacturers to protect the operator from horizontal intrusion by some manufacturers. Appendix A details the use of posts by various manufacturers. Arguments against the use of a post have been raised by some manufacturers in litigation. A rear post reduces visibility from the operator's position. A post located in close proximity to the operator may create a pinch or shear point when the operator is caught between the post and racking or a pallet. Currently several manufacturers are equipping trucks with a post(s) as a standard feature. Figure 6 is a Yale narrow aisle lift truck equipped with two posts.

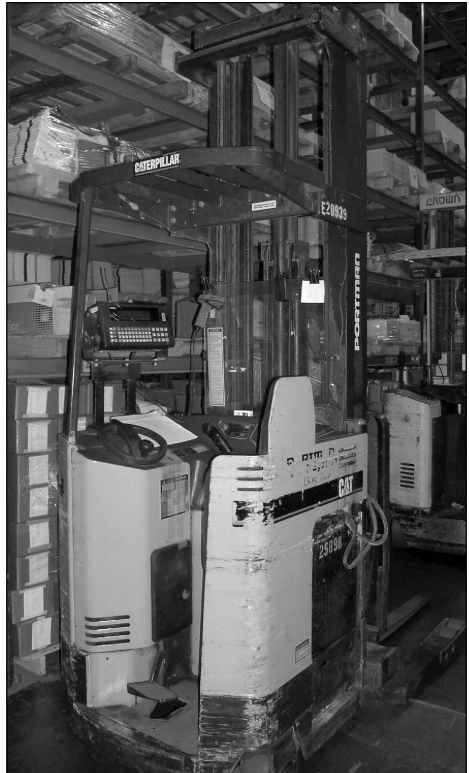
Figure 7 is a photograph of a Caterpillar reach truck equipped with a “backrest extension” that extends the wall or skirt of the lift truck above the height of the first rack beam in a warehouse.

**Figure 7**  
Caterpillar NRR45  
Stand up Narrow Aisle Reach Truck
