**Vol. XXV No. 2 December 2008**

# Forensic Engineering Investigations of Product Liability Cases

by *Richard M. Ziernicki, Ph.D., P.E. (NAFE 308F)*

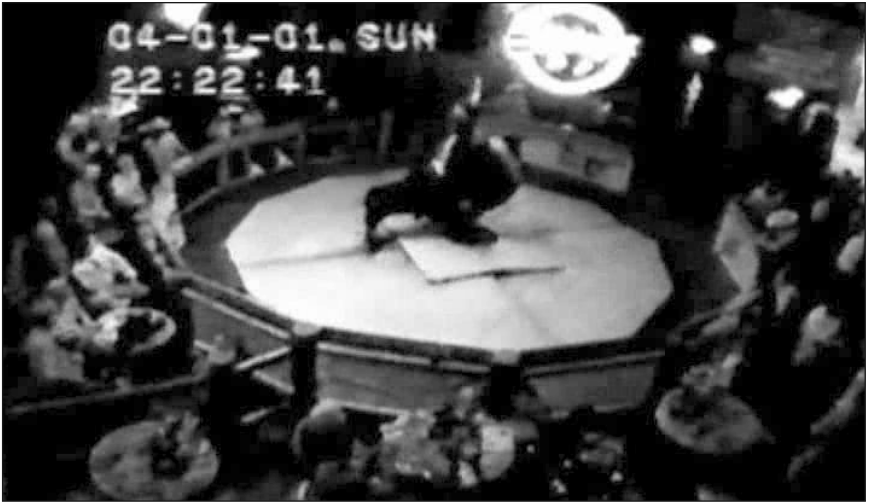
At approximately 10:20 pm, on April 1, 2001, the plaintiff mounted a mechanical bull in a night club located inside a casino in Las Vegas, Nevada. The plaintiff was an employee of the casino, and regularly rode the mechanical bull during his off duty hours. Security video cameras captured the incident in black and white video. Review of the video shows that the plaintiff was an experienced rider, and rode the bull for approximately 30 seconds. As the ride progressed the operator increased the bucking speed of the bull, and increased the rotational speed of the bull, while switching the rotation direction of the bull. When the ride approached the thirty second mark, the plaintiff began to fall off of the bull. Approximately 1 second after the rider began to separate from the bull, the operator stopped the ride. As the plaintiff separated from the bull, he was thrown approximately 6 feet in the air and fell on his head and neck with his body above him. The plaintiff described his body as being in a fetal position when he came into contact with the mat. A witness described the plaintiff as falling in a “pike” position onto his head, neck and shoulders. Figure 1 is a still frame extracted from the video during the ride and Figure 2 is a still frame of the plaintiff when he first came into contact with the mat.

**Figure 1**  
Still Frame from Video of Plaintiff's Ride

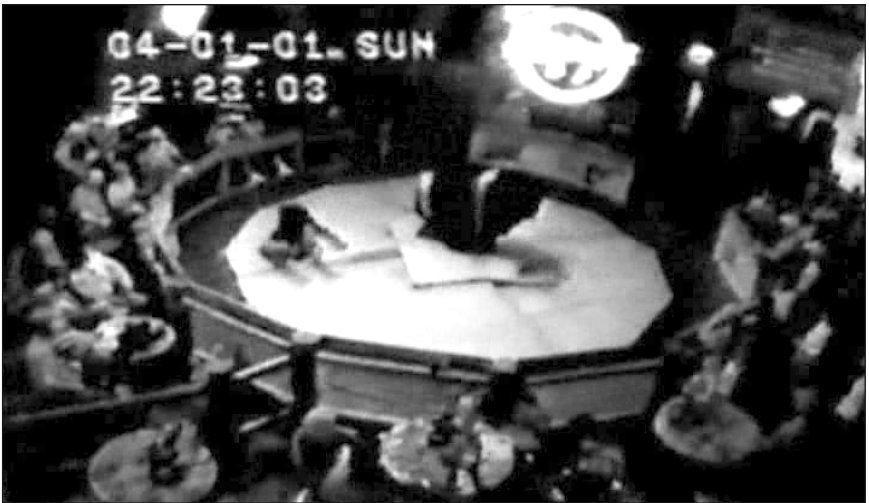
**Figure 2**  
Still Frame of Plaintiff Landing

These engineers reviewed medical records for the plaintiff which indicated that the plaintiff did not sustain any symptoms of a head injury as a result of the incident. These engineers further performed analysis to determine the head injury criteria (HIC) values that would have likely been generated during the incident based on analysis of the surveillance video of the incident. Because the plaintiff did not sustain a head injury, and the low HIC values associated with the incident, these engineers concluded that the foam padding significantly reduced the force applied to the plaintiff and his head during his landing.

Further, research literature available regarding foam padding, head injury, and neck injury indicated that a “pocketing” mechanism can develop where the head of a person can become trapped in a crash pad or landing pad when the pad is too compliant. When the head of person landing on a crash pad becomes trapped in a pocket, the torso can translate relative to the head leading to serious spinal injuries. Therefore, these engineers concluded that a more compliant mattress might actually increase the number of injuries associated with the bull ride.

Since the plaintiff was essentially alleging that the mattress was not compliant enough, but did not sustain a head injury these engineers concluded that additional padding or the use of an air mattress would not have significantly reduced or eliminated the injury. Further, the use of an air mattress may have generated additional injuries on the bull ride.

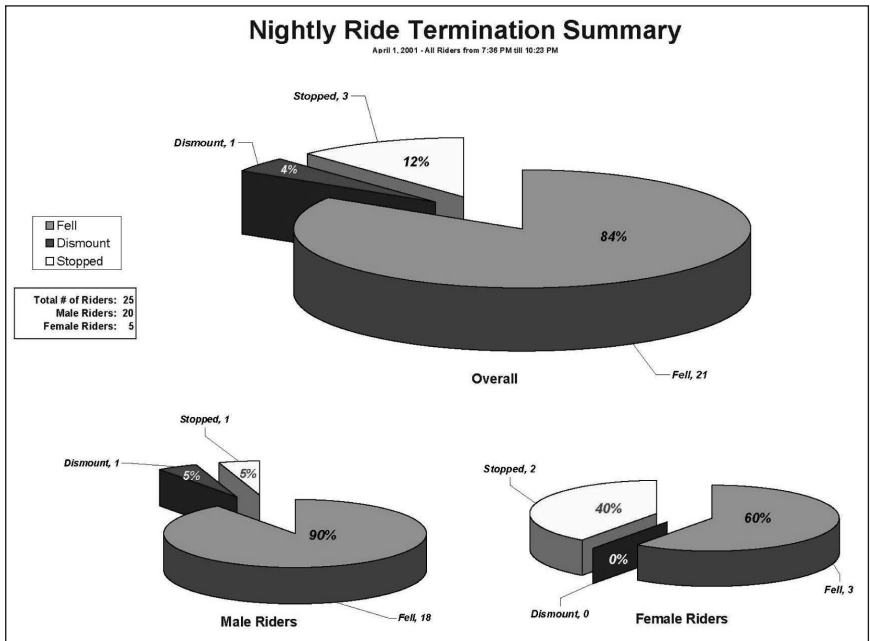
**Hazard Assessment/Risk Analysis:** The hazard associated with the mechanical bull ride is sustaining trauma as a result of being thrown from the ride. The risk, or probability of sustaining a severe injury, associated with the hazard depends on the nature of the dismount from the ride, the speed and/or height that the rider falls, and the force created by the landing. Most riders fall from the bull; however, the majority of riders did not sustain serious injury as a result of the ride. Figure 3. is a graphical representation of the ride termination analysis indicating that most riders fall from the bull.

**Figure 3**  
Analysis of Ride Termination

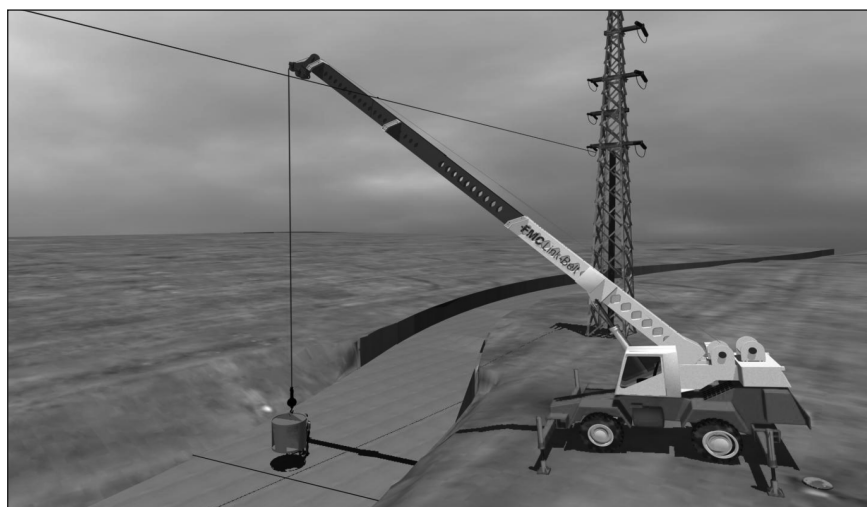
At approximately 3:00 pm on December 27, 1999, the plaintiff, a construction worker, was guiding a concrete bucket attached to the load line of a rough terrain hydraulic crane in St. Louis, Missouri. As the plaintiff guided the bucket to the desired location the crane operator began to raise the boom of the crane. The boom was located underneath high voltage power transmission lines, and as the crane operator raised the boom the tip of the boom came into contact with the overhead lines. Electric current traveled down the load line electrifying the concrete bucket held by the plaintiff. The current continued to travel through the plaintiff's hand, arm, body, and legs as it completed the path to ground. As a result of the incident the plaintiff sustained serious burns over the majority of his body. As a result of the burns and significant damage to his extremities in the ground path, the plaintiff's arm, and legs were amputated. Figure 4 is a computer generated graphic of the power line and crane.

**Figure 4**  
Crane and Power Line at Construction Site

**Design Options:** The crane in use at the time of the accident was not equipped with any design safety features specifically designed to prevent electrical shock incidents. The crane was equipped with an angle indicator which allows the operator to view the angle of inclination of the boom, and it was retrofitted with an anti-two block alarm/limit switch. The anti-two block alarm sounds and cuts power to the load line winch when the load hook is drawn too far back into the boom.

These engineers identified several technologies that would have prevented the accident, or significantly reduced the probability of the accident. Several crane and bucket truck manufacturers have produced booms that are insulated or composed of non-conducting material. Other crane manufacturers have produced cranes with insulated barriers surrounding the boom of the crane. The most significant technology that these engineers identified that would have prevented this incident (and other accidents) was the use of more advanced controls for the crane operator. The crane in use at the time of the accident was not equipped with any user defined motion limits. The only limits on boom motion were created by the natural limits of the machine. More advanced controls which would limit the angle that the boom could be raised, or the

distance that the boom could be extended (based on operator input) were available as an option. Such controls would have allowed the operator to preset the maximum angle that the boom could have been raised, which would have prevented the operator from accidentally raising the boom into the power line. The original retail price of the crane in 1984 was \$144,730. The price of the optional control package would have increased the cost of the crane by less than 5% which indicates that the control package was not only technically feasible, but was also economically feasible. Therefore, these engineers concluded that design options existed, available from the manufacturer, which would have prevented the accident.

**Guarding Options:** Because the hazard of cranes coming into contact with power lines has existed for a substantial period of time, multiple guarding solutions have been developed. Two of the guarding solutions identified by these engineers included insulated load line links and a proximity warning device. The insulating link is attached between the load line and the load to protect the construction worker on the ground by preventing electrical current from reaching the load. Insulating links are also available for tag lines used by ground crews to manipulate the load.

Proximity warning devices sense the electromagnetic field associated with power lines. An antenna is placed on the boom of the crane to sense the magnetic field, and a control box in the cab of the crane warns the operator when the boom of the crane is too close to the power line. The proximity warning device guards the crane against the hazard of power line contact by creating space between the power line and the crane. In essence the proximity warning device “guards by location.”

Proximity warning devices and insulating links represent at least two guarding options that would have prevented the electrical shock incident. Design options are always preferable to guarding options; however, multiple layers of safety may be beneficial in this case.
