# Forensic Engineering Investigation of Vehicle Wheel Separations

by John Leffler, P.E. (NAFE 709M)

## Abstract

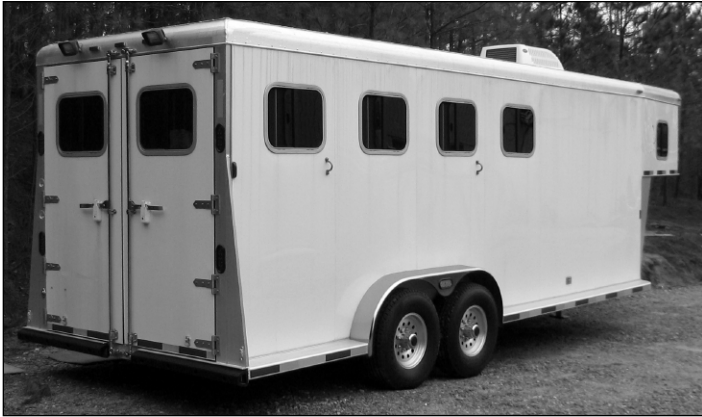
**Figure 1**  
subject trailer at initial inspection

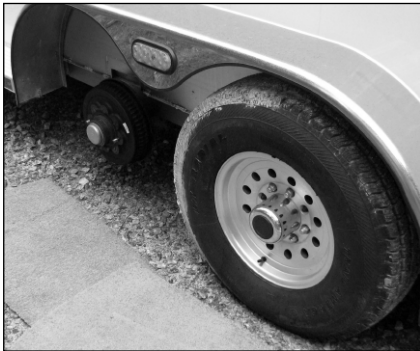
**Figure 2**  
left front hub and left rear wheel

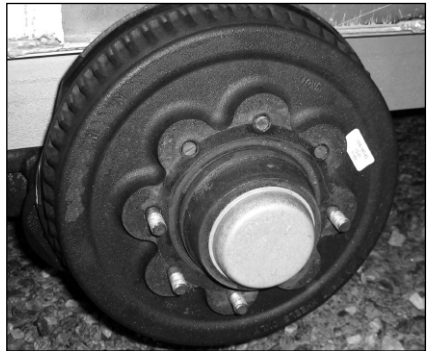
**Figure 3**  
damaged left front hub

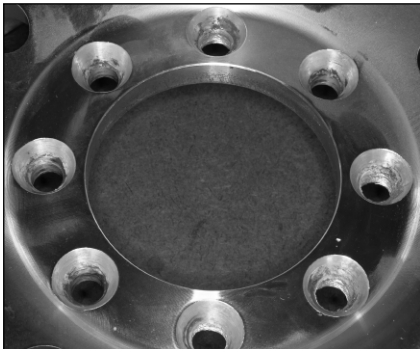
- Several of the conical nutseats in the subject wheel appeared to show embedment of the lugnut’s hex shape in the aluminum. The effective lugnut contact surface (observable in the remaining wheels) seemed minimal. Several of the conical nutseats also showed evidence of contamination with unknown substances.

**Figure 4**  
nutseats of separated wheel

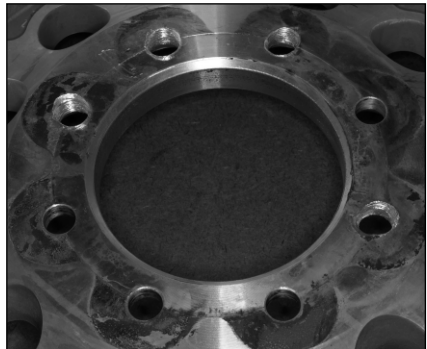
- The wheel’s hub mounting face featured a slight recess inboard of the bolt circle centerline. There was evidence of black paint accumulation on the hub contact surface of the wheel. The four lug holes corresponding to the unbroken studs were deformed and abraded.

**Figure 5**  
mounting face of separated wheel

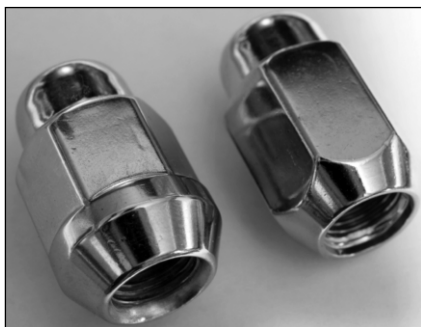
**Figure 11**

- **Lugnuts**
  - Low carbon (AISI 1015) steel, with a nominal 13/16” hex, case hardened to approximately Rockwell C32, and chrome plated. The lugnuts were not of the design typically used with aluminum wheels, known as “bulge” lugnuts. Lugnuts instead were a design we will comparatively refer to as “non-bulge” lugnuts, which are sometimes referred to as a “steel wheel” lugnuts. See Figure 11 for comparative views of these lugnut types.

These non-bulge lugnuts have a discontinuous conical surface of contact (with the wheel) due to the cone surface's intersection with the hex flats, and sharp "points" exist at these intersections. The hex points of the subject non-bulge lugnuts (from the remaining wheels) showed galling and accumulations of wheel aluminum. See Figures 12 & 13.

bulge lugnut (left) and non-bulge lugnut

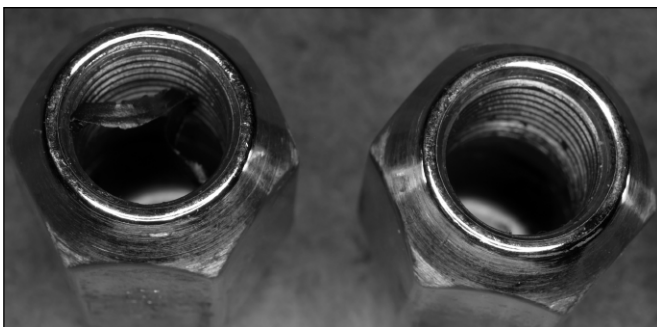
**Figure 12**  
subject lugnuts with aluminum transfer to hex points

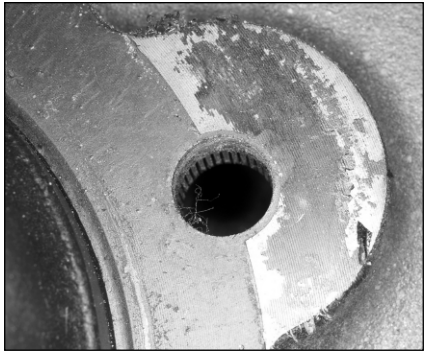
- The valleys of the spiral machining grooves provide a place for the paint to go after wheel assembly, as it is squeezed out of the interfacing groove peaks. This paint migration will cause stud preload relaxation. Once the grooves are full, paint will extrude out from the joint, primarily in a

tangential direction along the grooves. This can be observed on the subject trailer hubs and wheels – see Figure 14.

**Figure 14**  
view showing paint extrusion  
from hub face

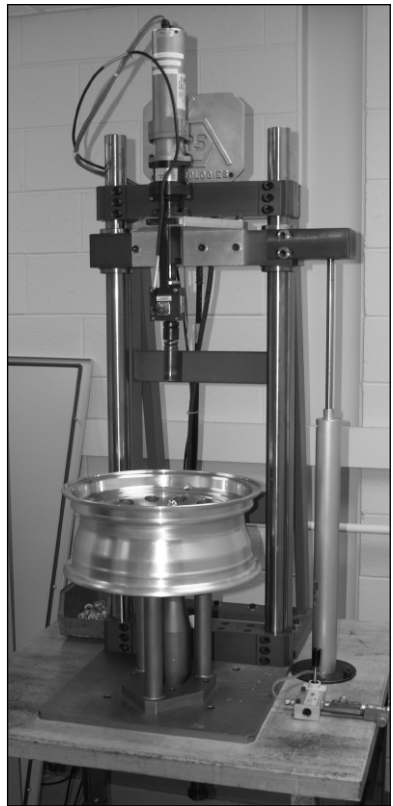
- The simpler method used a torque-tension tester, which tracks the torque application to a lugnut versus the stud tension. Such testing is done without the application of any radial or lateral loads to the wheel. Because of this, embedment and clamp load relaxation (due to loading) cannot be evaluated. However, in the absence of any other available data on the relative performance of non-bulge lugnuts versus bulge lugnuts in a subject style wheel, testing these types of lugnuts/wheels on a torque-tension machine seemed a reasonable step.
- The test apparatus (see Figure 15) used an electronically-controlled and instrumented wheel gun to tighten the lugnut at a prescribed rate and to a prescribed torque application limit, while a load cell measured the increase in stud tension relative to torque application. Exemplar wheels, studs, and both non-bulge and bulge lugnuts were obtained.

**Figure 15**  
torque/tension test apparatus

The testing apparatus and exemplars were set up and the test cycle initiated – tightening of the lugnut at 20rpm with tension values sampled at 85, 100, 115, and 130 ft\*lb of torque. A squeaking sound was heard as the tightening commenced, and after disassembly, an unexpected yet significant coating of the wheel’s clearcoat was found in the lugnut contact area of the wheel’s nutseat. The lugnut achieved the desired torque, with a high amount of stud tension, yet the steel lugnut and aluminum wheel nutseat were not actually touching – the clearcoat kept them from making the desired metal-to-metal contact. This was found with both bulge and non-bulge lugnuts. See Figures 16 and 17, and note the powdery clearcoat residue.

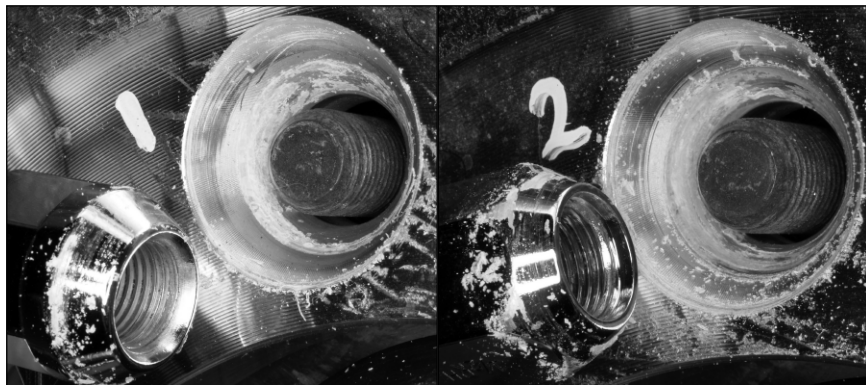
**Figures 16 & 17**

The biaxial wheel testing expert, a wheel industry veteran, observed that these surfaces were typically masked to prevent introduction of the soft coating between the wheel and lugnut. This finding highlighted the need to do more research, particularly into establishing whether the subject wheels also had clearcoat in the nutseats. It was also decided that the simple torque-

clearcoated nutseats after installation of bulge (left) and non-bulge lugnuts

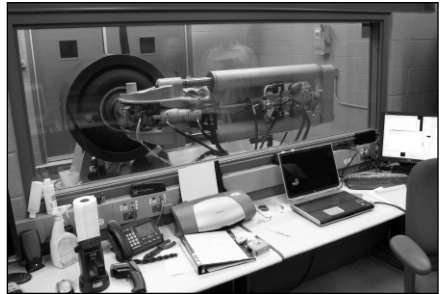
**Figure 21**  
biaxial wheel test machine and controls

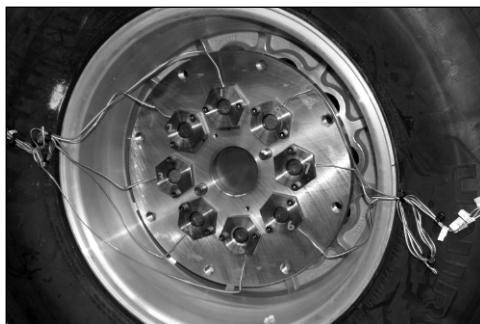
**Figure 26**

- **Test 2:** Wheel D (bare nutseats), non-bulge lugnuts. No retorquings were necessary, as the stud tension didn't drop over 5% in the first 50 miles. After testing, the apparatus functionality successfully allowed stud tension to be released from each lugnut without rotating the lugnut in the nutseat. See Figure 26.

stud/studholder assemblies prior to removal from lugnuts

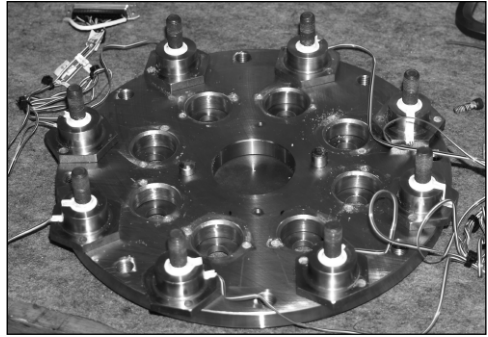
Test results data is shown in Figure 31. The apparatus was checked and reassembled for the next test. See Figure 32.

**Figure 32**  
inspection and reassembly of custom apparatus

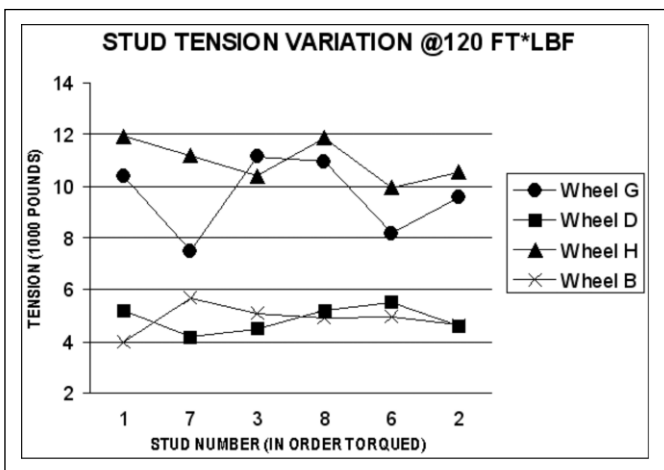
- Consistent with the earlier discussion of applied lugnut torque versus resulting stud tension, the test results show that even with indicated torque standard deviations of less than 1 ft\*lb, there were still stud tension standard deviations of 7% – 15% for each of the four wheel/lugnut combinations tested. The variability appeared to be largely independent of the sequence used in lugnut torquing – see Figure 41.
- It was decided to change the focus of testing to try testing various other elements. Suggestions by opposing parties included that the trailer manufacturer had not ever torqued the wheels, or that retorques were not performed, and the following supplemental tests were intended to explore those scenarios.

**Figure 41**  
stud tension variation versus tightening order
