Forensic Engineering Investigation of a Fall from a Construction Machine

By John Leffler, P.E. (NAFE 709S)

Erich Schlender, P.E. (NAFE 451C)

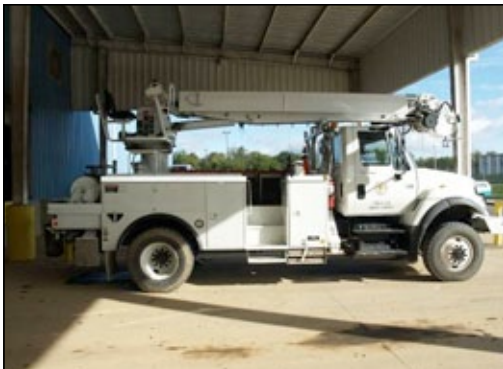
Figure 1
Subject Digger Derrick Truck

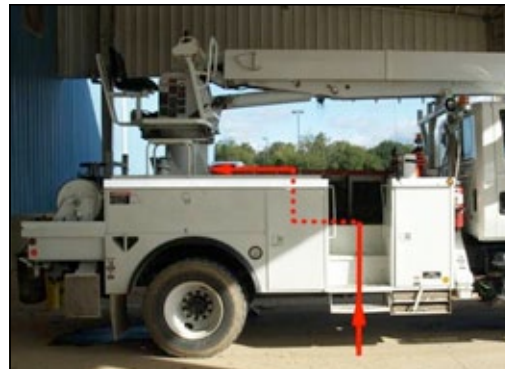
Figure 2
Sole boarding route for entering turret control platform

1. The manufacturer-designed route to be taken by operators when they climb to use the digger derrick controls is shown in Figure 2. Enroute to the turret control platform, the operator must climb atop the right-side cabinets of the truck body and stand on an expanded metal walkway. This walkway was approximately 72 inches above the ground and was 18 inches wide as shown in Figure 3.

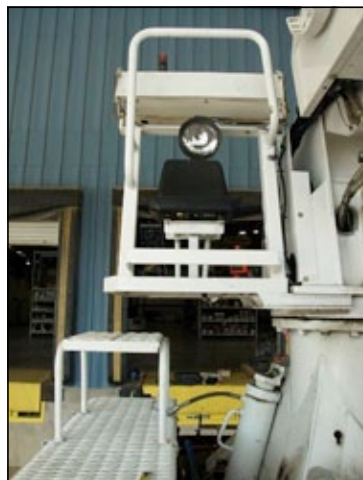
Figure 3
Walkway and access route to turret control platform, looking rearward

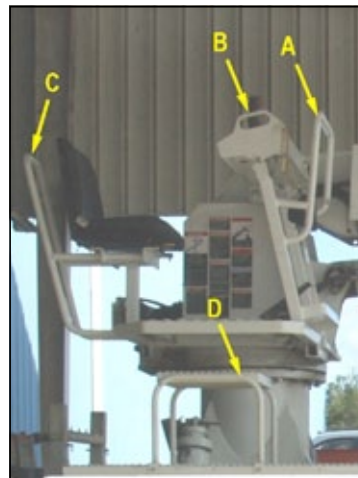
Figure 4
Access system features of subject turret control platform

2. Referring to the labels in Figure 4 depicting the digger derrick turret, Handrail **A** was a tubular loop approximately 1.5 inches in diameter, welded to the front of the dashboard support frame. Handhold **B** was a rounded-rectangular hole cut in the right-side dashboard end panel, which was made of 3/16-inch thick steel plate. Handrail **C** was a tubular loop approximately 1.5 inches in diameter, welded to the seat

support behind the seat. Also present in the access system for the turret control position was a fabricated metal platform step **D**. It was attached to the top of the walkway by 4 bolts, and reportedly had originally been mounted approximately 9 inches forward on the walkway using an alternate set of mounting holes still visible.

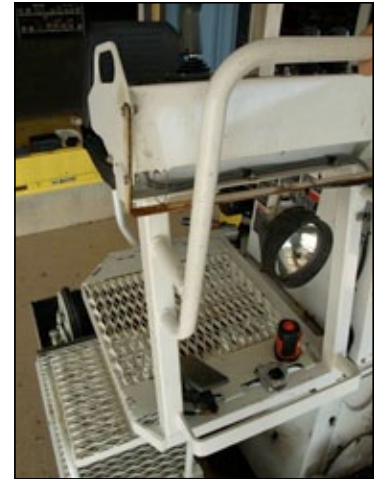
3. The viewing perspective of one author (6'3" in height) when standing on the walkway to mount the control position is shown in Figure 5. It can be observed that handholds **A** and **B** were both near the viewer, and past them was the actual entry area onto the platform and seat of the turret control position. Beyond the seat, and not generally visible to the viewer, was handhold **C**.

Figure 5
View prior to boarding turret control platform

step contacts the user's shins and prevents the user's heels from being able to rest on the walkway – thereby requiring the user to constantly hold onto handrails/handholds to avoid falling. See Figure 9. The user cannot climb the platform step **D** from the “starting position” shown in Figure 5 without relying on Handrail **A** and Handhold **B**, which both end up on the right side of the body during climbing, preventing the establishment of a stable 3-point-contact base of support. This is further complicated (as mentioned) by the general inability to see Handhold **C** when starting to board the turret control platform.

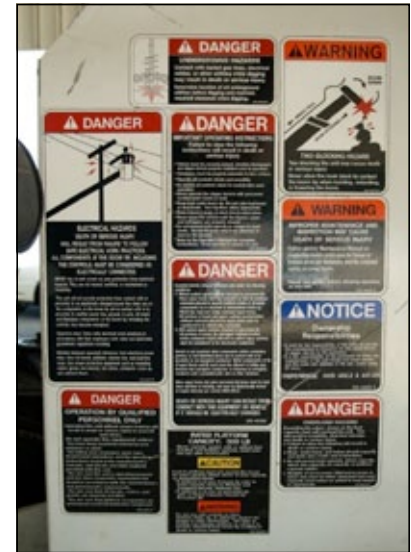
To the left side of the operator’s seat are a series of operator warning labels – see Figure 6. While various operational hazards are identified, no instructions for boarding/dismounting the turret control platform are given. Additionally, these warning labels are generally obscured from the operator’s view by the dashboard when the control platform is approached from the walkway as previously illustrated in Figure 5.

Figure 6
Warning labels

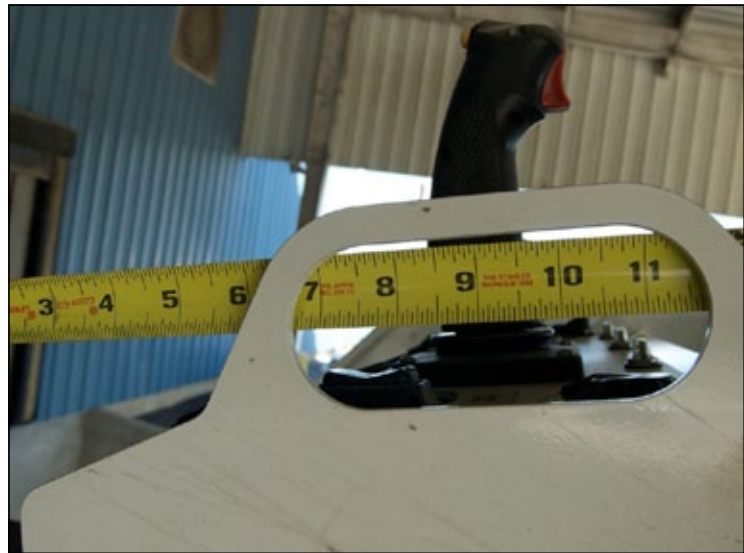
Handhold B: approximately 9 inches aft of Handrail **A** was a rounded rectangular handhold. This handhold was part of the plate forming the end of the turret control dashboard. The cutout slot of the 3/16-inch thick plate was measured to be approximately 5 inches wide by 2 inches tall. This left a handhold with a 1/2 x 3/16 inch cross-section. See Figure 8.

Figure 8
Handhold B

Another issue is that the dimensions of handhold **B** fell short of what is recommended in J185. Figure 10 shows a relative scalar comparison of the subject handhold and the J185 minimum grasping diameter of 0.63 inches.

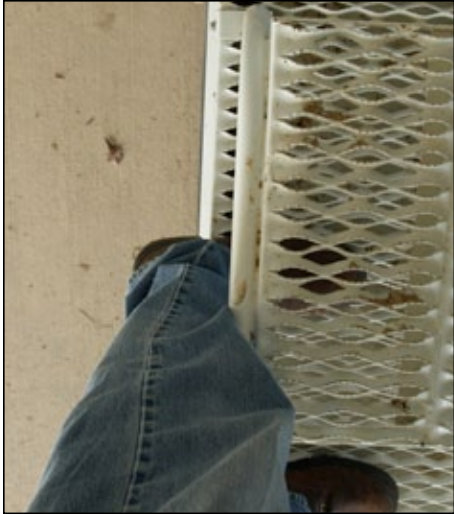
Figure 9

It can be seen that even if the vehicle's user wants to move to a position to attempt to use the existing handgrips and handhold, the platform step **D** basically blocks the user's way. The platform step must therefore either be carefully stepped around, over, or under, or straddled, before Handrail **C** can be grasped. If the feet are placed under the outboard side of the platform step, the tread of the

Shoe heel off walkway during frontal approach to turret control platform

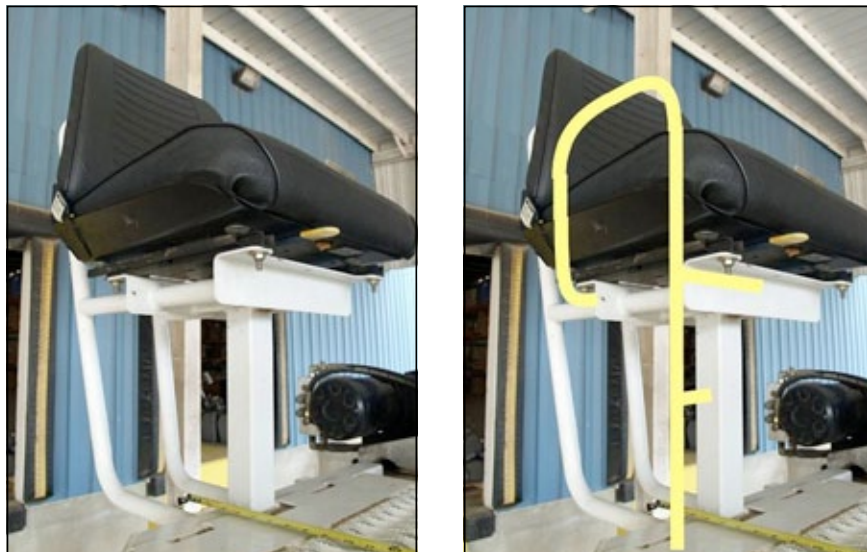
Figures 13 and 14
Comparison view showing alternate design for Handrail C

Figures 13 & 14 show a feasible alternate design for handrail C that is comprised of tubing welded to the seat base. It is formed to extend forward along the side of the seat and towards handrail A. The result is a handhold that is visible from all access positions prior to turret boarding and that is much closer to handrail A. This design would allow the manufacturer to stay within with the maximum distance between parallel handrails of 600mm (23.6 inches) as recommended by SAE J185, at a comparable cost to the existing design.
