Journal of the
National
Academy OF
Forensic
Engineers[®]

Forensic Engineering Investigation of Roof Failure in Rollovers

By Stephen A. Batzer, Ph.D., P.E. (NAFE 677M)

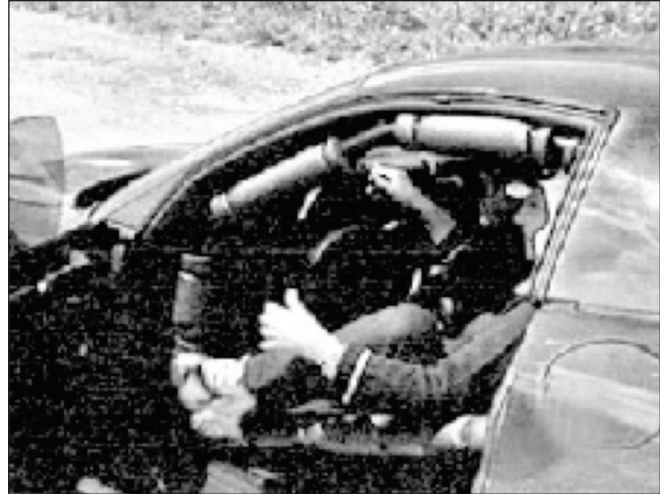
Corvette on GM test track with roll cage⁶.

The American regulation governing the laboratory performance of most passenger automobile roofs is found in the Code of Federal Regulation, *49 CFR Ch. V, 571.216 Standard 216; Roof Crush Resistance*³. The FMVSS-216 replaced the FMVSS-208 provision for a dolly rollover test, and is generally used instead of the now-rescinded SAE recommended practice J996, *Inverted Drop Test*. The 216 pre-amble states, “The purpose of this amendment...is to add a new Motor Vehicle Safety Standard...that sets minimum strength requirements for a passenger car roof **to reduce the likelihood of roof collapse in a rollover accident**” (emphasis added). Kahane⁴ of NHTSA restated this commitment to roof integrity, indicating that, “*The relationship between roof crush and occupant injury is self-evident and supported by statistics.*” Baccouche⁵ gave a concurring statement, “The crush resistance of roof structures is critical to minimizing injuries and enhancing occupant survival during rollover crashes.” Of note, the automotive industry has historically installed roll cages in developmental vehicles to increase the safety of the test drivers, as documented below.

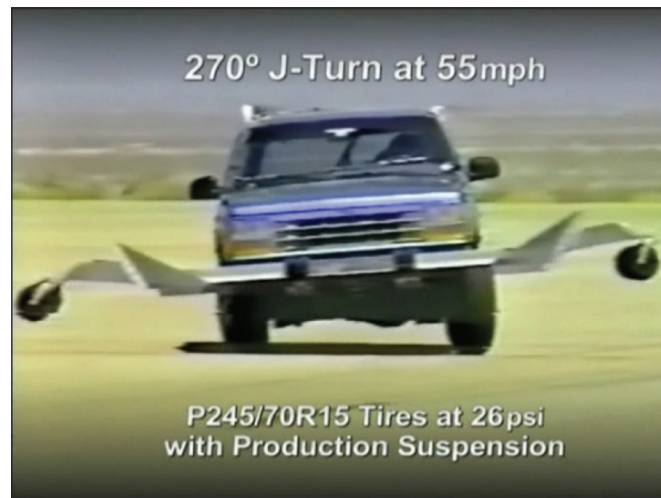
First generation production Ford Explorer in stability testing⁷.

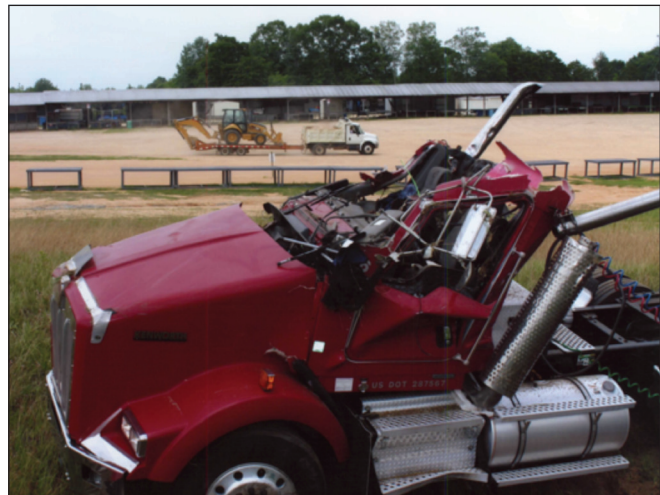
Fatal rollover of a 2007 Kenworth tractor showing loss of roof integrity⁸.

Heavy commercial vehicles are not regulated for roof strength. This produces predictable results. The roofs of many Class VIII trucks are little more than aluminum and/or fiberglass tents that are designed to keep out the elements, but have no appreciable rollover strength.

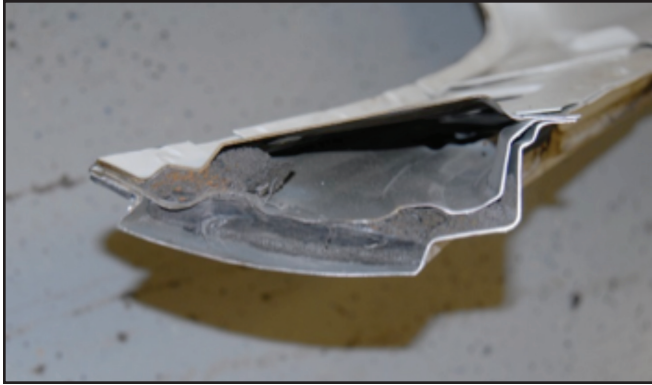
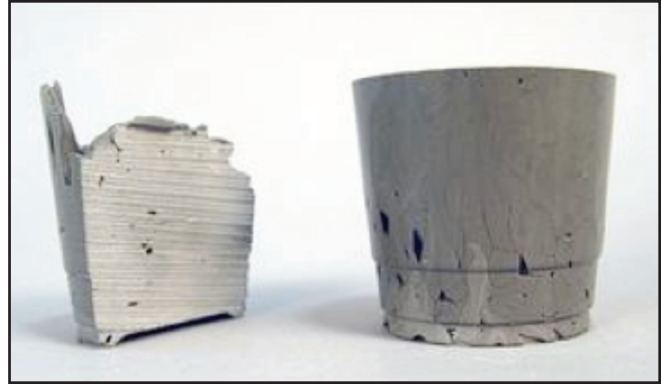
(L) Dampening foam (soft and lightweight) to reduce noise, vibration, harshness.

(R) Structural foam (rigid and dense) to support void spaces and increase crashworthiness.

6. **Rigid foam** can be applied to weak points of linear members to prevent column buckling. Thin-wall segments are inherently susceptible to collapse. Foam can be added during assembly to pillars and side and head rails cost effectively and quickly. This material will add strength, rigidity, and reduce vibration. Foam is currently used for NVH (Noise, Vibration and Harshness) attenuation in many automobiles. Lilley and Mani¹⁶ studied foam additions to hollow structural sections, and confirmed the assertion that filling A and B pillar sections with foam increased their strength. Higher densities of polymer yielded stronger, stiffer structures. For a mass penalty of 1.24 kg per vehicle, foam could be applied to the B-pillars and realize a 14% roof strength increase. As early as 1974, Fiat used structural foam in the A-pillars of their Experimental Safety Vehicle, with good results¹⁷.

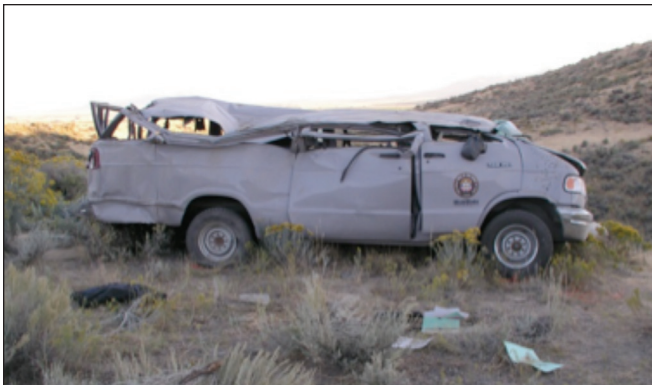
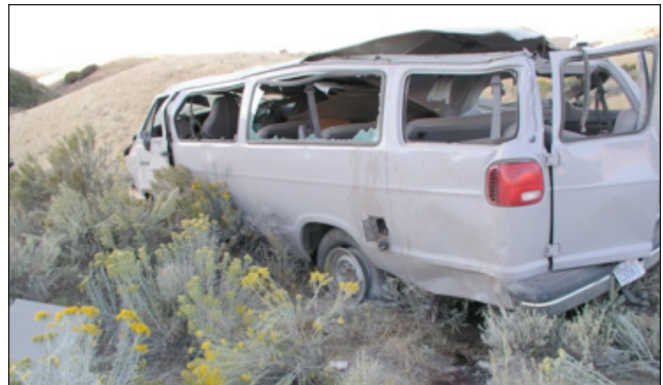
1994 Dodge Ram Van, 3 rolls, driver's side leading, roof avulsiongrity¹⁸.

in a driver's side leading roll. The van rolled down a hillside and came to rest on a small outcrop above a ravine. During the rollover event all eleven of the van occupants were ejected, resulting in nine of them dying. The vehicle's roof had 80+% spot weld failure at the drip line.

This was a single vehicle accident that occurred in the eastbound lanes and south roadside of Interstate 84 in Utah on September 26, 2005. The van had just completed passing another vehicle. At a point after the passing maneuver, when the van driver was reentering the right (outside) travel lane; the left rear tire began to experience a tread separation. Following the tread separation, the van exited the right (south) side of the road, as it was experiencing a clockwise yaw. After leaving the pavement, the van rolled over

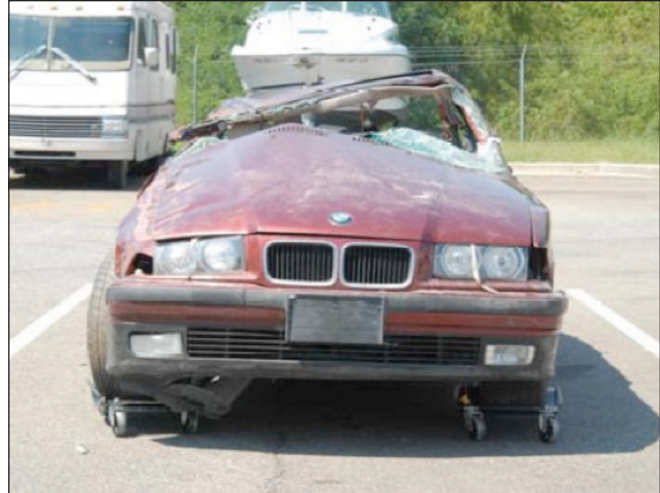
1995 BMW 325is. The roof has been cut off by first responders and placed back into position for this photograph¹⁹.

On July 30, 2006, two young men were in a 1995 BMW 325is on Blue Star Memorial Highway in Maryland. The vehicle traveling to their front made an erratic lane change which caused the BMW driver to conduct an accident avoidance maneuver. His vehicle exited the roadway to the right side of the road and rolled over. The front right passenger, though belted and retained in the vehicle, received a spinal injury due to roof crush during the single contact of the roof above his head.

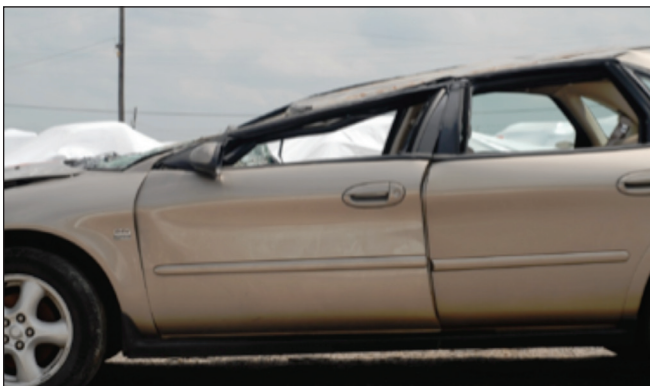
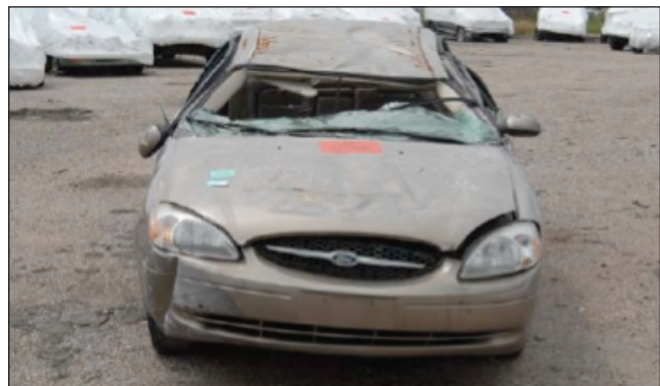
2003 Ford Taurus, ½ roll²².

leading. The Taurus rolled onto its roof and slid to its final point of rest. The driver was fatally injured due to roof crush as his head was forced down, resulting in multi-level skeletal/ligamentous injuries to his cervical and thoracic spine. The deformation was so great that his chin fractured his sternum. The occupant seated behind him underwent the same “diving” kinematics **without** consequential roof crush, and he walked away uninjured.

On October 10, 2006, the driver of a group of car poolers was driving a 2003 Ford Taurus northbound on the Dallas North Tollway. In the vehicle with him were three passengers. The driver encountered standing water on the roadway and lost directional control of the vehicle. The vehicle yawed clockwise and traveled to the right at which time it struck and climbed a concrete bridge barrier. The Taurus traveled along the barrier until the right rear corner struck a utility pole, and it rolled passenger's side

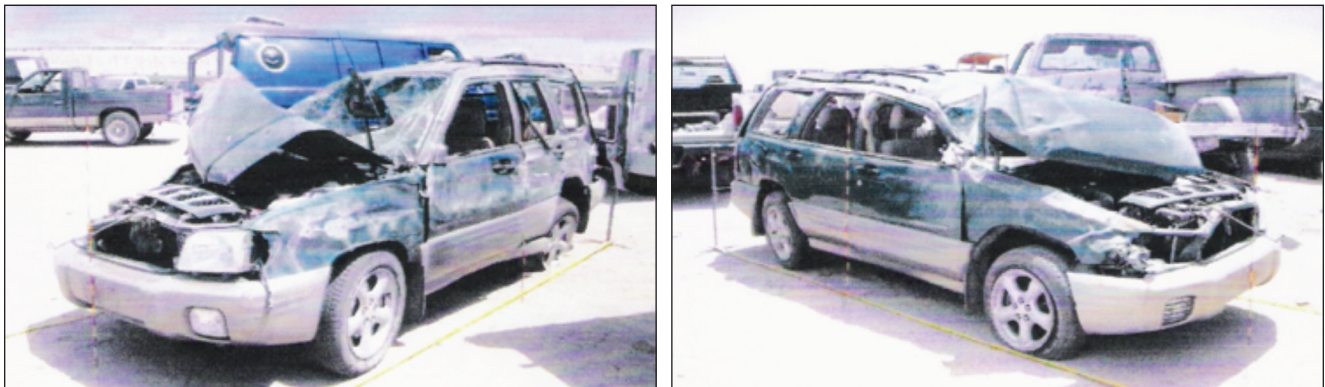
Left and right oblique views of 2001 Subaru Forester.

According to Perrone²³, “The efficacy of strong roofs is perhaps best demonstrated by a 2001 Subaru accident which underwent a rollover at approximately 55 mph and rolled laterally almost the distance of a football field. The 70- year-old 5'6" female driver and 69-year-old 6' male passenger both exited the vehicle under their own power after the vehicle came to rest in an upright mode [NASS case number 2002-078-044].”
