Journal of the
National
Academy OF
Forensic
Engineers[®]

Forensic Engineering Analysis of a Concrete Pumping Accident

By Paul R. Stephens, P.E. (NAFE 560F)

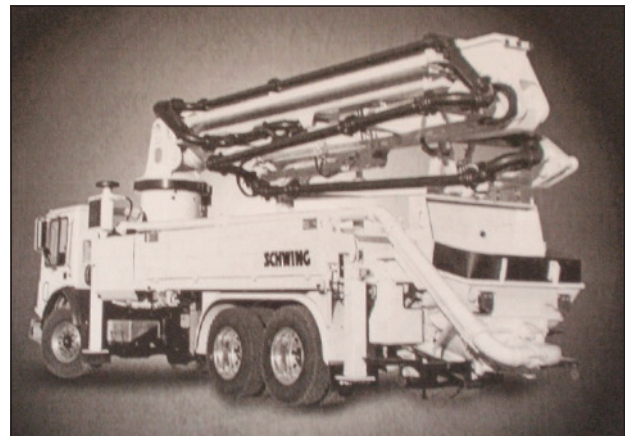
Truck-mounted concrete pumps with articulating booms permit concrete placement at considerable distances from the concrete delivery trucks or mixers. Some concrete pumps feature telescoping booms. Such booms, by reducing the overhead clearance required to deploy the boom, permit the concrete pump's telescoping boom to be positioned under structures located over the concrete placement location, such as structural steel. A photograph of a typical concrete pump is presented at right.

Figure 1
A Typical Concrete Pump with Articulated Boom.

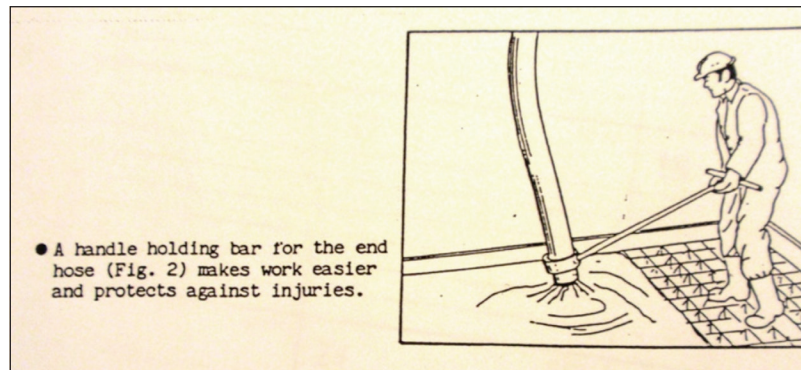
Safe, proper, and recommended operating practice with such construction machinery is to place the concrete using a vertically-oriented “tip hose.” When

Figure 3
Use of a Tip Hose Holding Bar.

so used, the pump truck’s boom supports the weight of the tip hose and the plastic concrete and laborers are able to push or pull the tip of the vertically-oriented tip hose laterally during the placement. However, use of a holding bar as depicted in the figure above is suggested to make the work easier and prevent injury.

The principal of the placement/finishing subcontractor testified that four hoses had been attached to the pump's boom that was up in the air. He also testified that he did not have holding bars, such as the one depicted in figure 3, on the job to drag concrete pump delivery hoses located on the ground as he did not expect to need them.

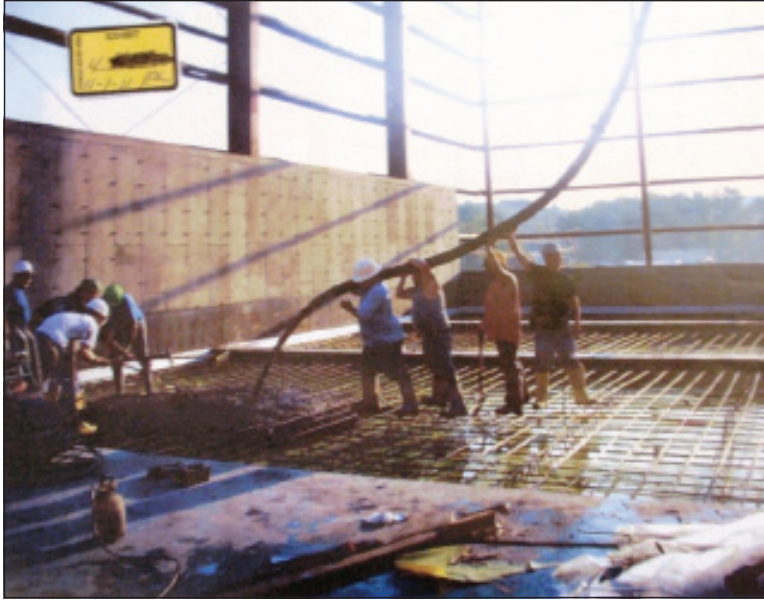
Photographs of the jobsite were taken by a concrete salesman immediately before the incident. The photograph presented below depicts how the men were distributing the concrete. The plaintiff is the man wearing the white-colored hardhat.

Figure 4
The Plaintiff and Co-Workers Dispensing Concrete
Using the Concrete Pump's Tip Hose.

From such an analysis, it was concluded that use of men to support the weight of the tip hose and concrete being delivered exposes them to the risk of injury, either from the effects of holding and carrying excessive weight or from unexpected hose movement during the pumping process. Therefore, it also was concluded that support of the concrete hose on laborers' shoulders as the plaintiff and his two co-workers were doing when the accident occurred, was an unsafe practice.

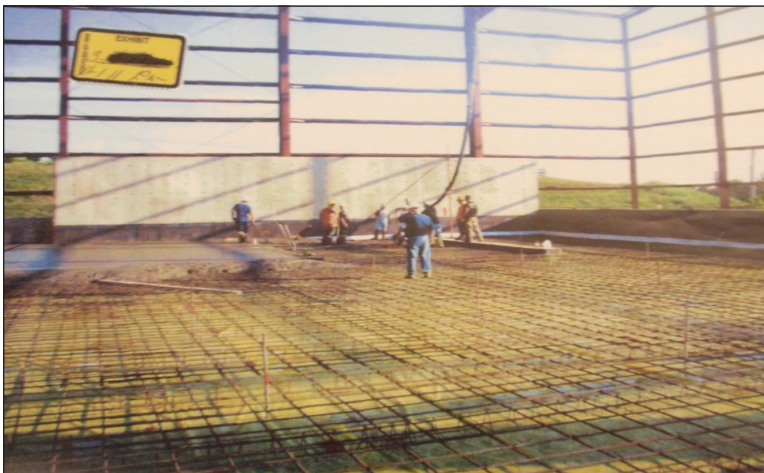
Figure 5
Overall View of the Jobsite.

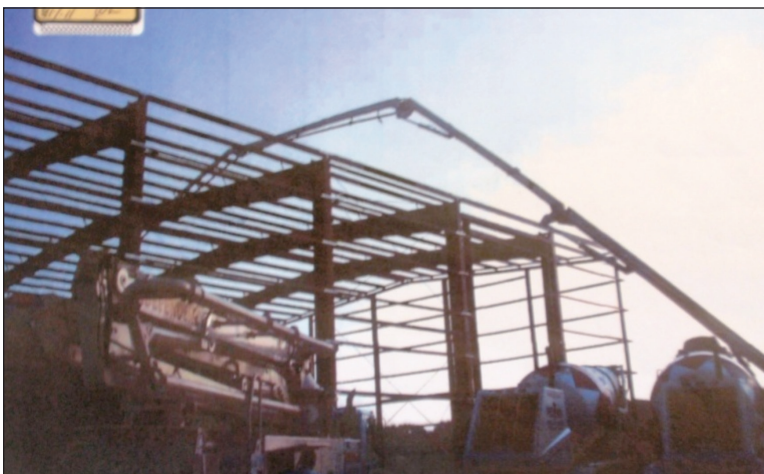
The photograph presented below illustrates that the concrete pump’s boom had to be extended over the roof-related structural steel. A larger than expected concrete pump was dispatched to the site. It was too tall to be located inside the building. As a result, it was not possible to setup the pump inside

Figure 6
Concrete Pump's Boom Routed Above Roof Steel
Shortening the Pump's Horizontal Reach.

the building so that it could reach the most distant concrete placement location where the incident occurred.

Improper construction sequencing also was an issue in this case. Specifically, the presence of the structural steel was an impediment to constructing the large concrete floor because it extended concrete pump setup times and prevented the pump's tip hose from being oriented in the safe, proper vertical orientation capable of reaching all sections of the pour. This fact was evident in the jobsite photographs figures 4-6. If the structural steel had not been present the concrete pump's boom could have reached all areas of the pour with the tip hose oriented in the proper, safe vertical position.

Safe, alternative pump delivery methods were available that day. For example, the concrete pump's boom is rotatable. Absent information to the contrary, the boom could have been rotated over a different roof opening, either eliminating the need for the crew to support the hose on their shoulders or reducing the time that the hose was so supported, reducing the probability of an incident.
