Vol. 37 No. 1 December 2020

FE Evaluation of Landowner Dispute Following Retaining Wall Failure

By Rune Storesund, DEng, PE, GE (NAFE 474S)

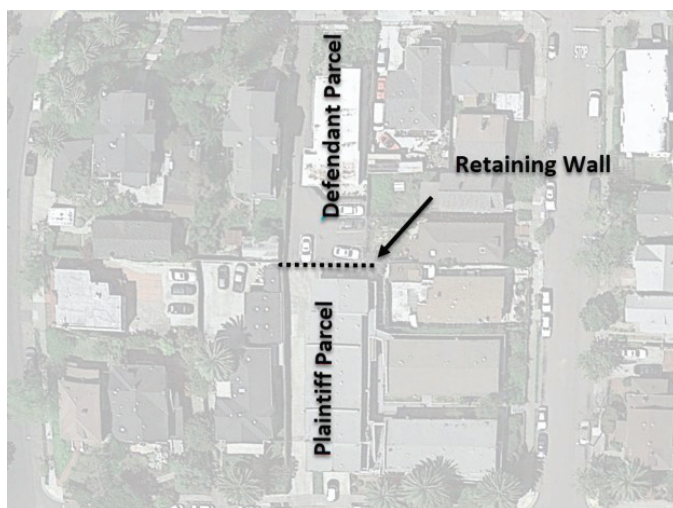
Figure 1

Site plan showing the location of the retaining wall in question relative to the plaintiff and defendant parcels.

This case involves a dispute between two neighboring property owners regarding costs associated with replacement of a compromised retaining wall. The orientation and location of the retaining wall relative to the two properties is shown in **Figure 1**. The two properties are situated near the top of a gradually sloping topographic knoll. The defendant's parcel is situated up-slope of the plaintiff's property.

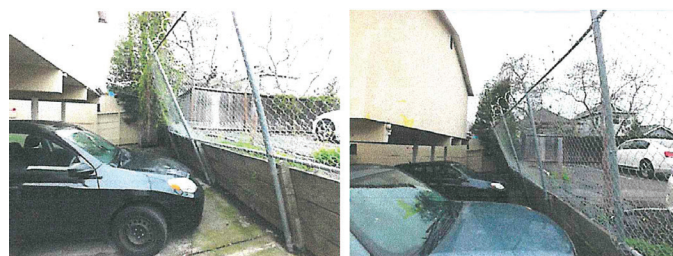
Figure 2

Photographs of the original wood retaining wall (2017).

attached to the wooden retaining wall. The retaining wall, which is approximately 3.5 ft in height, is situated immediately adjacent to the property line between the two neighboring properties (**Figure 2**). The area in front of the retaining wall and behind the retaining wall were used primarily as parking areas — both before and after the replacement of the retaining wall. No design documentation or as-built information was available for the original retaining wall. Additionally, the retaining wall had been fully removed and replaced prior to the forensic engagement. Some photographic information was available, but no photographic information was available relative to the foundation conditions of the original retaining wall, which precluded meaningful structural analyses of the wall.

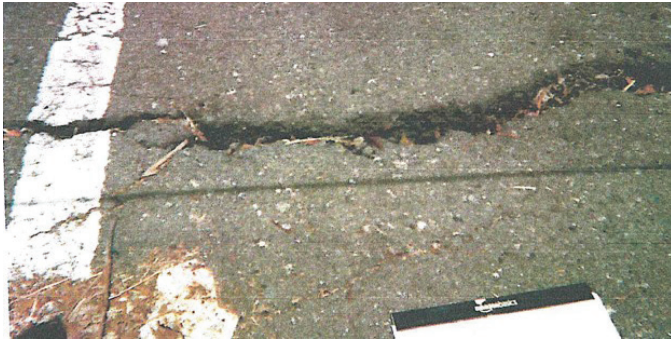
Figure 3

Extension cracks were visible in the defendant's parking area as a result of rotation of the retaining wall toward plaintiff's property.

Extension cracks were visible in the defendant's parking area (**Figure 3** and **Figure 4**). These cracks formed as a result of translation/rotation of the retaining wall, with the top of the retaining wall displacing away from the defendant's property toward the plaintiff's property. Drain

- The observed expansion cracks were indicators of potential loss of wall integrity, requiring a heightened level of mindfulness, monitoring, and care by the defendant to ensure additional loss of integrity from excessive demands does not occur;

- The observed expansion cracks allow for the infiltration of water into the soils behind the retaining wall. These expansion cracks could have been sealed by the defendant to limit the quantity of water infiltrating the soils, which in turn, would limit the potential for increased hydrostatic pressures and the potential for increased lateral soil pressures due to swell of the cohesive clayey soils;

- The observed expansion cracks were an indicator of lateral displacements of the retaining wall. The defendant had the ability to limit the magnitude of surcharge loading on the retaining wall by eliminating or offsetting the parking stalls;

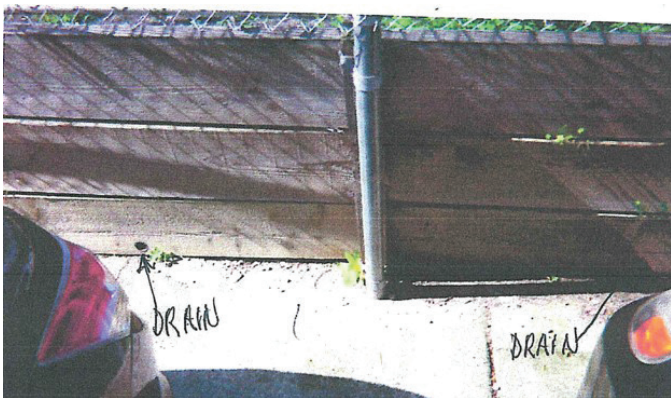
Figure 5

Drain holes in the original retaining wall to facilitate drainage behind the wall and mitigate potential for hydrostatic pressure loads on the wall.

holes to prevent hydrostatic pressure behind the wall were also observed at the base of the retaining wall (**Figure 5**).

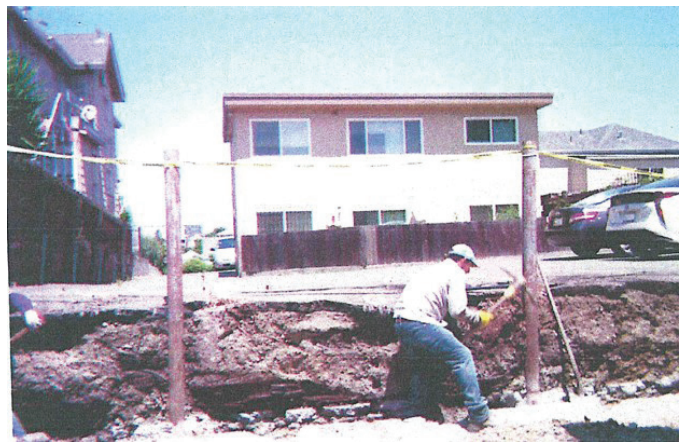
Exposed soil conditions following removal of the distressed retaining wall in 2018. Steel posts are bollards.

Figure 6 shows the exposed soil conditions following removal of the distressed retaining wall in 2018. These soils appear to consist primarily of cohesive clayey soils,

which have the ability to “stand” with a near vertical cut.

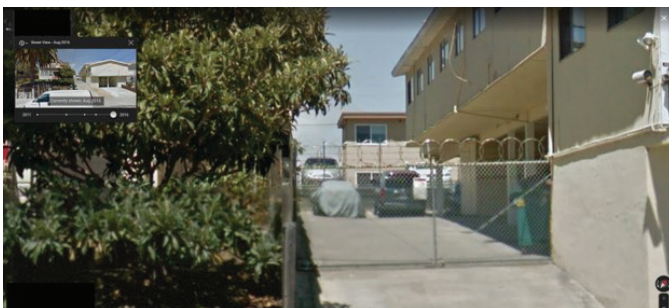
Figure 7

Example “street view” image available from Google Maps (note available timeline of photos in upper left).

In addition to aerial images, “street view” images (Figure 7) were also available from Google Maps, which allowed views of the retaining wall by looking from the street down the driveway toward the retaining wall in question. While this data is fairly recent, extending back to about 2010, it provides a valuable high-resolution perspective that is not available with conventional aerial imagery.

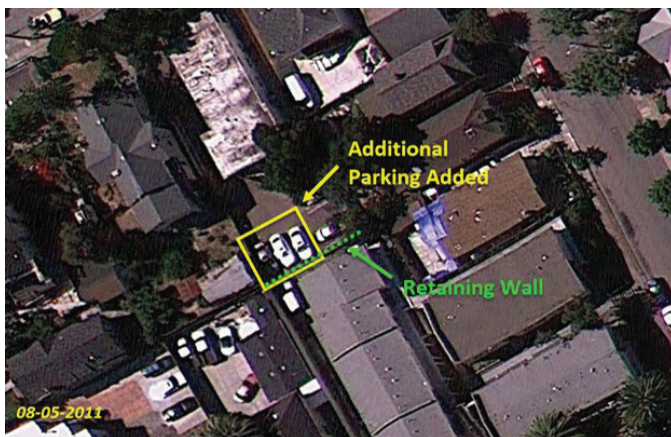
Figure 10

Additional parking spaces added on the defendant’s parcel immediately adjacent to the retaining wall.

A review of the aerial imagery as well as the street view photos established that the area immediately behind the retaining wall was delineated as parking area on the defendant’s property. The aerial imagery establishes the original (early 1960s) parking configuration (four parking spaces) as being limited to the northeast (NE) fence line (**Figure 9**). By the early 2000s, additional parking stalls were observed in the aerial images. **Figure 10** shows an

aerial image from 2011 with a total of four vehicles parked adjacent to the retaining wall on this particular day. **Figure 11** documents vehicles parked immediately adjacent to the retaining wall from a street view perspective.

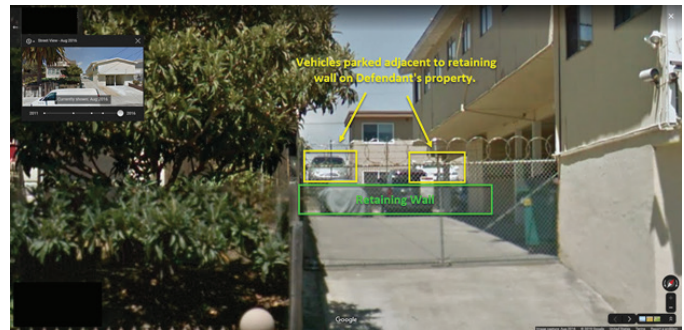
Figure 11

Vehicles parked immediately adjacent to the retaining wall exerting a surcharge load.

Vehicles have the ability to “bump” into both the bollards along the alignment of the retaining wall as well as the fence secured to the retaining wall, resulting in moment loads on the wall. These moment loads directly impact the lateral displacements of the retaining wall. A review of the available photos (such as **Figure 6**) did not reveal the presence of any curb stops in the parking spaces that would have limited the ability for vehicles to accidentally bump into the bollards or fence as well as imposing a “setback” between the parked vehicle and the retaining wall, thereby reducing the magnitude of the surcharge load from the vehicle and the retaining wall.
