Vol. 37 No. 1 December 2020

# Forensic Engineering Evaluation of Excessive Differential Settlement on Compressible Clays

By Rune Storesund, DEng, PE, GE (NAFE 474S) and Alan Kropp, PE, GE

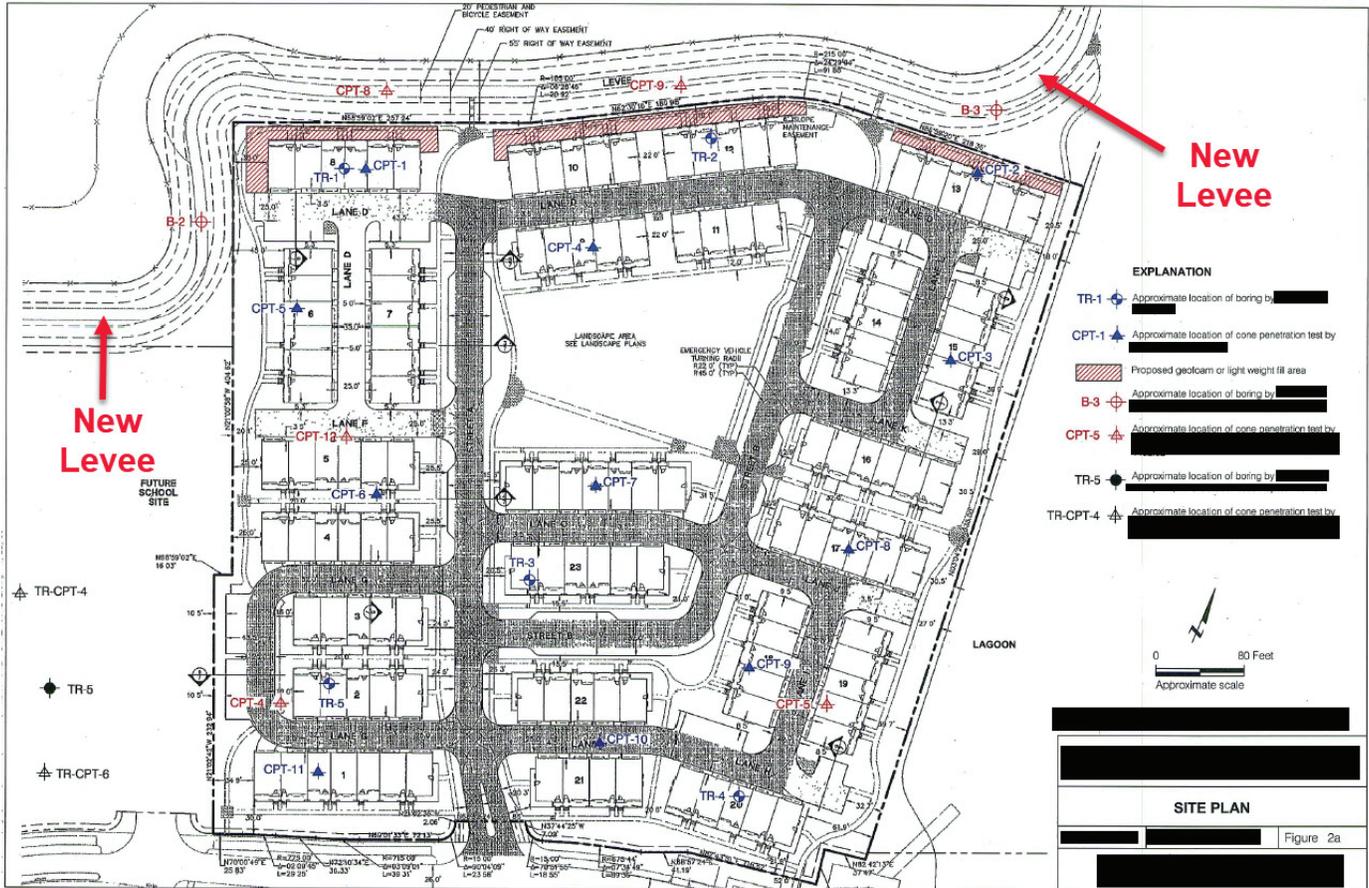
Figure 1

Overview of development features, which included a perimeter levee, site grading, multi-unit structures, and streets/utilities. Source: Discovery Docs.

(Figure 1). The potential for large and variable settlements were identified early in the planning process. Figure 2 shows an overlay of an aerial image of the project area before initiation of construction. The area is situated in a bay margin with wetlands and sloughs. Interpolated contours of compressible clay are shown. The clay thickness varies

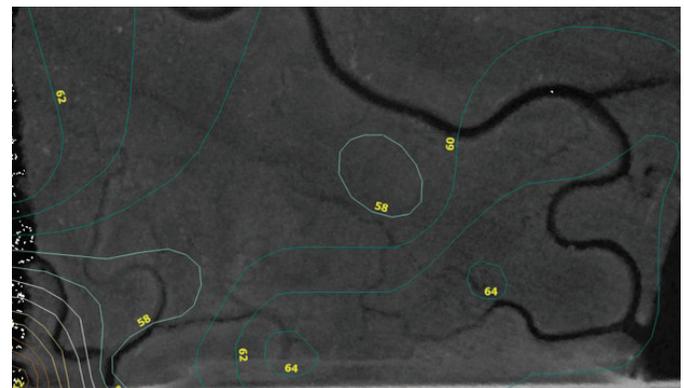
Figure 2

Overlay of compressible clay thickness and aerial image showing sloughs traversing the project area. Source: Author.

from about 58 ft to 64 ft, based on the available subsurface information. **Figure 3** shows the same overlay, but with the planned site rough grading.

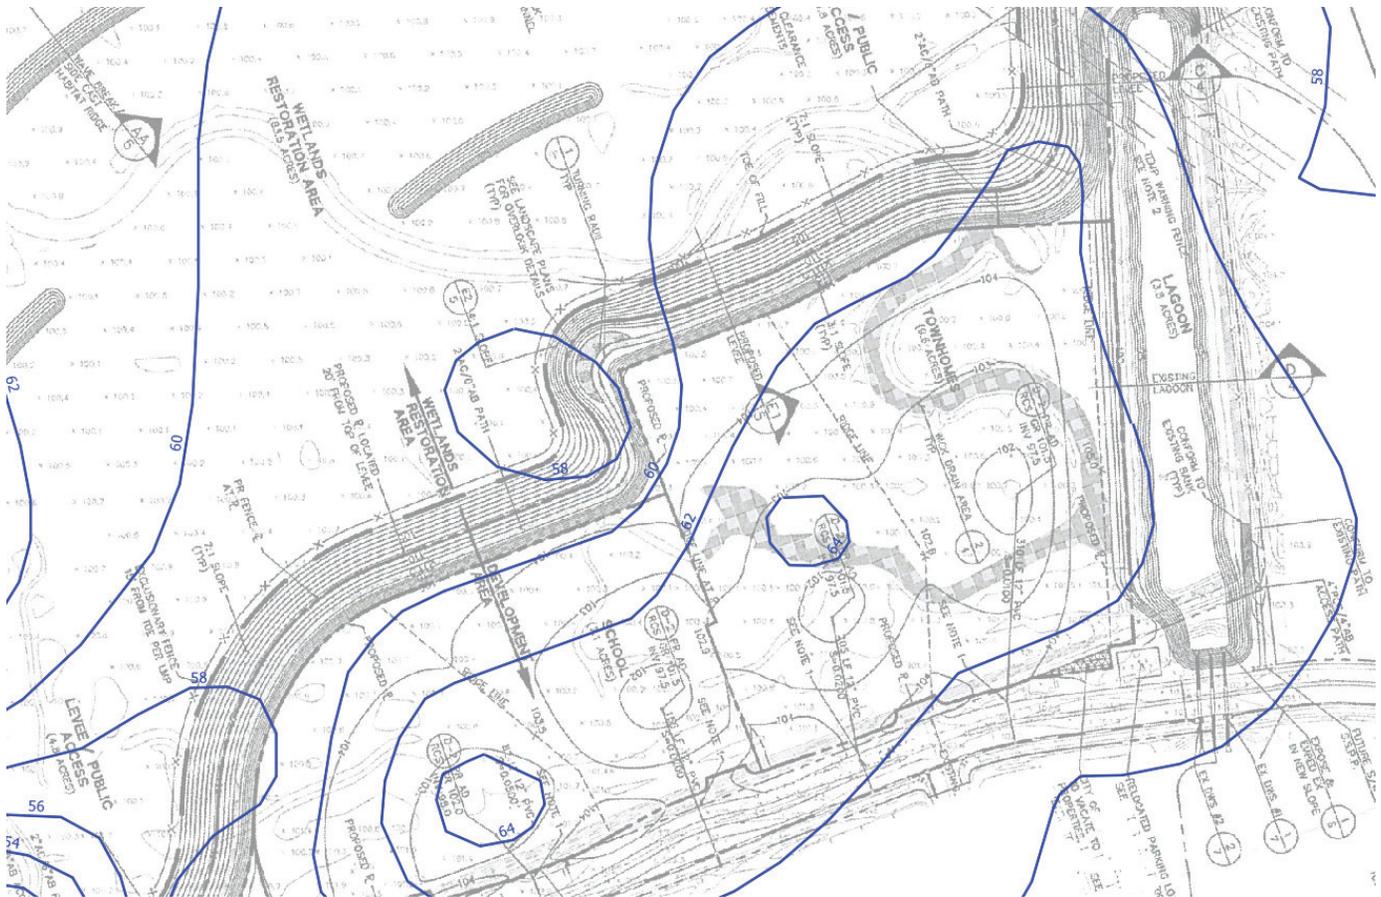
**Figure 3**

Overlay of compressible clay thickness and planned rough grading for the residential development and perimeter levee within the project area. Source: Discovery Docs; contours by author.

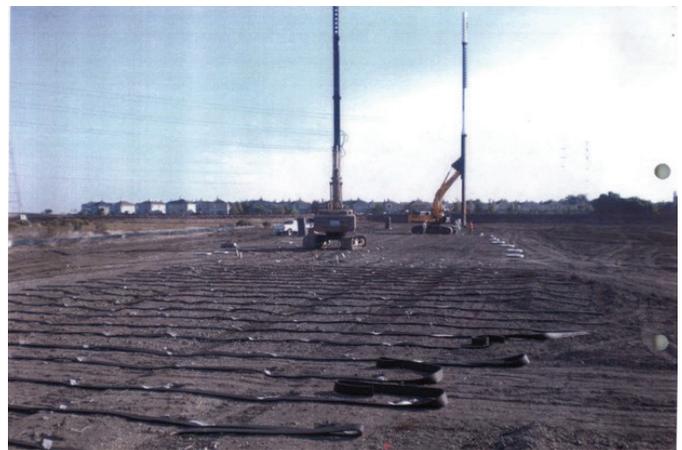
**Figure 4**

Installation of wick drains at select locations to facilitate “rapid” consolidation settlement. Source: Discovery Docs.

To accomplish the project in a shortened construction period, wick drains were used along with staged fill placement to accelerate consolidation settlement (**Figure 4**).

Wick drains facilitate acceleration of the consolidation settlement process by reducing the drainage path of the water to evacuate the soil skeleton. By reducing the distance, the water has to travel before evacuating the soil mass, the time rate of consolidation is accelerated.

For example, without wick drains and a clay thickness of 60 ft, the water may have to travel a distance of 30 ft before it can be fully evacuated from the soil mass. With wick drains installed at a spacing of 6 ft (and driven the full depth of the clay layer thickness), the water now only needs to travel 6 ft before being evacuated. Thus, the reduced travel distance directly reduces the time required to achieve the anticipated settlement magnitude.

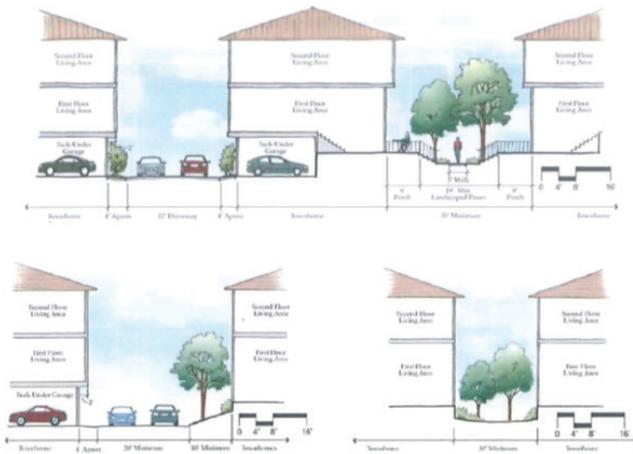
**Figure 6**

Architectural rendering of the multi-unit structures showing the micro-topography and variable site grade elevations across the project area. Source: Discovery Docs.

Figure 6 shows a conceptual rendering of the proposed residential units. The units were anticipated to be

three stories tall, with the parking garage situated facing the street and the main entrance on the opposite side of the structure. All units had a stepped entrance with staircases to the front door elevated several feet above the surrounding grade. Some units were configured to have an elevated walkway (called a paseo), some units had slightly elevated landscaping area, and some units had porches with steps leading up from street level.

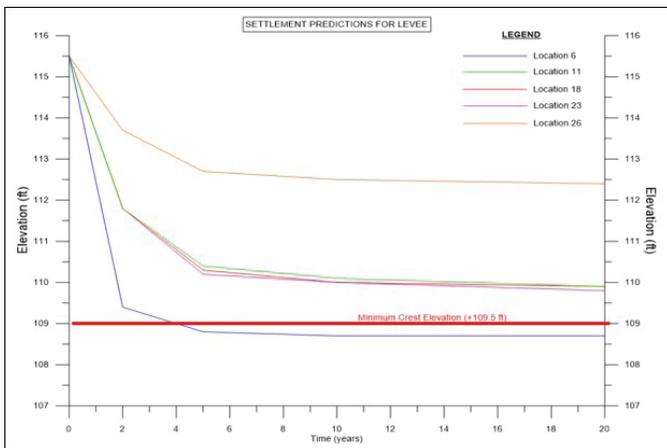
Plot of estimated site settlements at select locations for the first 20 years after levee grading. Settlement for the interior residential development would have a similar shape, but different ultimate magnitude 2 ft as predicted by the geotechnical engineer. Source: Author.

**Figure 10** shows the general trend of settlement over time, with the majority of the settlement occurring in the first two to four years. The plot shown in **Figure 10** was prepared for the perimeter levee. No equivalent plots were developed for the interior residential development.

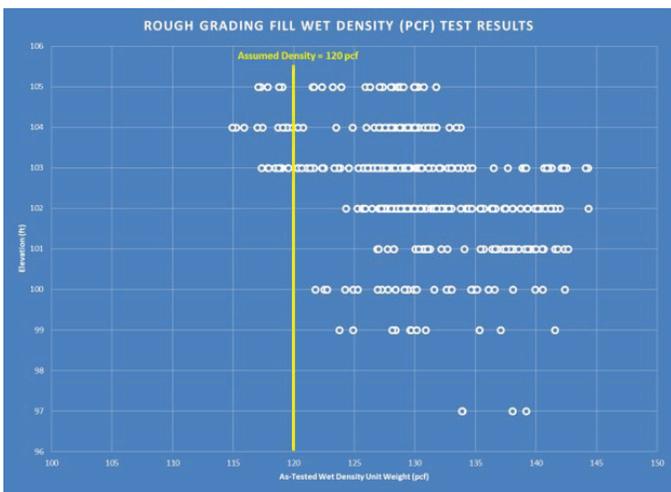
Distribution of actual in-place soil densities as a result of differing import sources and compaction effort. Source: Author.

**Figure 11** shows a plot of measured soil densities during fill placement. The assumed density of 120 pcf is highlighted in yellow. The white circles are individual test results and span a density range of about 115 pcf to just under 145 pcf. Of the 359 soil density tests, 330 tests were in excess of 120 pcf, which is approximately 92% of all the tests. Additionally, the spatial distribution of the varying soil densities was not uniform, resulting in heterogeneous distributions of differing soil densities across the spatial footprint of the development. In addition to the large skew between assumed soil density and actual soil density, the complexity of the finish grading for the development further exacerbated the magnitude of realized differential settlements.

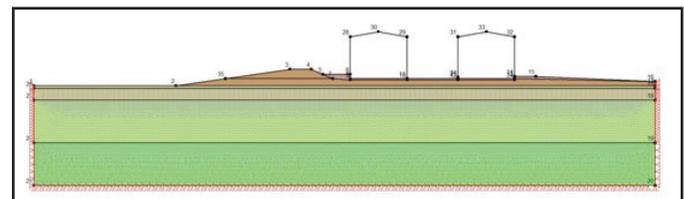
Simplified numerical model to explore implications of micro-topography. Source: Author.

**Figure 12** shows a simplified numerical model to examine the effects of small variations in fill thicknesses as a result of micro-topography. The micro-topography included levee fill on the left side of the houses and sloping landscape fill on the right-hand side of the houses. The analyses were not intended to directly replicate the realized differential settlements as the subsurface conditions and associated soil material properties were not sufficiently established. The model, however, was generally calibrated to the range of vertical settlements observed as part of the site response following fill placement and construction of the residential units.

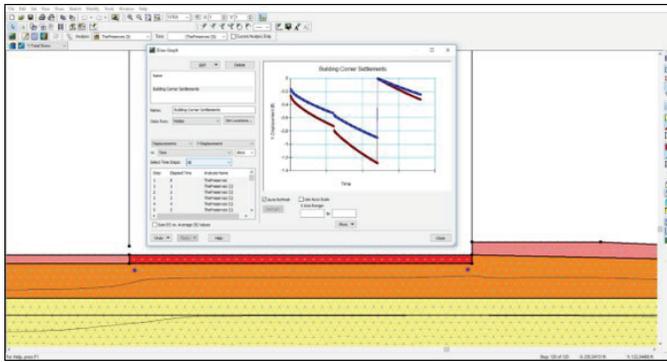
**Figure 13**

Calculated settlements at building edges with micro-topography effects accounted for. Source: Author.

The results of the numerical modeling of Building B-B are illustrated in **Figure 13**. The model evaluated the impact on differential settlement across the building. Point “A” is situated on the street side of the building with site grade at approximately El. +102 ft. Point “B” is located on the opposite side of the building, with site grade at approximately El. +106 ft. The numerical analyses of the simplified model show the impact of this fill thickness differential has the ability to increase the magnitude of differential settlement by a factor of two to three. Thus, the project geotechnical engineer’s predicted differential settlements of 2 in. in 40 ft, would increase, as a result

of the different fill thicknesses, to 4 in. in 40 ft or 6 in. in 40 ft. This simplified analysis illustrates the non-uniform fill results in differential settlements which are in excess of the maximum design differential settlement of 2 in. in 40 ft.
