Forensic Engineering Analysis of Building Depressurization Induced Product Re-Entry

by John Certuse P.E. (NAFE 708F)

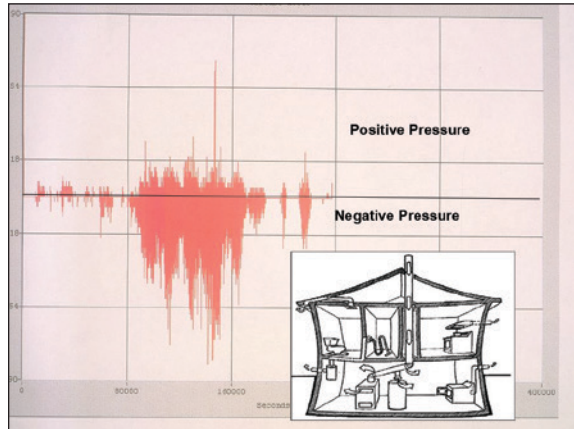
This photo of the differential pressure between the inside and outside of a house shows the existence of a negative pressure condition.

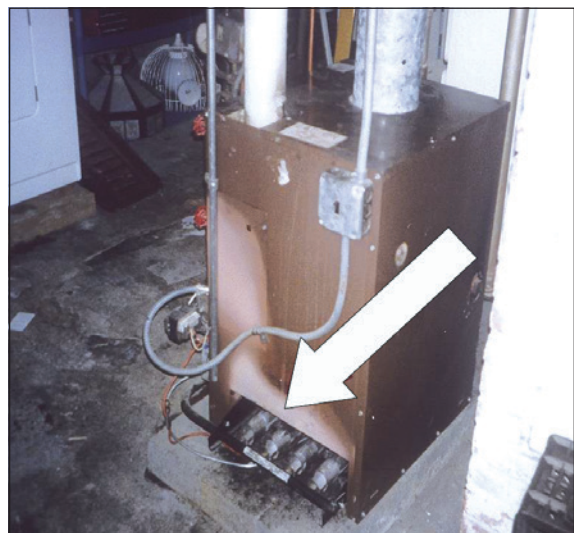
This type of problem manifests itself as emissions being seen backing out of heating system components such as barometric dampers and draft hoods as well as out of combustion chambers and fireplace dampers.

Oftentimes this phenomenon is known as “Rollout” in gas fired appliances.

Upon the appliance shutting down however, when there are emissions in the chimney flue between the appliance and the peak of the chimney, upon the termination of combustion, the negative air pressure effects within the structure will reverse the flow direction of these emissions. This causes these products of combustion to back out of the chimney flue and appliance and into the home until the building air pressure differences are equalized.

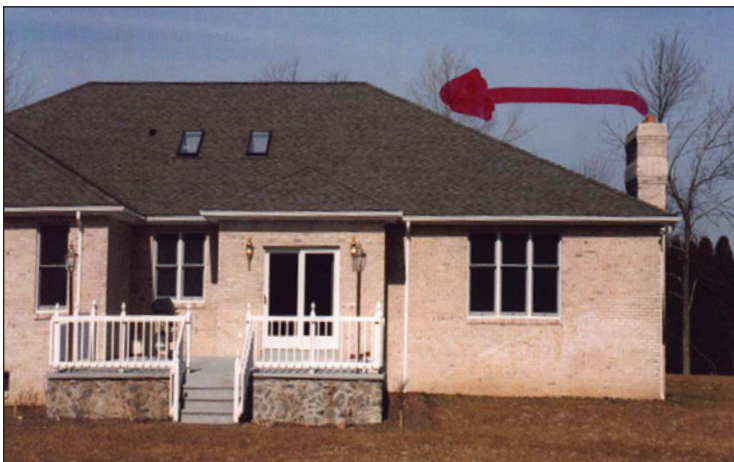
A chimney that is properly built on a 1-story portion of the home may have its discharge plume strike a portion of the building that is higher than the 1-story addition, which in turn allows products of combustion to come into contact with and then re-enter the structure.

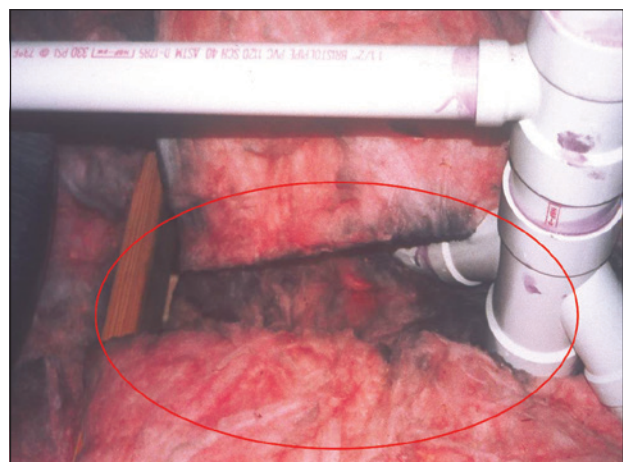
Accumulations of soot within attics on insulation materials is the result of emissions exiting the structure and reentering through ridge and soffit vents into the attic space.

As negative air pressures draw these emission particles into the attic space, the particles are "filtered" through the insulations fiberglass strands leaving a blackened deposit on the insulation

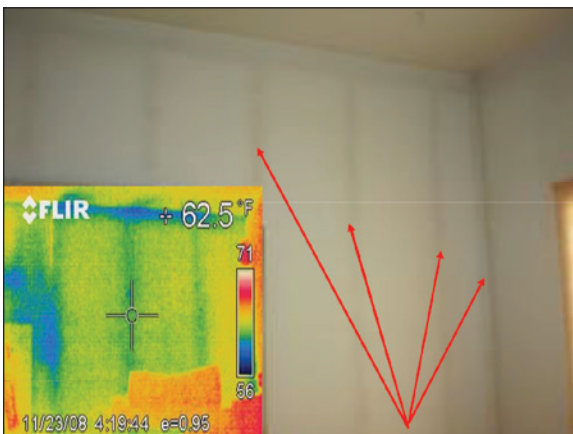
Particle staining on stud framing members within walls are an indication of poor indoor air quality within the structure.

Precipitation of these particles onto the wall at the framing locations is the result of thermal bridging and cooler temperatures at these frames allowing localized condensation which attracts airborne particles.

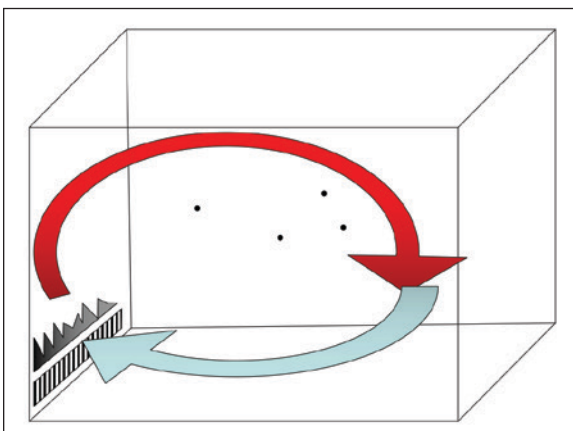
Particle accumulation above forced hot water baseboards are also common due to the air particles within the room being re-circulated in the convection air current flow within the room due to the heating action of the baseboard.

These particles will pass through the baseboard and concentrate these onto the adjacent wall due to moisture and temperature differences as well.

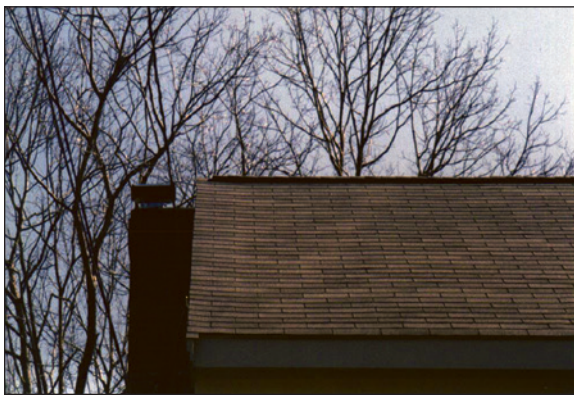
Although each house is unique upon itself and a blanket statement cannot be made that will address all structures, in our experience, the most cost effective, as well as effective way to address this problem is with chimney height extension or abandonment of direct venting appliances.

By increasing the chimney height, this increases the stack effect of the chimney which contributes to the appliance being capable of overcoming any negative air pressures within the building, and additionally, it deposits these products of combustion up in the air stream where they are more capable of being removed from the immediate vicinity of the building, allowing any infiltration air to be free of these substances.
