# Forensic Engineering Investigation of an LP-Gas Installation and an Analysis of Odor Fade

by Robert N. Anderson, Ph.D., P.E. (NAFE 402F)

### Case Study FE Analysis of Odor Fade of an LP-Gas Installation

### **The Thermodynamics of Odor Fade in Propane and LPG**

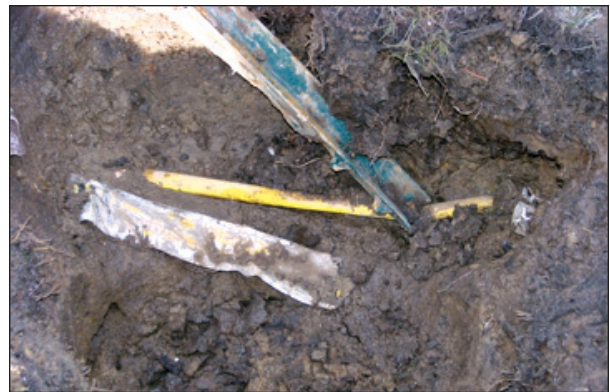
In October of 2006, a propane marketer received a phone call from the local fire department to assist in the investigation of an explosion and fire that had occurred the previous evening. The gas company quickly determined that they had filled the tank the previous morning. In assisting the fire department, they found a breach in a buried gas line. A fence post had pierced the line about fifteen feet from the house. A landscaping crew had set the post the previous day.

- LP-gas was delivered while landscapers were beginning fencing modification.
- The landscapers failed to have someone locate the gas line before driving fence posts for fencing.
- A fence post pierced the buried line (~10" below surface)
- The breach in line undetected due to wet soil (stayed underground)
- Fugitive gas followed gas line to house
- The fugitive gas entered the house through the foundation
