Forensic Engineering Investigation of an ATV Crash Involving Two Riders on a One-Rider ATV

by Gary E. Kilpatrick, P.E. (NAFE 741M)

Abstract

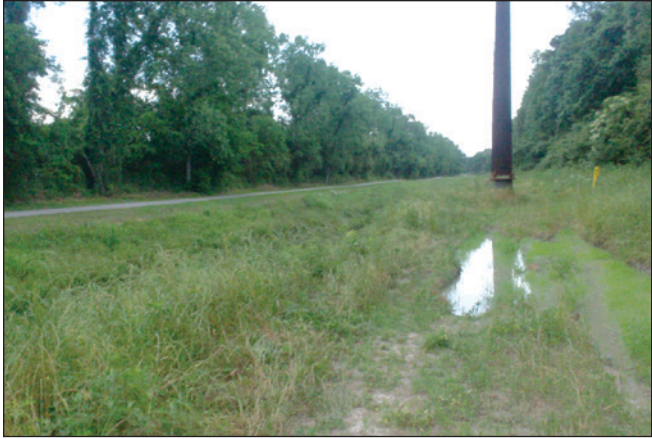
Figure 1

Police distance photo of the location where the ATV was driven off of the shelf.

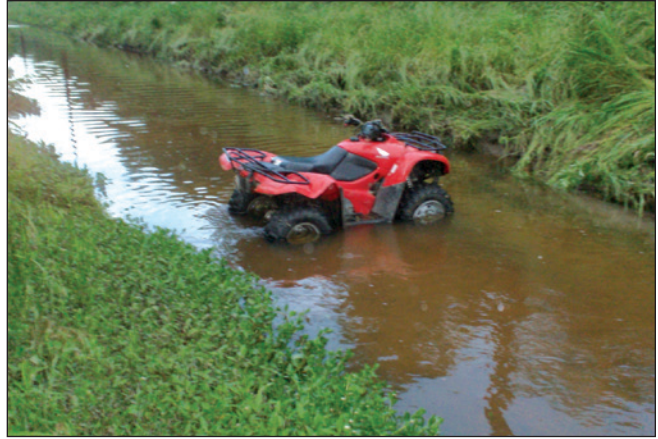
Figure 2

Police photo of the resting location of the ATV.

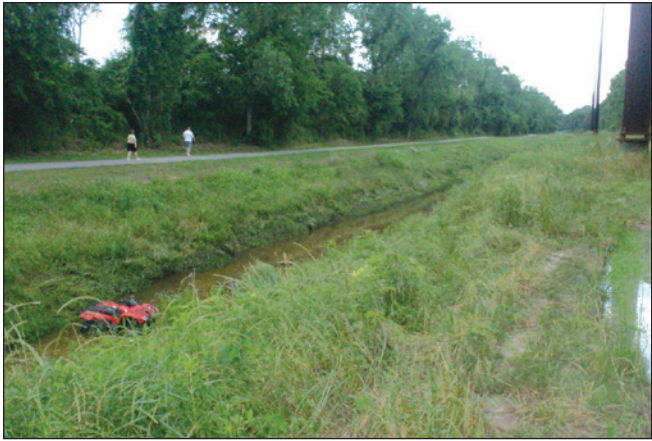
Figure 3

Police closer photo of the location where the ATV was driven off of the shelf.

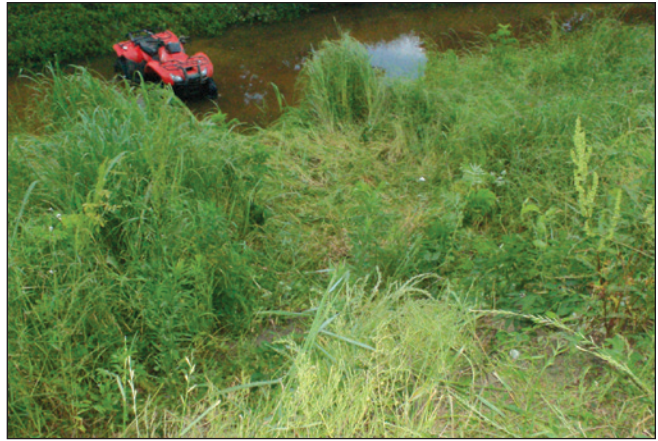
Figure 4

Police photo of where the ATV tumbled down the bank of the canal.

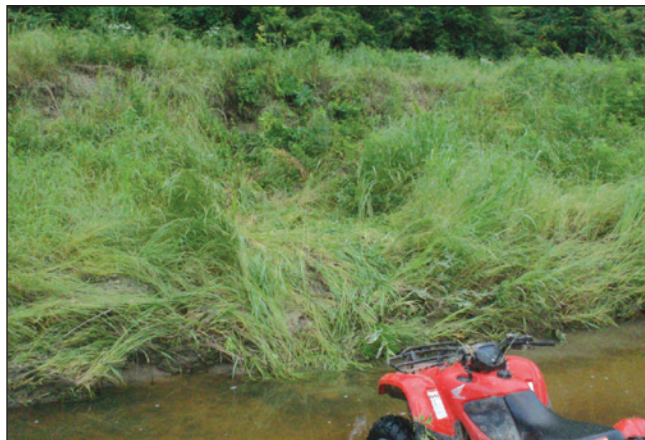
Figure 5

Police photo of where the ATV tumbled down the bank of the canal.

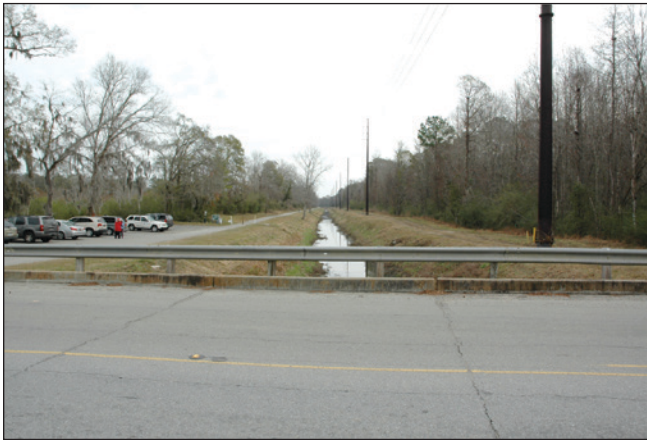
Figure 6

Author's photo of the canal (middle), walking trail (left) and canal shelf (right).

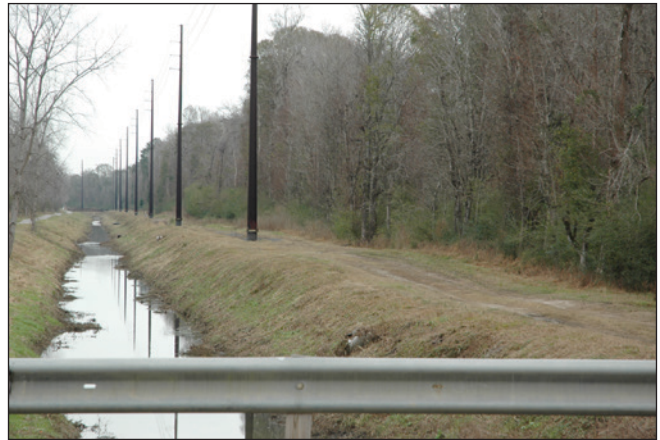
Figure 7

Author's photo of the canal shelf.

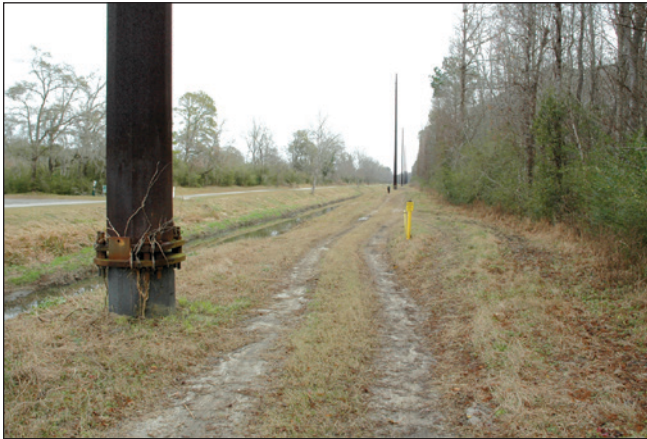
Figure 8

Author's photo of canal shelf trail surface.

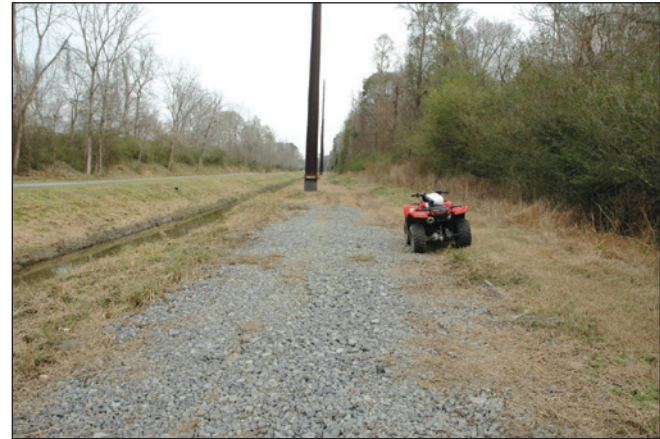
Figure 9

Author's photo of his ATV at the location where the accident occurred.
