Vol. XXX No. 2 December 2013

Forensic Engineering Analysis of Injury Biomechanics Related to Elevator Malfunctions

by William E. Lee III, Ph.D., P.E. (NAFE 655S)

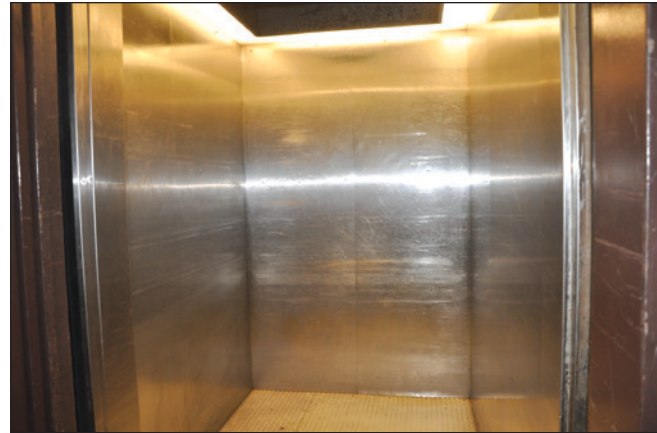
Figure 2

The actual elevator car involved in the incident (outside looking in). This was a service elevator.

A woman was working in a 30 story building and using the building service elevator (see Figure 2) to go from a high floor to a low floor during the course of her normal work routine. She was alone in the elevator when it began its descent. During the descent, the elevator experienced 2-3 sudden full stops over a very short time period. She claimed the elevator car was shaking side-to-side during the stops. She claims her body “hit all over” as she “fell down several times” and had bruises everywhere (not substantiated by the post-incident medical records except for a knee bruise). There was no loss of consciousness.
