Vol. 39 No. 2 December 2022

Current Assessment of Stand-Up Forklifts' Underride Accidents

By Richard M. Ziernicki, PhD, PE, DFE (NAFE 308F) and Ricky Nguyen, PE, DFE (NAFE 1223M)

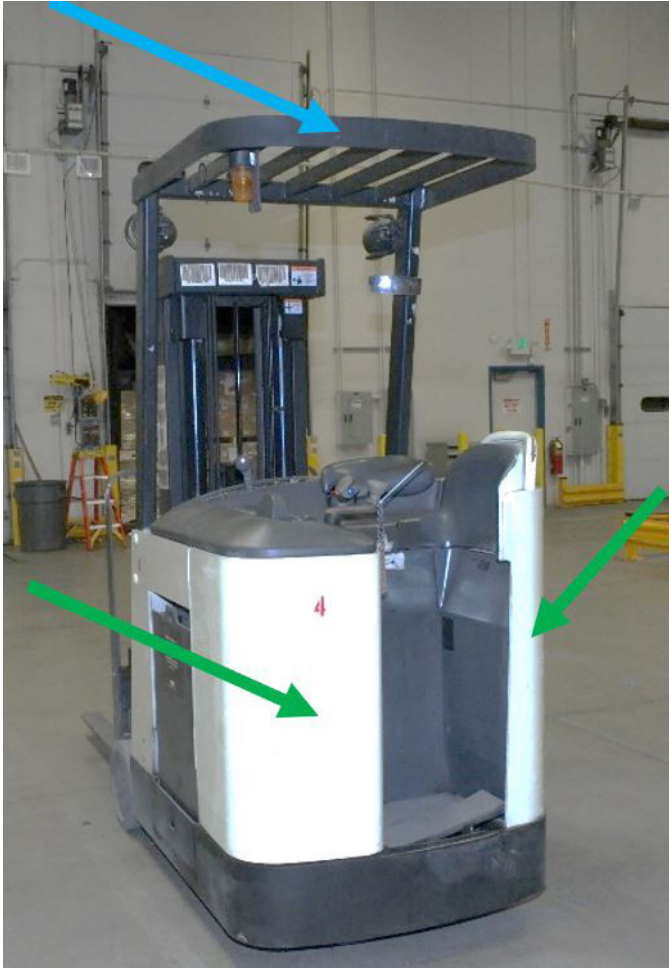
Figure 1

A stand-up forklift (green arrows added to outline the walls around the operator compartment). Blue arrow added to show overhead guard.

The operator compartment structure for a stand-up forklift typically consists of four walls with an opening to allow operators to ingress and egress from the compartment. The walls at the end of the forklift (opposite the forks) typically extend up to a height of approximately 4.5

feet tall off the floor. Stand-up forklifts are also equipped with overhead guards that are at a height of typically 7 feet to 8 feet off the floor (**Figure 1**).

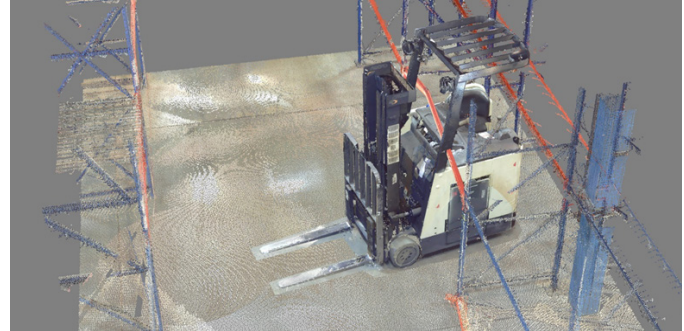
Figure 3

3D graphic of a rack beam that had intruded into a stand-up forklift's occupant compartment.

Underride incidents are serious — many times even deadly — when there is a lack of horizontal intrusion guarding to prevent or mitigate the adverse effects of the collision. **Figure 3** and **Figure 4** are 3D graphics that depict the result of a stand-up forklift override incident the authors investigated and reconstructed.

A horizontal intrusion incident involving a stand-up forklift and a storage rack that resulted in serious injury was investigated and reconstructed (**Figure 1, 2, 3, and 4**). The horizontal rack beam, which had intruded into the forklift and crushed the operator, was 96 inches long with a C-channel profile that was 3 inches tall, 1.4 inches wide, and ¼ inches thick. The beam was made out of A992 steel. The forklift involved in the incident was not originally equipped with a third corner post but was equipped with the fourth corner extension. However, the third corner post was offered by Manufacturer A as an optional feature when the forklift was originally sold. As part of the incident reconstruction, it was determined that the forklift (with no load) traveled into the rack at a speed of up to 6.1 mph.

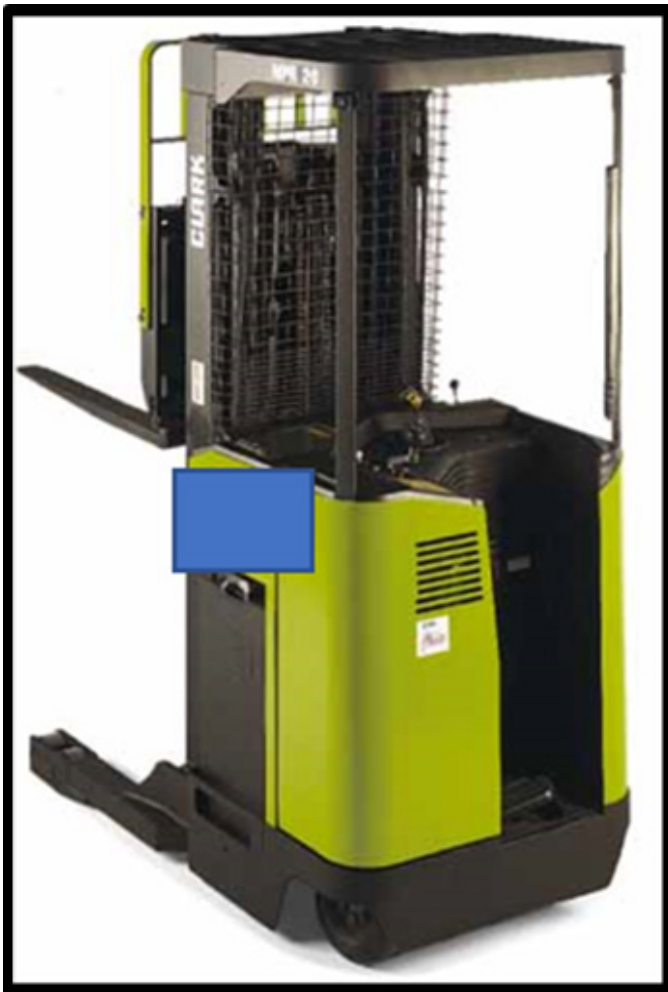
Figure 5

A stand-up forklift equipped with a third corner post and fourth corner post as a standard feature.

available for the forklift's fourth corner (or the rear right corner) to provide additional horizontal intrusion protection (**Figure 5**). However, others have equipped their stand-up forklifts with a fourth corner extension to provide horizontal intrusion protection instead (**Figure 6**). These extensions are typically either a weldment to the forklift's outer wall plate metal or was formed with the plate metal that surrounds the operator compartment. However, unlike a post that extends from the walls of the operator compartment to the overhead guard, these extensions do not extend to the operator guard — and typically extend to only about a height of 5 to 6 inches above the height of the operator compartment walls.

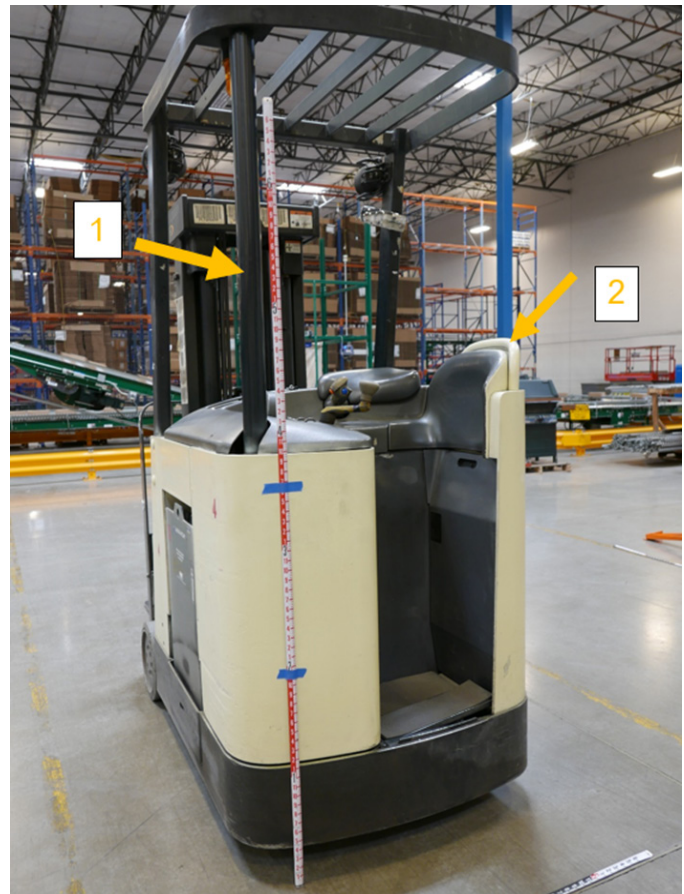
Figure 6

Stand-up forklift equipped with a third corner post (arrow "1") and a fourth corner extension (arrow "2").

overhead guard at the rear left corner the forklift (with the front of the forklift being where the forklift's forks are pointing toward), hence the "third-corner" designation (**Figure 6**). This post needs to be provided by the forklift manufacturer due to Occupational Safety and Health Administration's (OSHA) regulations that state any modifications to the forklift must be approved by the forklift's manufacturer (Title 29, 1910.178(a)(4)). Furthermore, when forklifts are equipped with horizontal intrusion guarding systems, the system must meet performance requirements outlined by the American National Standards Institute (ANSI)/Industrial Truck Standards Development Foundation's (ITSDF) B56.1 "Safety Standard for Low Lift and High Lift Trucks" for the manufacturer of forklifts.

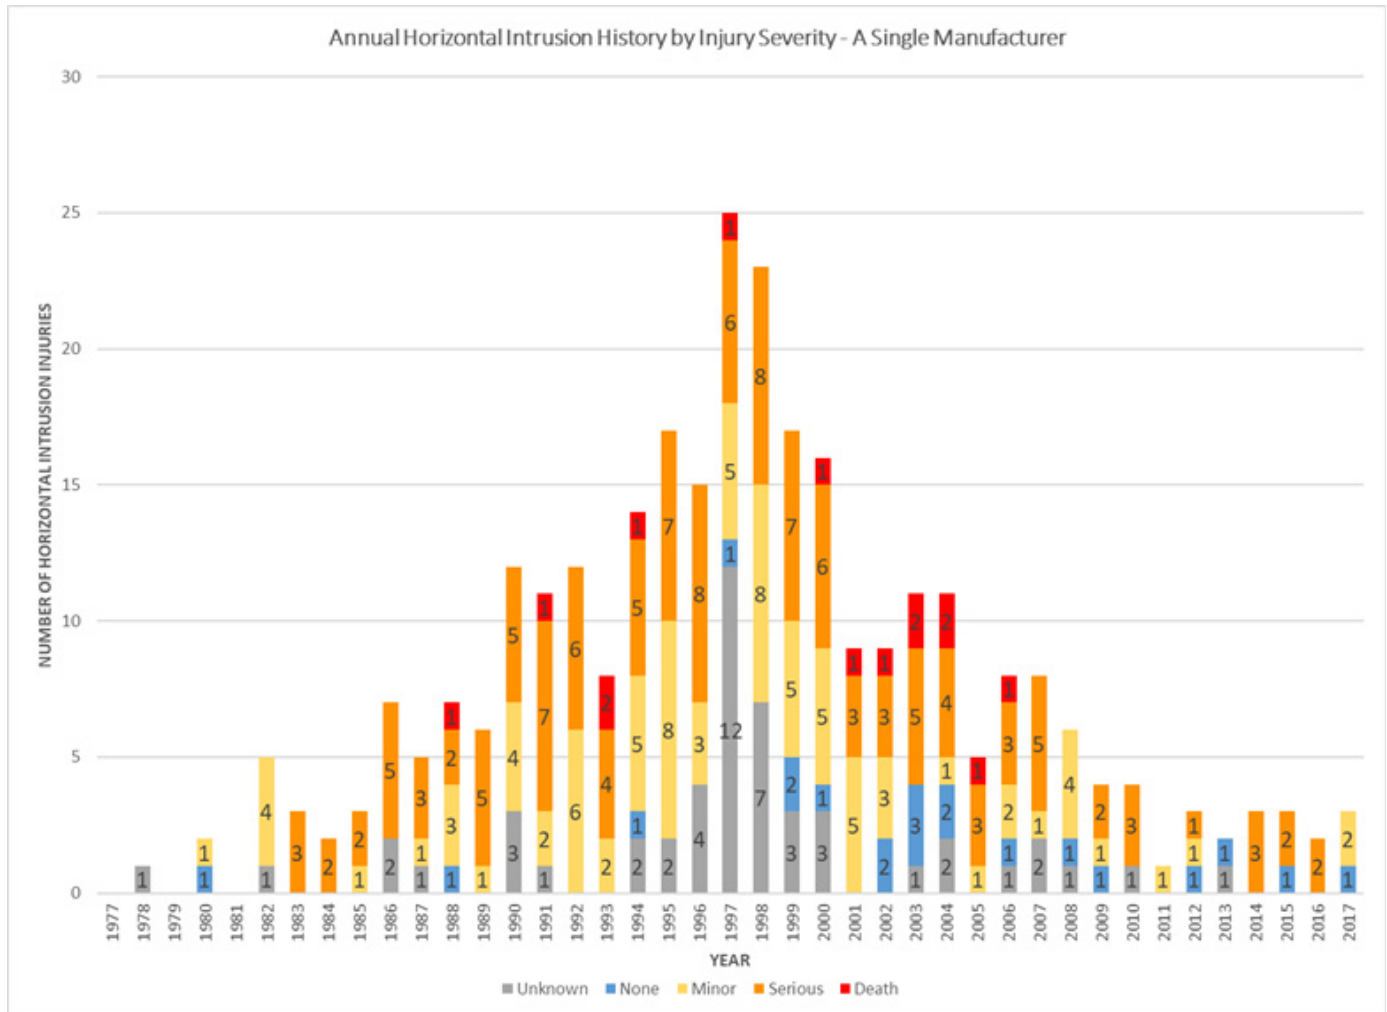
Figure 8

Graph showing the number of annual horizontal intrusion accidents, categorized by injury severity from Manufacturer A’s updated database.

than 12 fatalities and 100 serious injuries from 1977 to 2005¹. The database has since been updated, with records of more than 5,000 accidents that occurred up to the year 2017. **Figure 7** through **Figure 10** are graphs created with information from the updated database.

for the combined number of serious and fatal injuries in horizontal intrusion accidents did not have the same rapid decline (four to eight occurrences per year) until the year 2008 (less than four occurrences per year), as shown in **Figure 11**. It is also worth mentioning that there has been zero reported deaths since the year 2007.

The decline in serious and fatal accidents starting in the year 2008 coincides with the manufacturer's decision to make a third corner post a standard feature on all its stand-up forklifts, starting in 2007. From review of the updated database, the authors also found zero horizontal intrusion accidents that resulted in serious or fatal injuries involving their stand-up forklifts that were equipped with a third corner post as a standard feature. Although there are still reported occurrences of horizontal intrusion accidents that resulted in serious injuries since 2007, the data showed these accidents involved older model forklifts that were not equipped with a third corner post as a

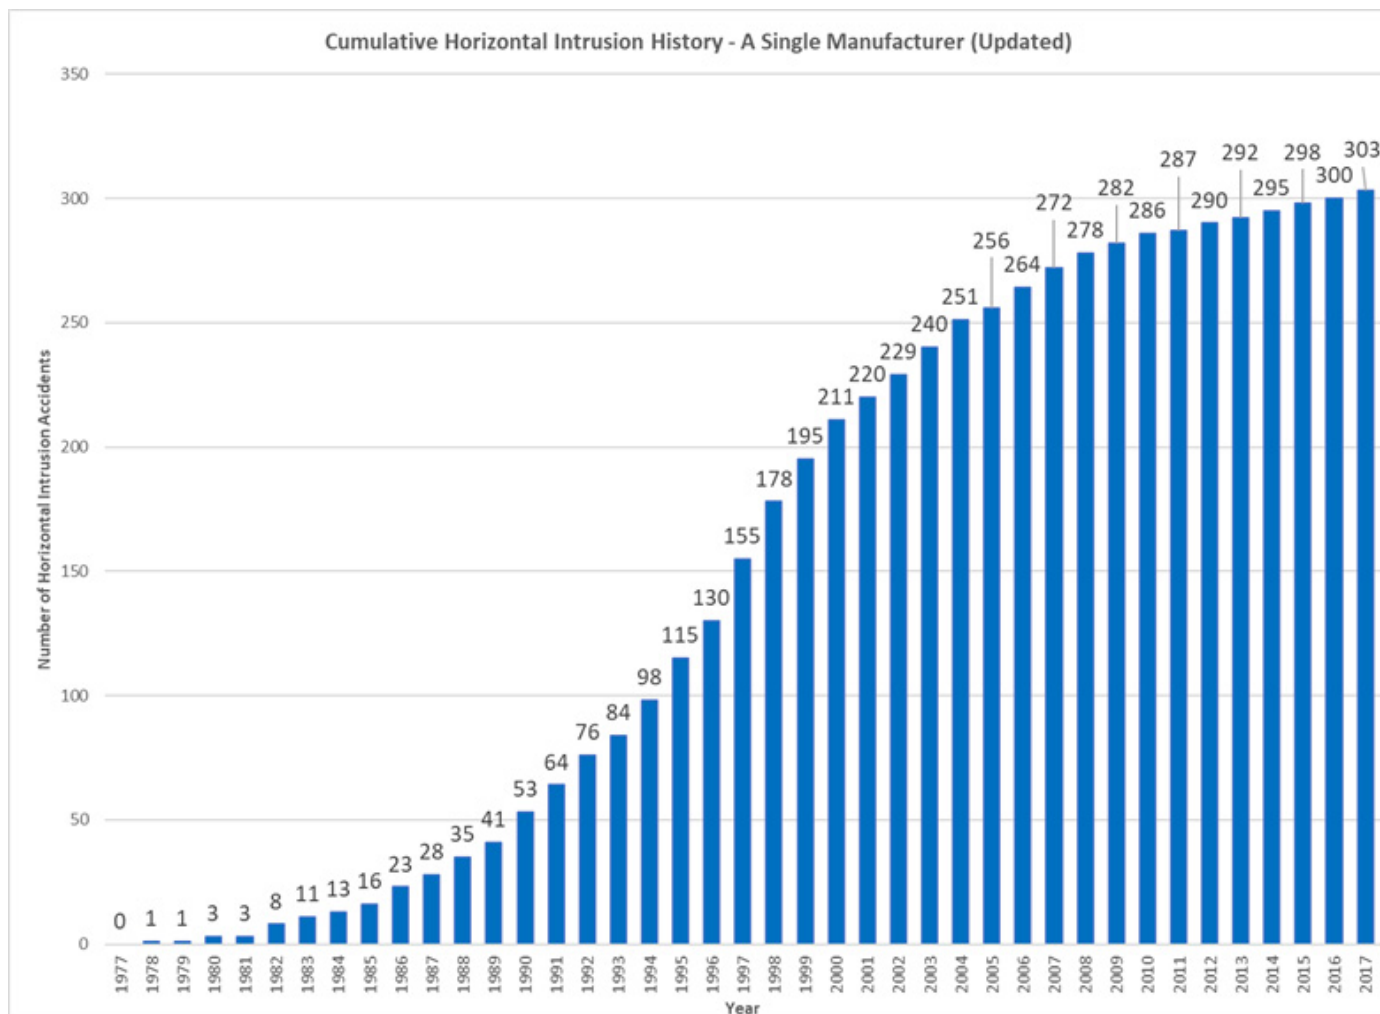
Figure 9

Graph showing the cumulative number of horizontal intrusion accidents from Manufacturer A's updated database.

The authors acknowledge that the presence of a third corner post potentially introduces hazards associated with the above negative considerations. However, review of Manufacturer A’s accident database from 1977 through 2017 showed the number of serious or fatal injuries (18

accidents) that were reportedly caused by claimed hazards associated with the third corner post was an order of magnitude less than the occurrence of serious or fatal horizontal intrusion accidents (more than 140 accidents from 1977 through 2017). The data would indicate that the likelihood of serious/fatal injury caused by the claimed hazards associated with the posts are low compared to the likelihood of injury caused by the lack of post on a forklift. Therefore, the data would also indicate the third corner post's safety benefits outweigh the claimed negative considerations with the post, and the post does provide an overall increase in safety to stand-up forklifts.

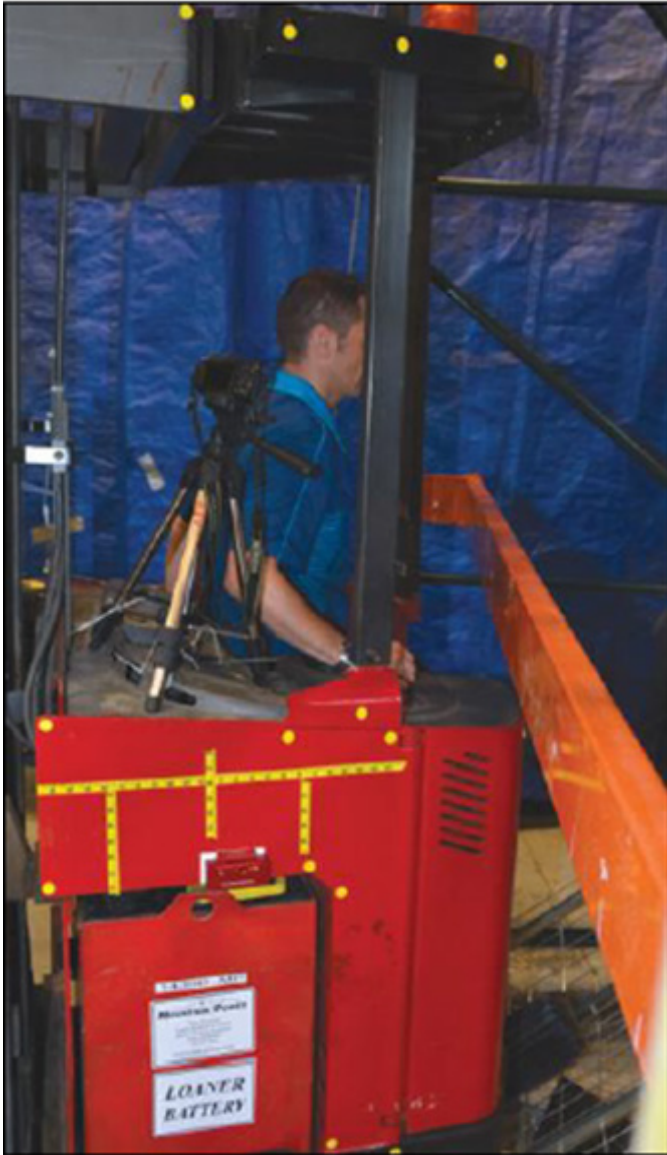
Figure 12

Photograph showing the results of the physical testing performed from the 2015 study³.

One study published in 2015 evaluated the effectiveness of rear posts in guarding against horizontal intrusion at higher travel impact speeds than what is required by the ANSI/ITSDF B56.1 standard³. In the 2015 study, another major manufacturer's (henceforth, will be referred to as “Manufacturer B”) forklift equipped with a third corner post and a fourth corner post system was tested. The rear

posts had a 1.5-inch by 2.5-inch rectangular tube cross-section with a wall thickness of 0.19 inches. The posts had a length of 41 inches and were made out of mild steel.

Manufacturer B's forklift, while carrying its rated load capacity, collided into a section of typical warehouse racking in a perpendicular manner four separate times at speeds of up to 3.4 mph. The portions of the posts that made contact with the rack beam were approximately 5 to 10 inches from the bottom of the 41-inch-long post.

During the tests, both posts contacted a horizontal beam, with the fourth corner post contacting the beam first because the position of the post on the forklift was a few inches further rearward than the third corner post. The test results showed the maximum permanent deformation of the posts was 0.229 inches — a fraction of the 3.9-inch maximum allowed by the B56.1 standard (a factor of safety of approximately 17 in these type of collisions). Further, the test results showed there was up to 9.5 inches of deformation to the impacted rack beam or significantly more than the deformation to the post (**Figure 12** and **Figure 13**).

The study concluded that the rear posts system from Manufacturer B met and exceeded the B56.1 standard and provided operator protection in the event of a horizontal intrusion incident. Furthermore, based on the minimal deflection of the post and the fact that the rack beam did not significantly intrude into forklift operator compartment, the test results showed the rear corner posts had a significant factor of safety and would have been effective in operator protection at higher collision speeds than the tested 3.4 mph speed.

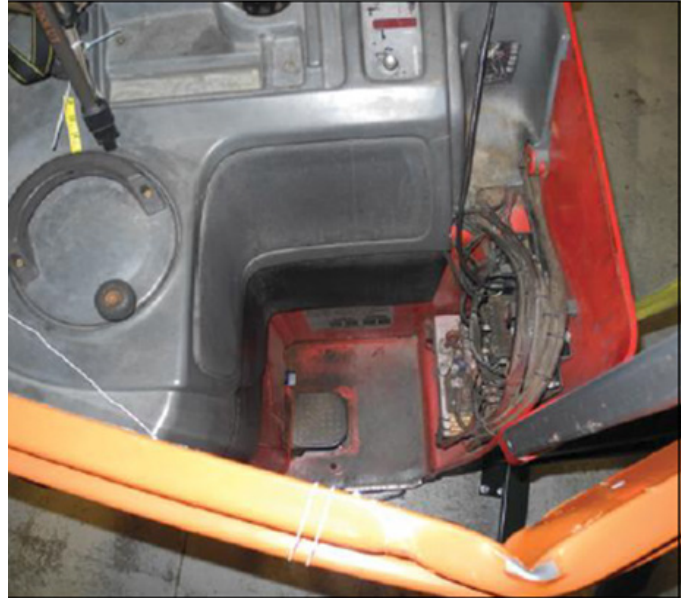
Figure 13

Photograph showing the results of the physical testing performed from the 2015 study (view showing the operator compartment and the deformed beam)³.

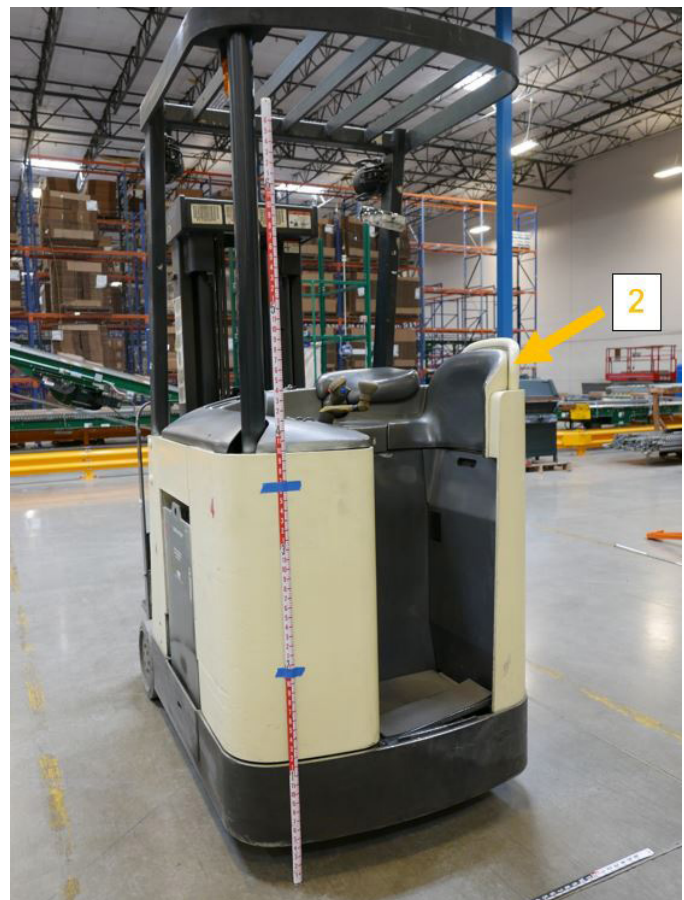
Figure 16
Stand-up forklift equipped with a horseshoe-shaped fourth corner extension feature (arrow #2).

Although the fourth corner extension does offer some horizontal intrusion protection, these extensions have been shown to have significant deficiencies when compared to a full vertical post. Since these extensions require overlap of the rack beam and the fourth corner for the extensions to be effective in preventing horizontal intrusion of rack beams, these extensions are only effective in certain rack configurations and forklift travel directions. The forklift in the previously discussed case study, was equipped with a fourth corner extension (Figure 16). Physical evidence showed the extension did contact the rack beam, and there was an overlap of approximately 4 inches between the rack beam and the fourth corner extension. However, due to the extension's "horseshoe" profile, the rack beam had deformed upward from impact. The beam overrode the extension, and the beam still significantly intruded into the operator compartment, crushing the operator. Therefore, the case study showed these extensions have deficiency in horizontal intrusion protection in certain impact configurations.
