Vol. 38 No. 2 December 2021

Forensic Engineering Investigation of Electrical and Electronic Causes of an Industrial Equipment Failure

By Robert O. Peruzzi, PhD, PE, DFE (NAFE 954M)

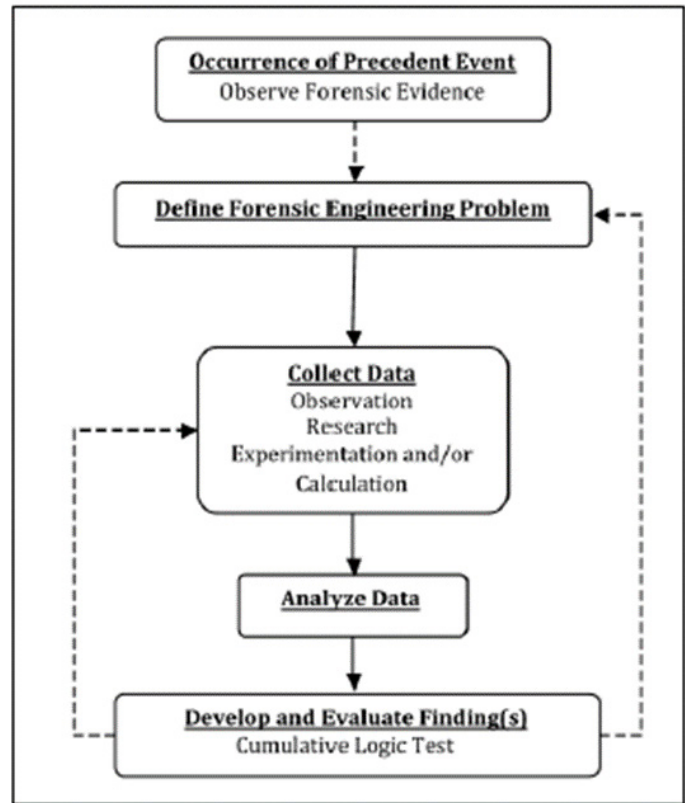
For a complete description of the scientific method as it applies to forensic engineers, see “Forensic Engineering and the Scientific Method”³. From that article is **Figure 1**, a flowchart illustrating the forensic engineering method utilized in applied science or technology, which is an adaptation of the most general scientific method.

Figure 1
Flowchart illustrating forensic engineering method presented in “Forensic Engineering and the Scientific Method” by Liptai and Cecil.

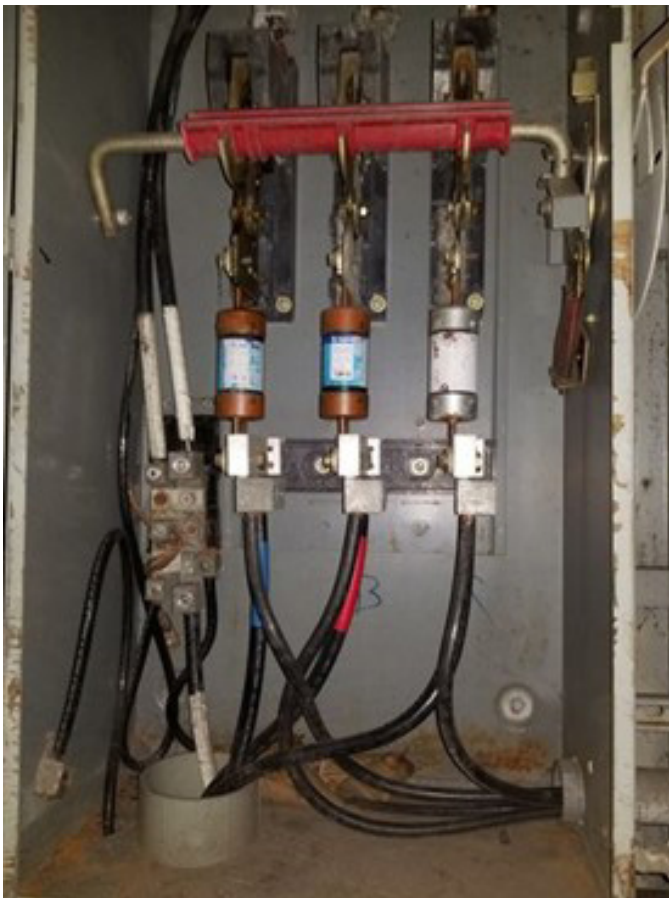
Figure 5
Panel 1, showing proper configuration of three fuses and neutral-to-ground bonding point.

The bonding point of neutral to ground for the building can be seen to the left of **Figure 5**. All of the neutral return lines within the building should be isolated from ground until they reach this bonding point within Panel 1. One can see that panel cabinet is also bonded to this ground point.

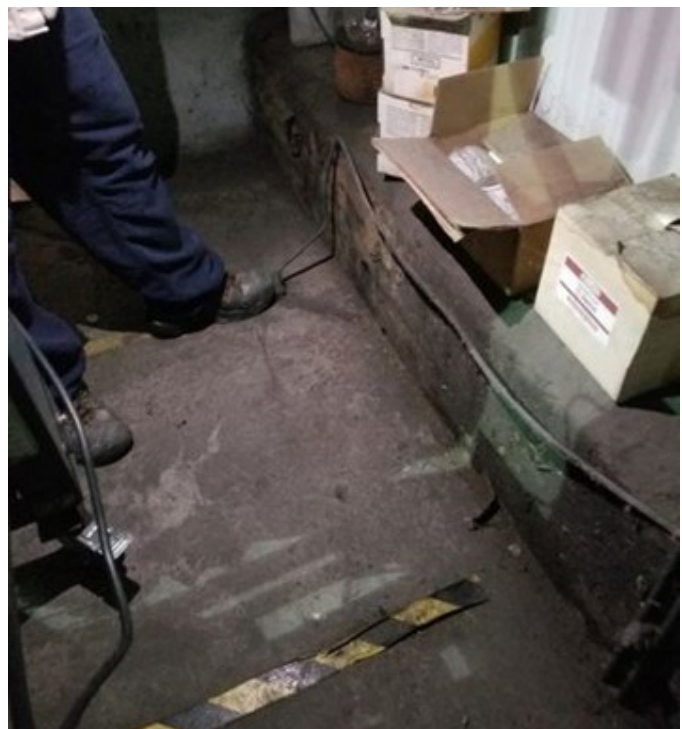
Earth grounding is established by a grounding rod penetrating the foundation into the earth as shown in **Figure 6** (pointed out by the author's foot). This earth-ground is bonded to the node shown in **Figure 5**.

Figure 6
Service ground is established by a steel rod penetrating the foundation into the earth.

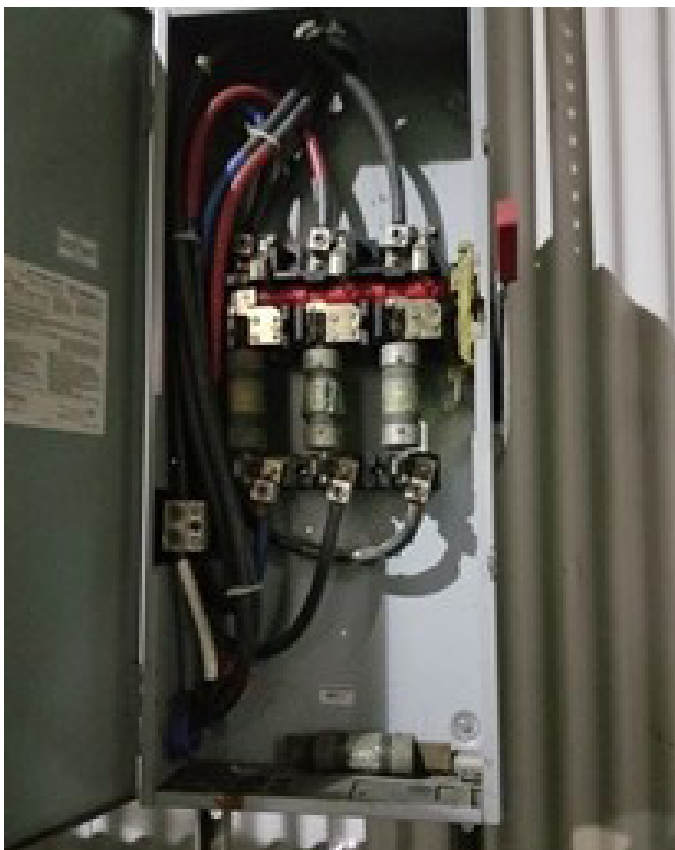
Figure 7

Panel 2 is mounted on the same exterior wall, a few meters from Panel 1. Panel 2, shown in **Figure 7**, limits the available current to 200A. Three hot phases, neutral, and ground wires can be seen. As is proper, neutral and ground are isolated from each other by insulating fittings. This isolation and the bonding between the cabinet of Panel 2 and ground can be seen more readily in **Figure 8**.

Internal view of Panel 2 shows neutral isolated from ground.

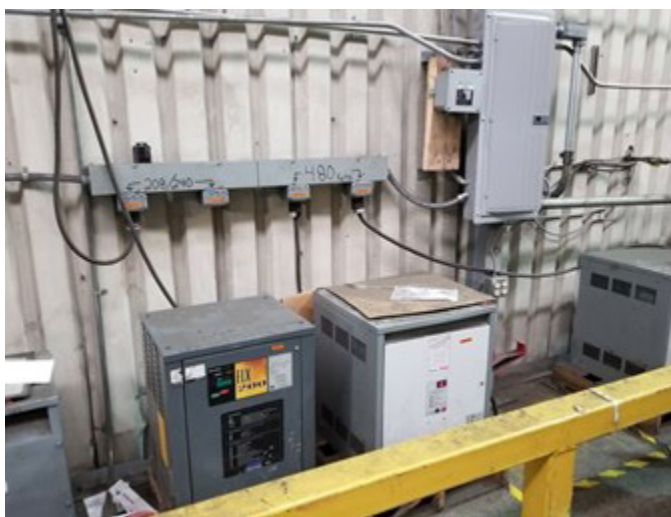
Panel 3 is the first panel upstream from the equipment and is shown on the upper right of **Figure 11** (on page 28). Panel 3 supplies power to the two chargers for the

lithium-ion batteries of electric-powered forklifts on the floor beside Panel 3 — and to the subject equipment in a large factory room across the wall from Panel 3.

Figure 11
Panel 3 and two forklift battery chargers.

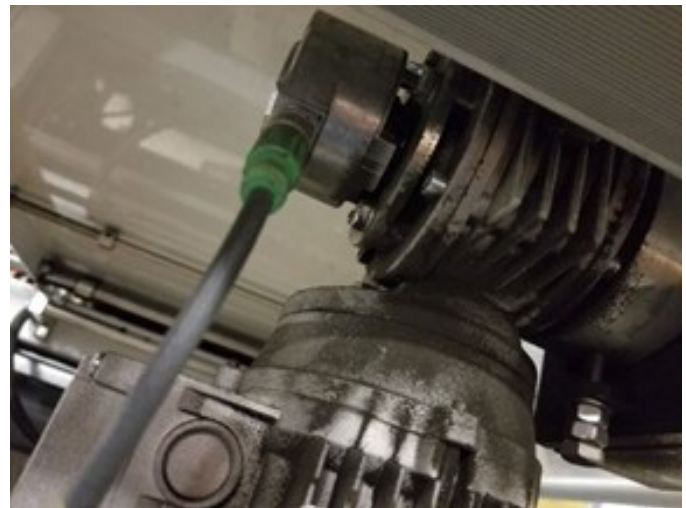
shows one of the position sensors that failed regularly. The green collar attaches the cable to the output stage of the sensor — that is, the push-pull driver shown in **Figure 4**. The green collar also bonds the cable's shielding to the sensor's housing.

Figure 12
One of the position sensors that regularly failed shows intact cabling and shielding.

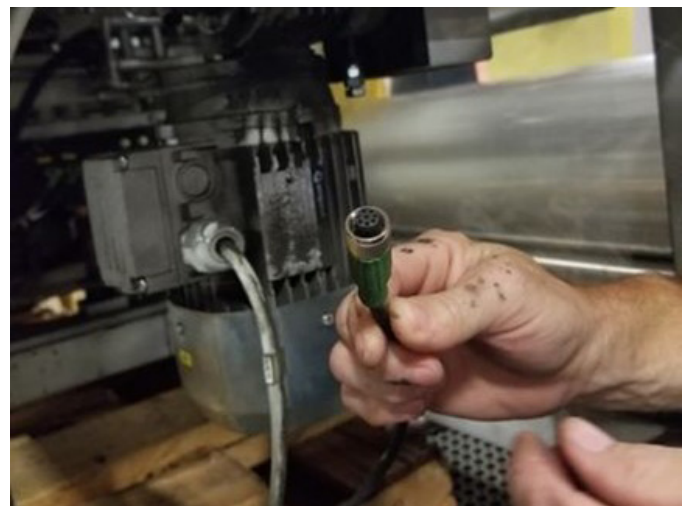
The opposite end of the green cable connector is shown in **Figure 13**, along with the connecting fixture to the microprocessor. Cable and connector include shielding. Outside of connector is connected to shield and makes electrical contact with the encoder housing. Shielded point to point connectivity to grounded metal housings provides protection from ESD and RFI damage. The author observed similar proper grounding and shielding techniques throughout the equipment, making hypotheses

Figure 13
Opposite end of the cable of **Figure 10** where it attaches to the microprocessor.
